CERTA PROPERTY INSPECTIONS

PROPERTY REPORT

345 Demo Street
Calgary, AB T2N 3C7

JULY 24, 2023

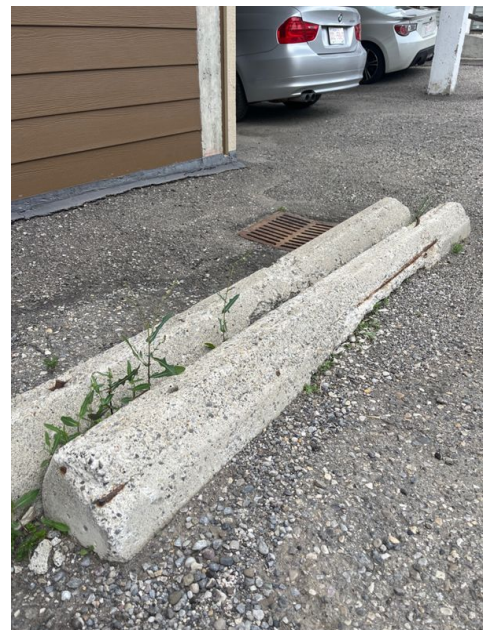
DAMAGE

One or more curb stops were damaged and should be repaired or replaced.

Contact a qualified professional.

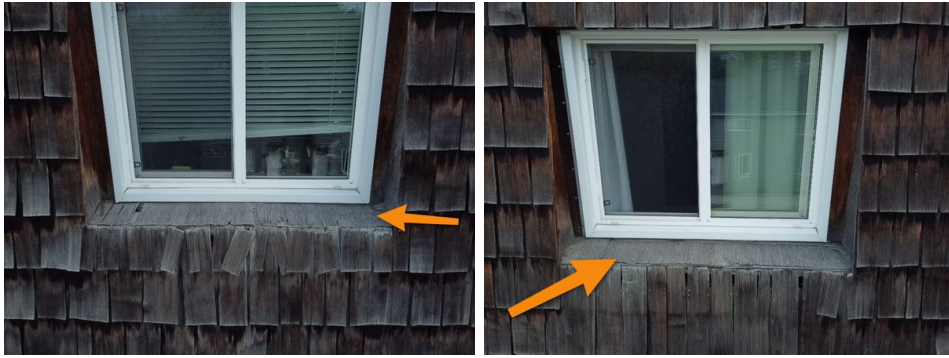
FLASHING MISSING

It is recommended to have flashing installed to prevent weather and vermin intrusion.

Contact a qualified siding specialist.

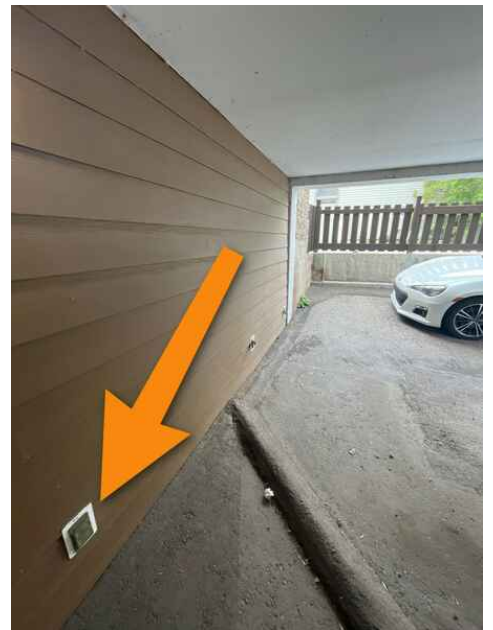
2.19.1 GFCI

NO GFCI

It is recommended that GFI protected receptacles be installed within 6 feet of any water sources as well as receptacles found outside below 2.5 meters. It is recommended to have a qualified electrician install these.

Contact a qualified electrical contractor.

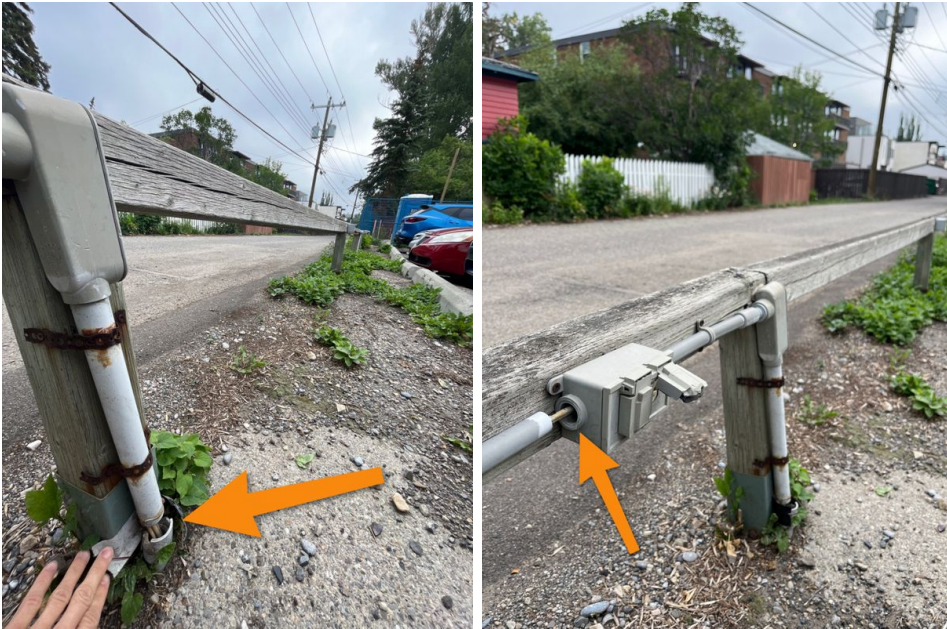
2.24.1 Conduit

DISCONNECTED / DAMAGED

One or more conduits were damaged / disconnected. This should be corrected by a qualified electrician.

Contact a qualified electrical contractor.

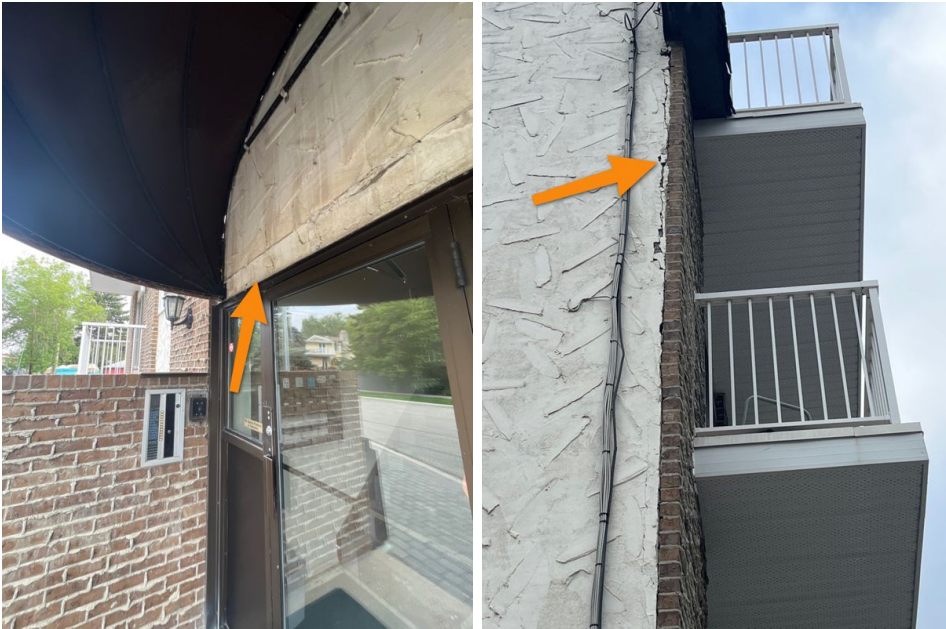
CRACKS IN STUCCO

Some cracks in the stucco were found at the exterior walls of the structure. All cracks and openings should be sealed and monitored for further expansion as they may indicate an ongoing issue.

Contact a qualified siding specialist.

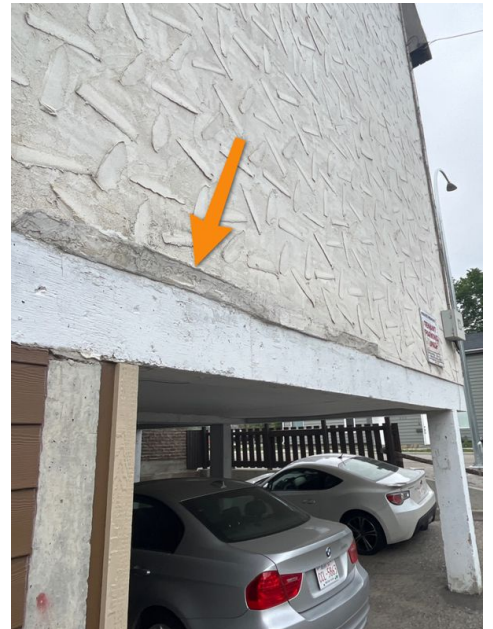
2.30.2 Siding

DAMAGE

Damage was noted at the siding. It is always recommended to seal / caulk any gaps and penetrations around the building envelope. Doing so helps prevent weather and critters from entering and damaging the structure.

Contact a qualified siding specialist.

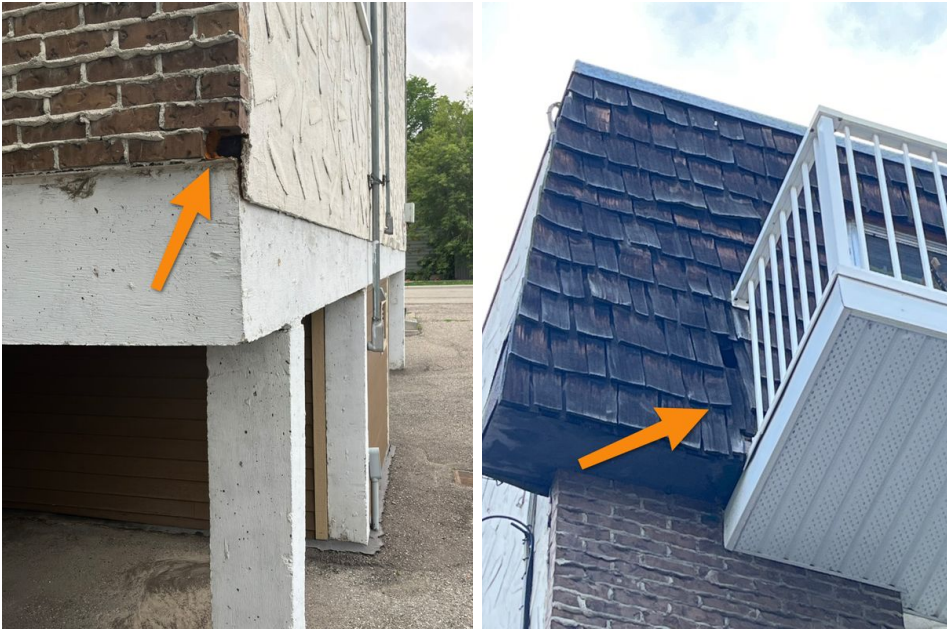
Some areas of siding were missing and should be installed to keep the weather and vermin out.

Contact a qualified siding specialist.

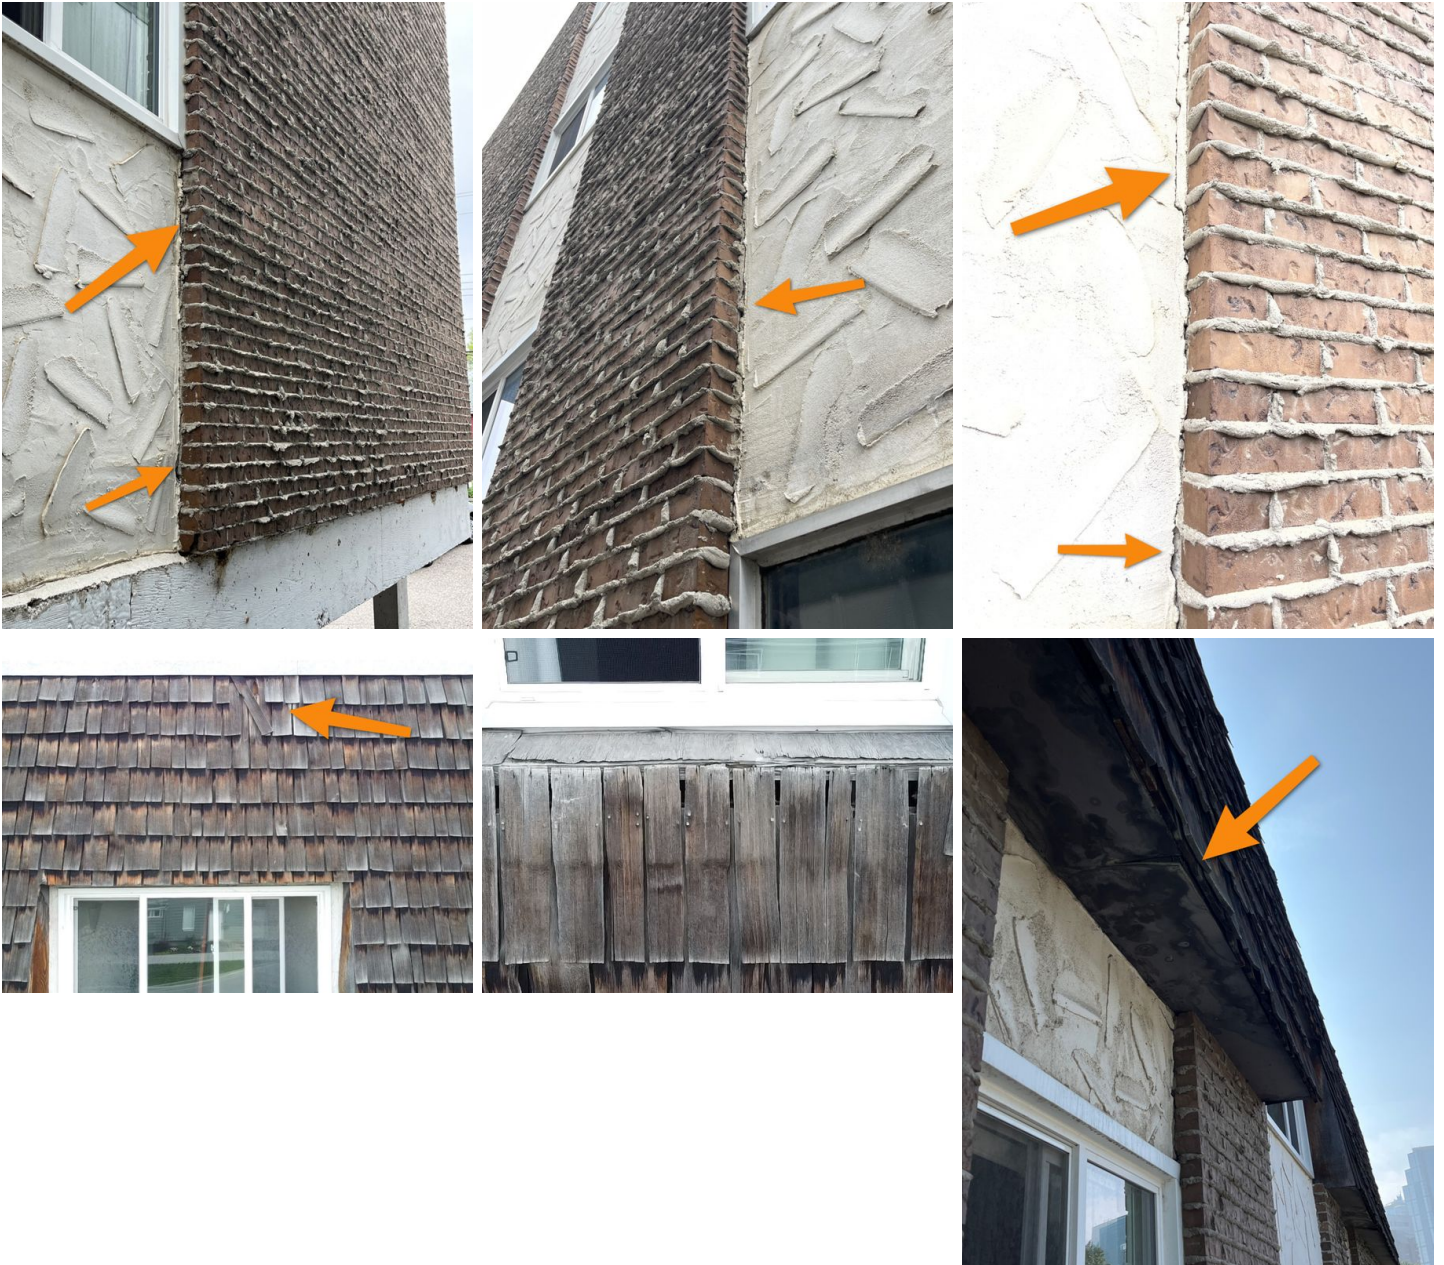
It is always recommended to seal / caulk any gaps and penetrations around the building envelope. Doing so helps prevent weather and critters from entering and damaging the structure.

Contact a qualified siding specialist.

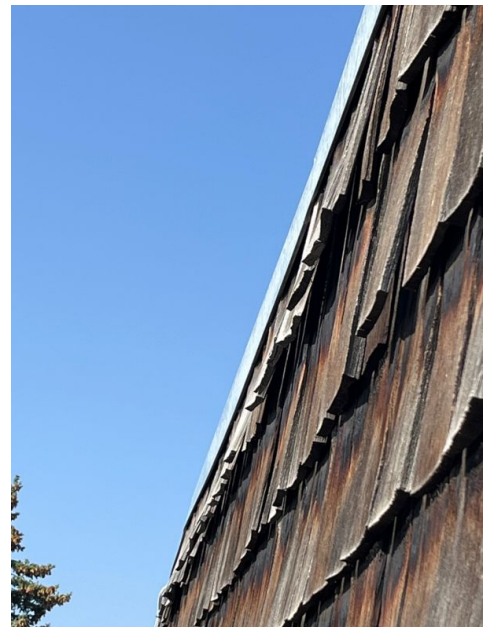
2.30.7 Siding

CURLING

Curling is a sign of ageing for wood products. It is recommended to budget for future replacements.

Contact a qualified professional.

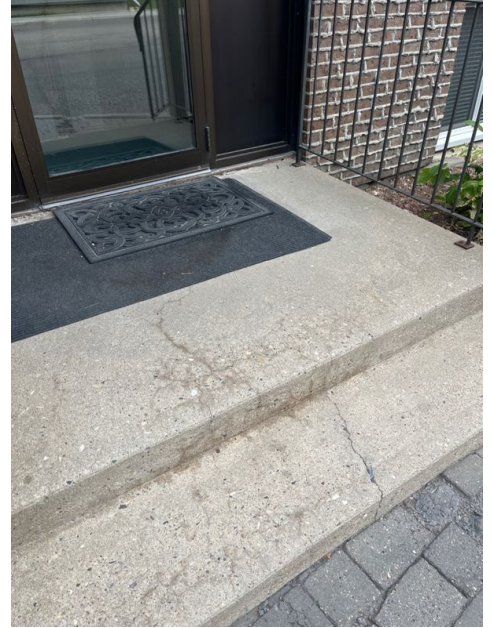
2.33.1 Steps

CRACKS / SPALLING IN STAIRS

The entrance steps were given a brief inspection. Typical cracks and spalling were noted. It is recommended these areas be repaired to prevent further deterioration.

Contact a qualified concrete contractor.

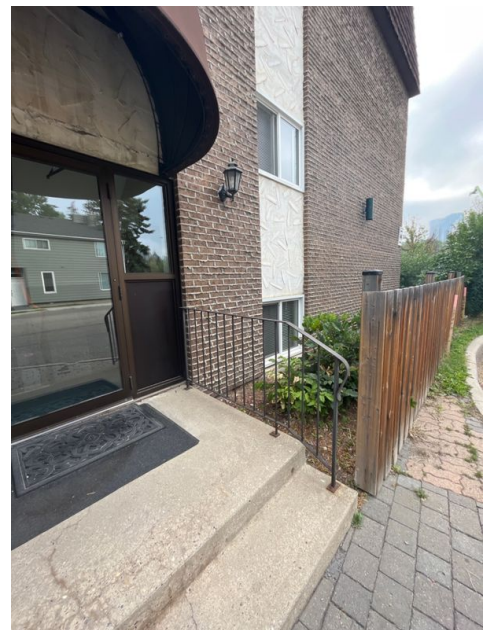
2.33.2 Steps

HANDRAIL LOOSE

One or more handrails were noted to be loose and should be better secured by a qualified professional.

Contact a qualified carpenter.

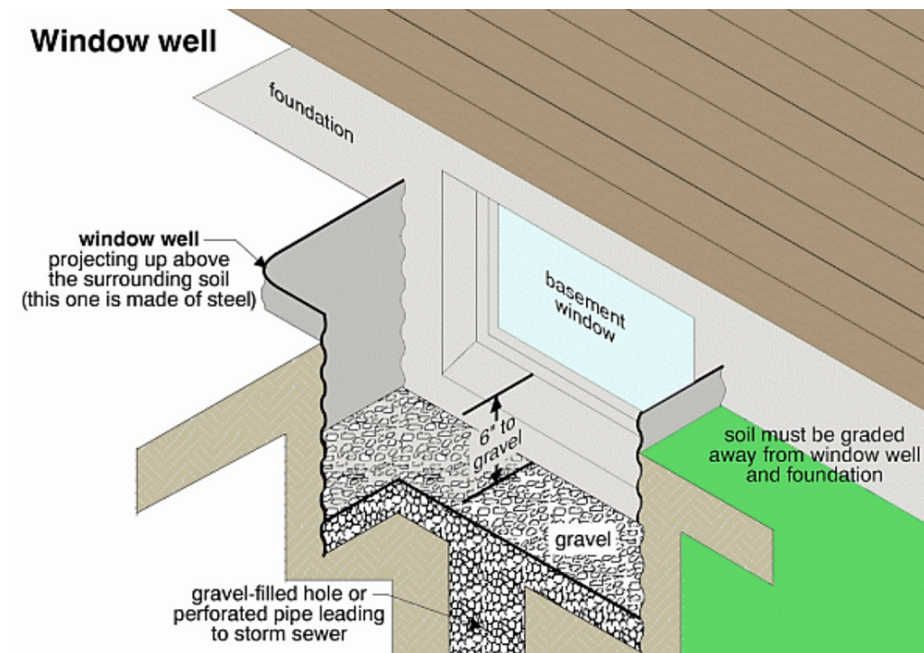
WINDOW WELLS MISSING

It is recommended to have window wells around basement windows to prevent water intrusion around the framing.

Recommendation
Contact a qualified carpenter.

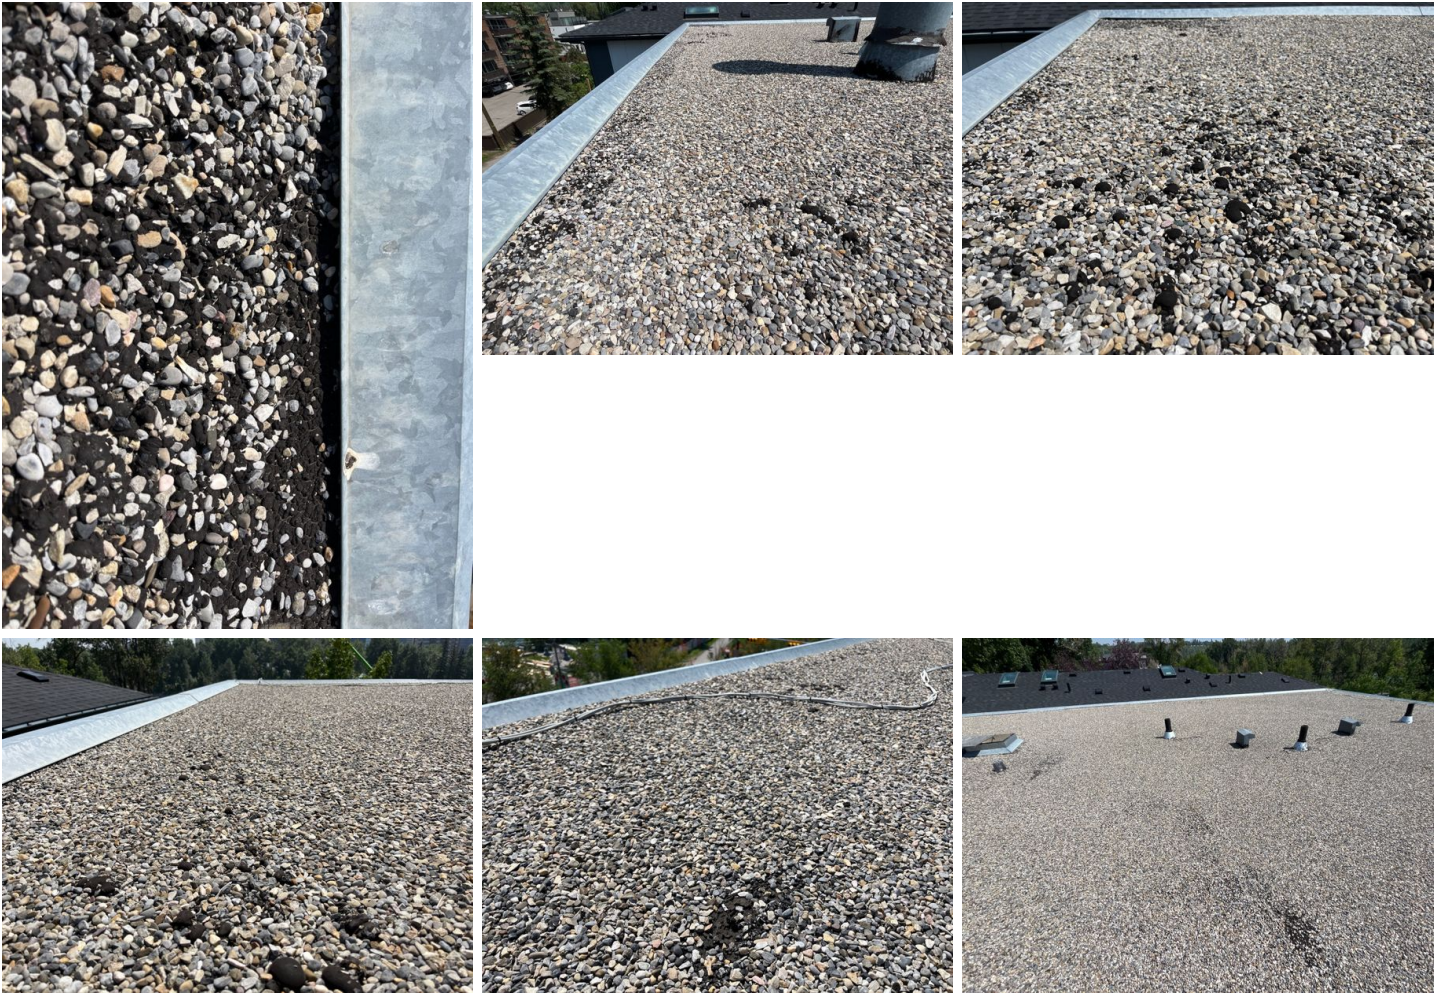
BUILT UP ROOFING DEFECT(S)

Exposed areas of the membrane were noted along with cracking / alligatoring. It is recommended to replace the missing ballast and monitor the areas for leakage. No active leaks were noted in these areas at the time of the inspection.

Recommendation
Contact a qualified roofing professional.

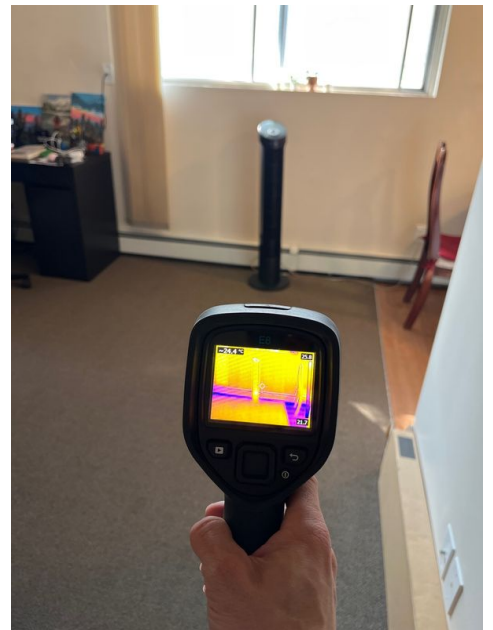
HYDRONIC HEATING INOPERATIVE - TEMPERATURE

It should be noted that the hydronic heating is not functional. This may be due to the high ambient temperature.

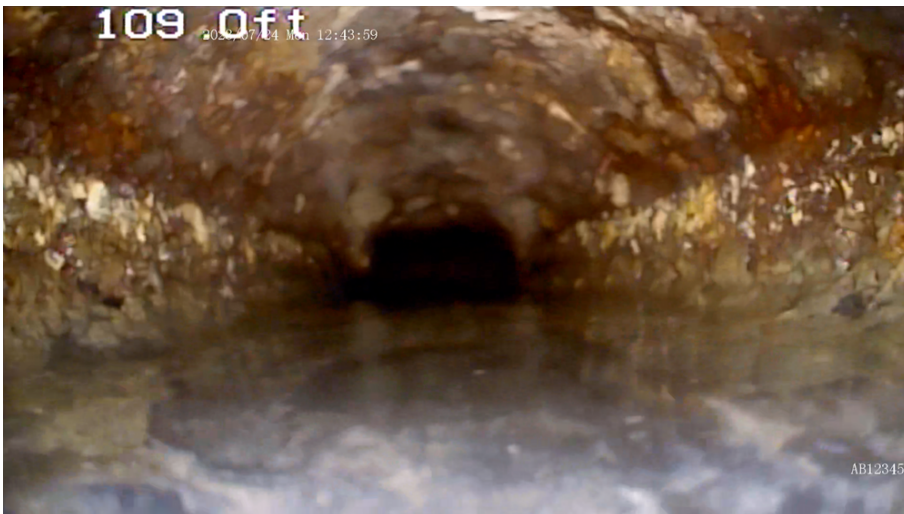
Sewer Camera Inspection: Sewer Inspection Performed

A sewer camera inspection was performed. The municipal tie in was reached at approximately 110 feet.

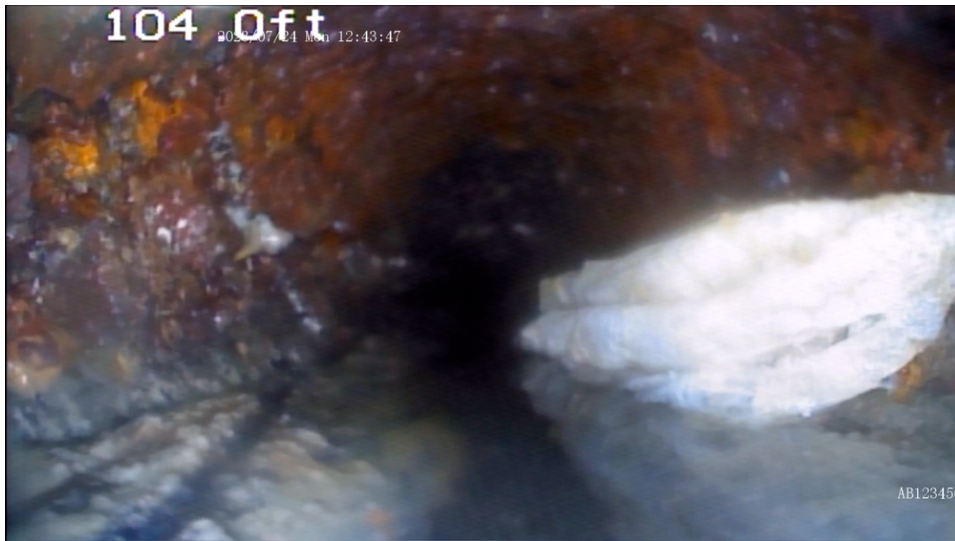
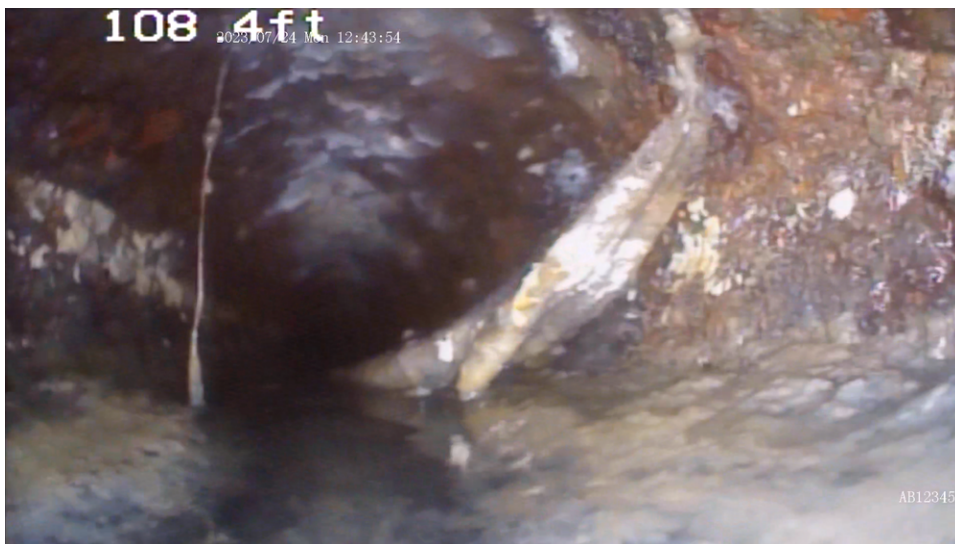
5.9.1 Sewer Camera Inspection

DEBRIS

Some debris was noted in the sewer line. It is recommended to have a cleaning program to remove the debris to help mitigate the chance of a sewer back up.

Recommendation
Contact a qualified professional.

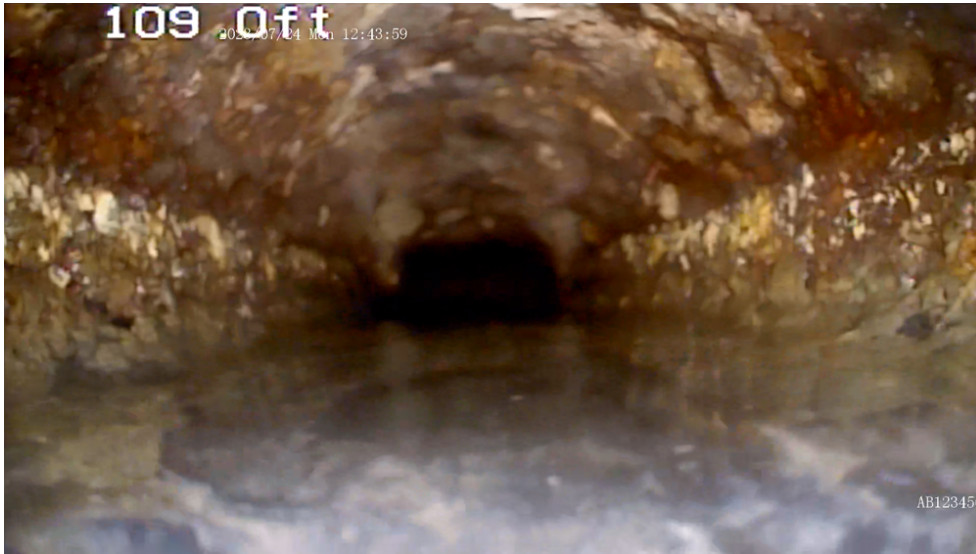
5.9.2 Sewer Camera Inspection
DIP / BELLY

A dip / belly was noted at appx. 3, 40, 47, 56, 95, 99, 104 and 109 feet. It is always recommended that drain lines have a negative slope towards the municipal tie in points as dips and bellies can cause debris to accumulate which may result in a sewage backup. It is recommended to maintain an annual or biannual cleaning maintenance program as debris was noted in several areas.

Contact a qualified plumbing contractor.

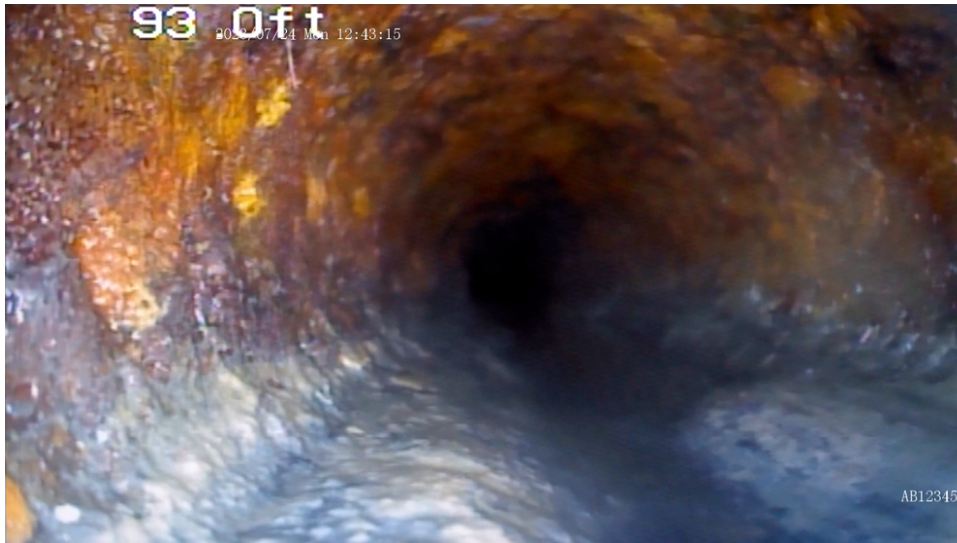
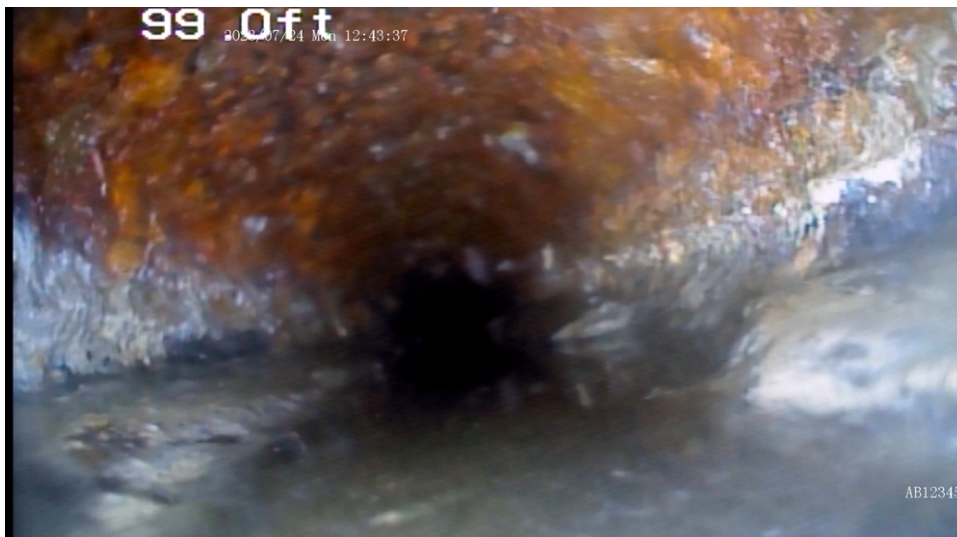
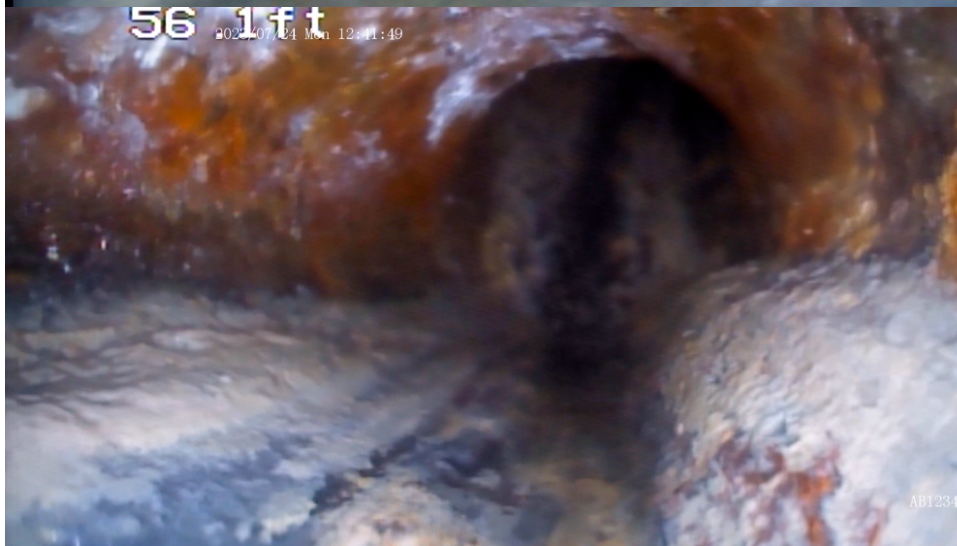
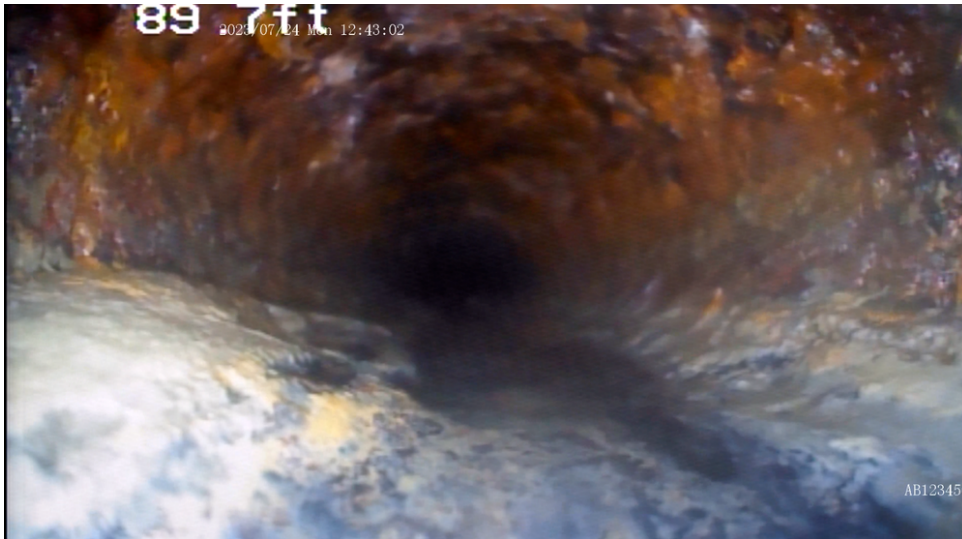
Build up was noted in various areas of the sewer line. It is recommended to clean the line to mitigate the chance of a sewer backup. Once cleared, it is recommended to perform another sewer camera inspection to confirm no bulges exist below the build up.

Contact a qualified professional.

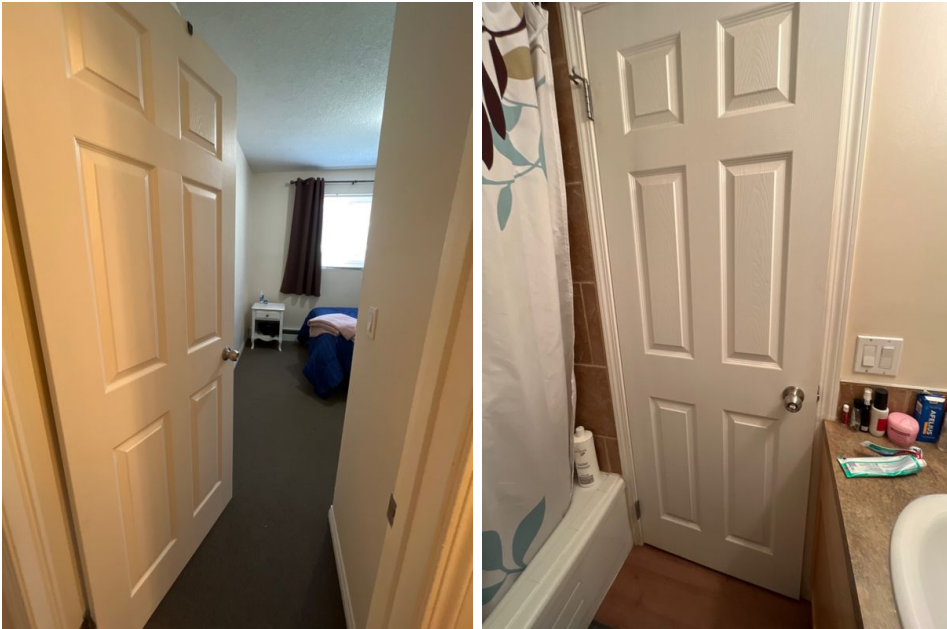
UNIT 12

One or more doors did not latch well. A servicing is recommended for smoother operation.

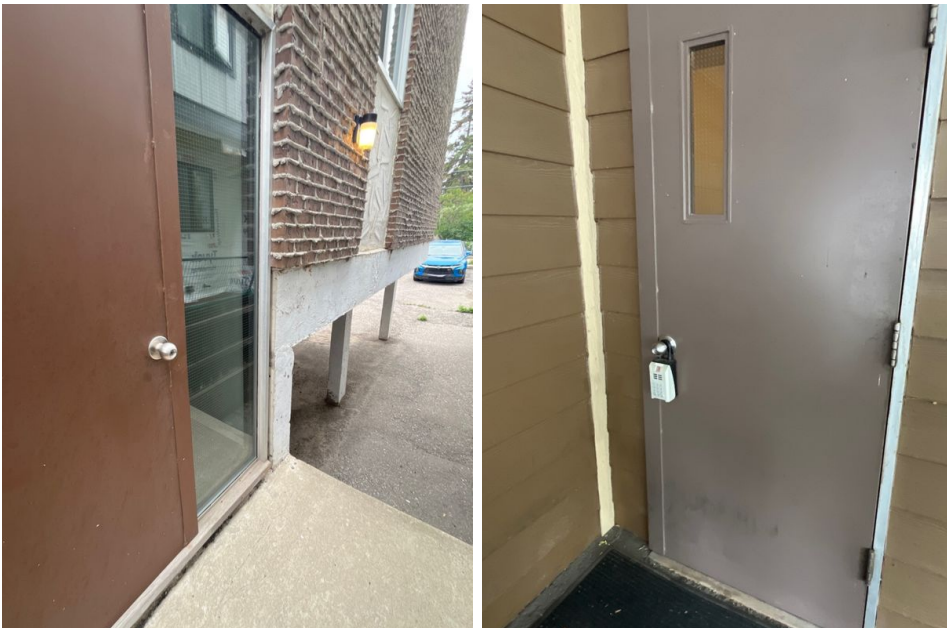
9.4.5 Doors

HARDWARE MISSING - DEADBOLT

It is recommended to install deadbolts for exterior doors.
