# CERTA PROPERTY INSPECTIONS

## PROPERTY REPORT

234 Demo Street  
Calgary, AB T4B 1L1

SEPTEMBER 12, 2023

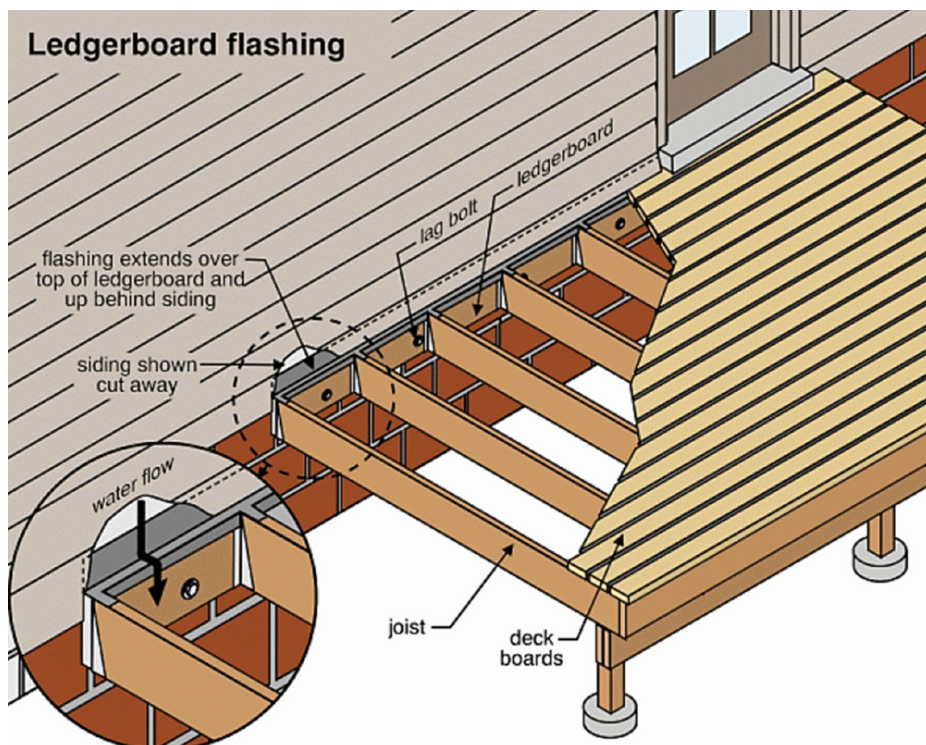
### 2.7.2 Deck(s)

#### **DRIP EDGE NOT FOUND AT LEDGER BOARD**

No drip edge was found between the deck and the dwelling. This should be added, if missing, as it helps to keep moisture from entering the building envelope.

##### Recommendation

Contact a qualified carpenter.

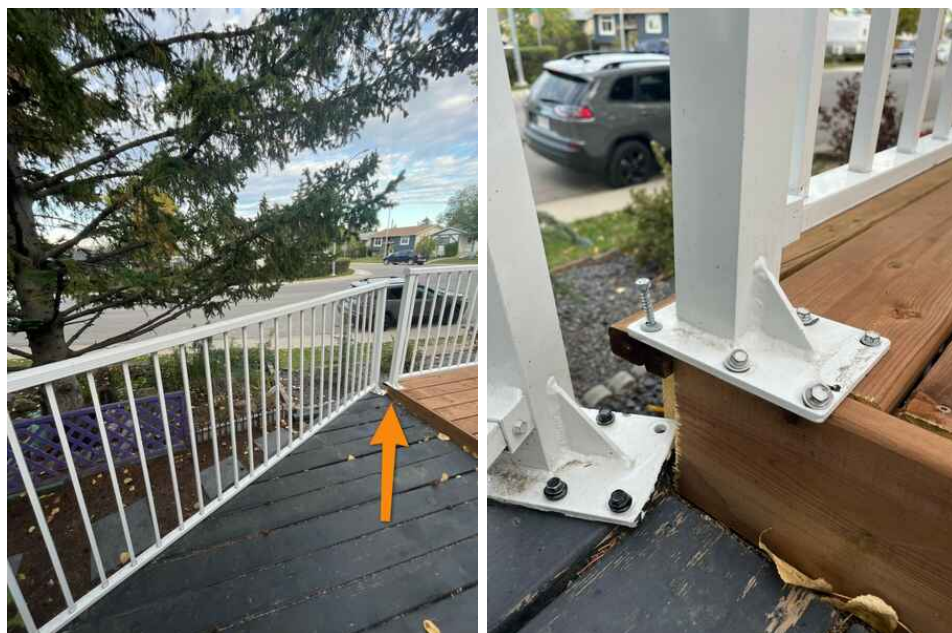
### 2.7.3 Deck(s)

#### **HANDRAIL LOOSE**

One or more handrails were noted to be loose and should be better secured by a qualified professional.

Recommendation

Contact a qualified carpenter.

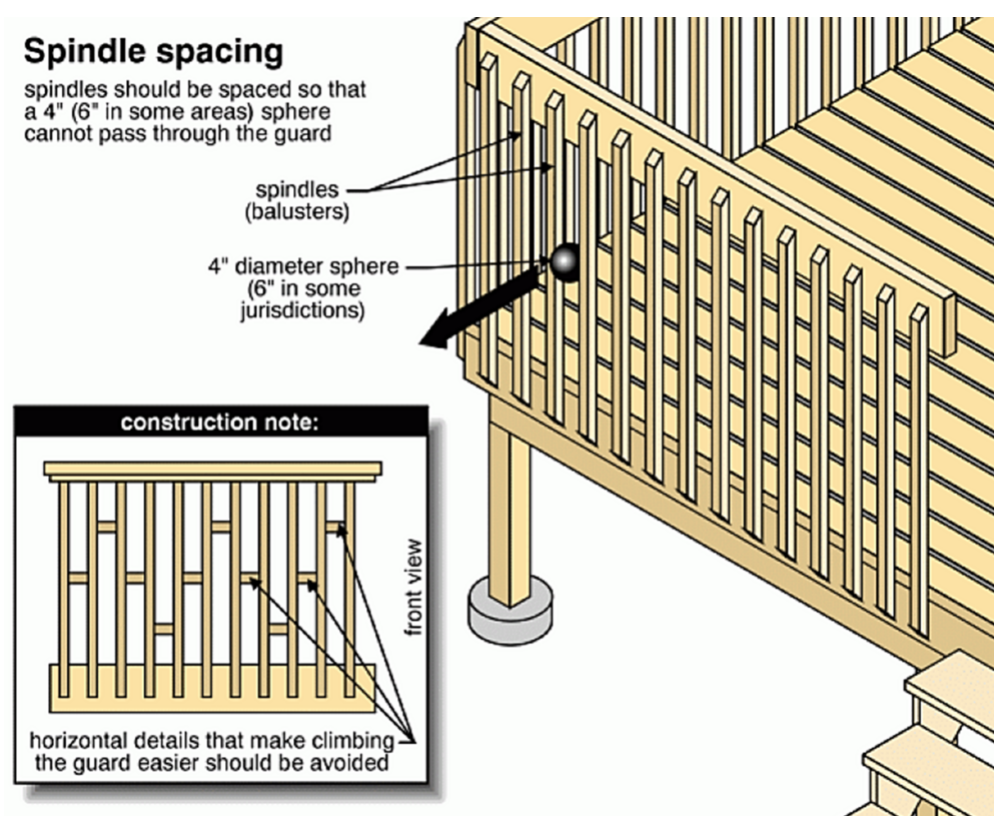
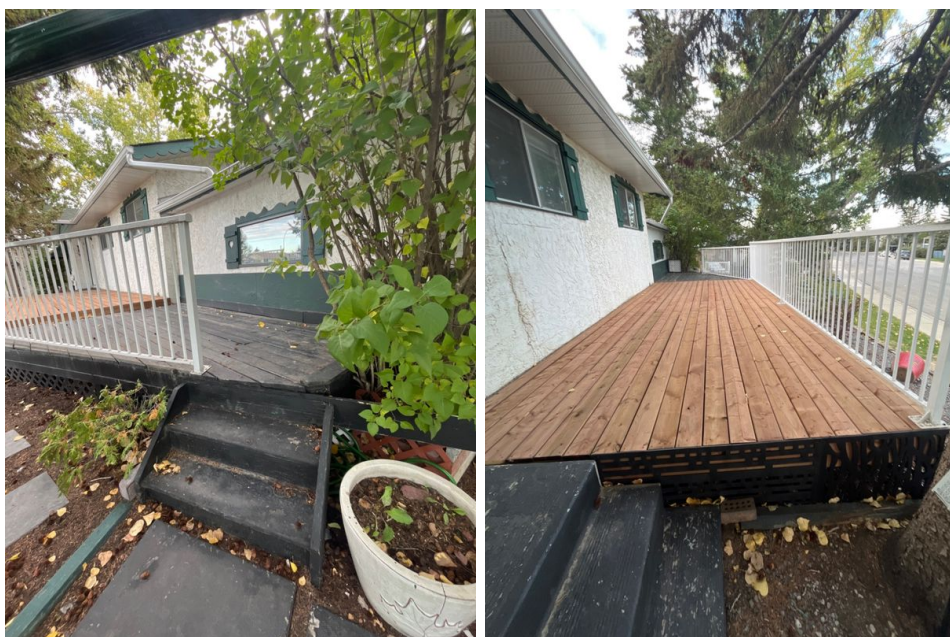
### 2.7.4 Deck(s)

#### **HANDRAILS RECOMMENDED**

Structures over 24" in height should have handrails and balusters to help prevent falling incidents.

Recommendation  
Contact a qualified carpenter.

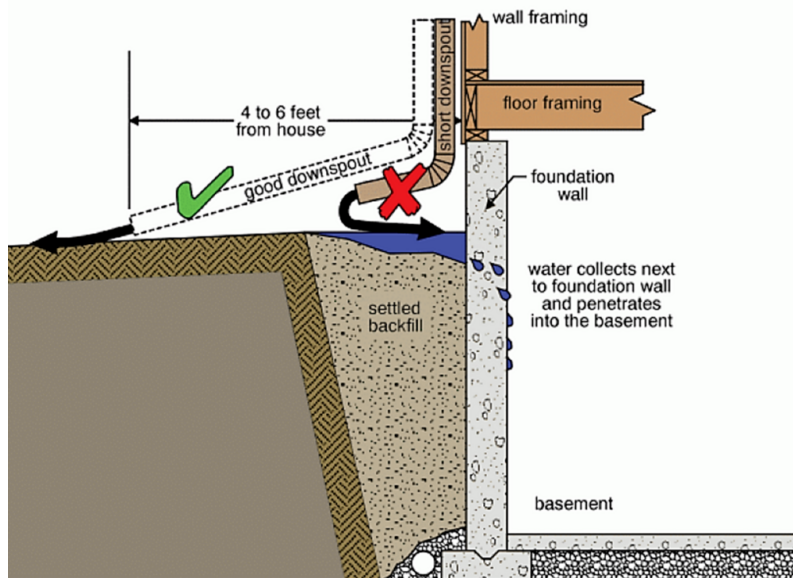
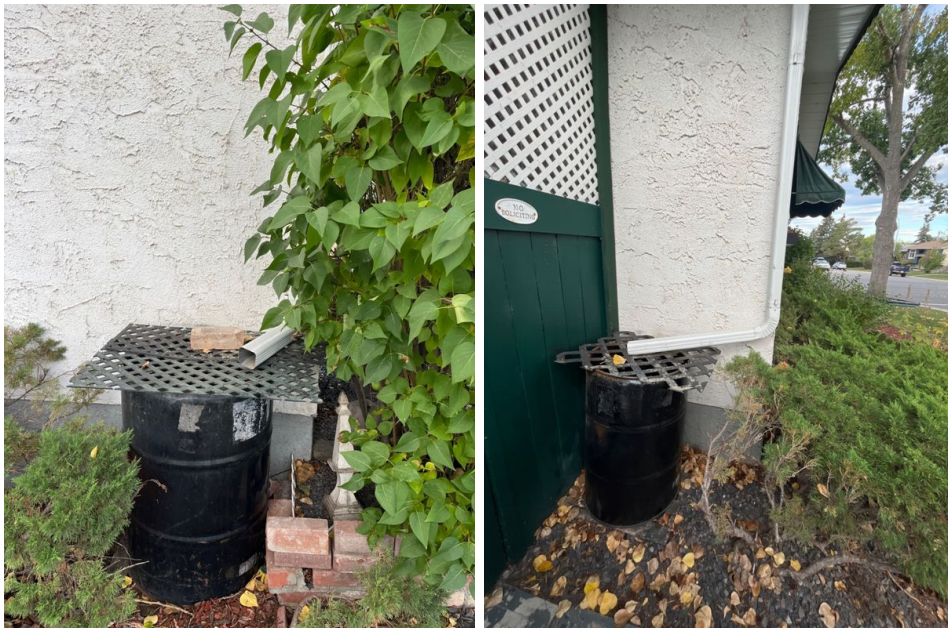
## 2.9.1 Downspouts / Gutters

**DRAIN NEAR STRUCTURE**

Downspouts should always be deployed to aid in water expulsion away 6 feet from the structure. Downspout extensions should be secured to downspouts and extended away from the building. This helps to prevent water migrating into the building. Downspouts should be checked for leaks and sealed or replaced if found.

#### Downspout extension too short

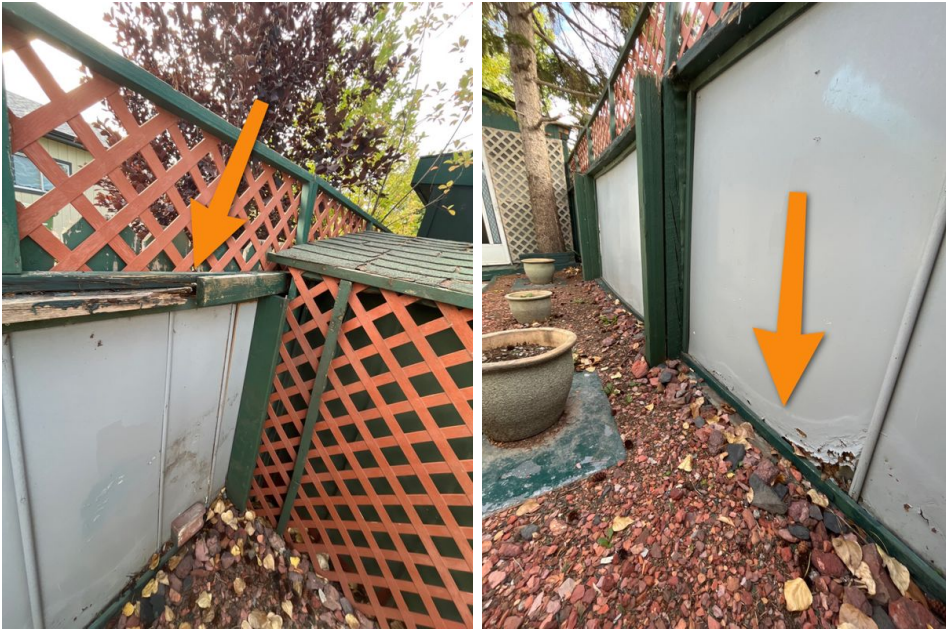
##### **ROT**

Rot was noted in several areas of the fence line. It is recommended to budget for replacement components.

Recommendation

Contact a qualified carpenter.

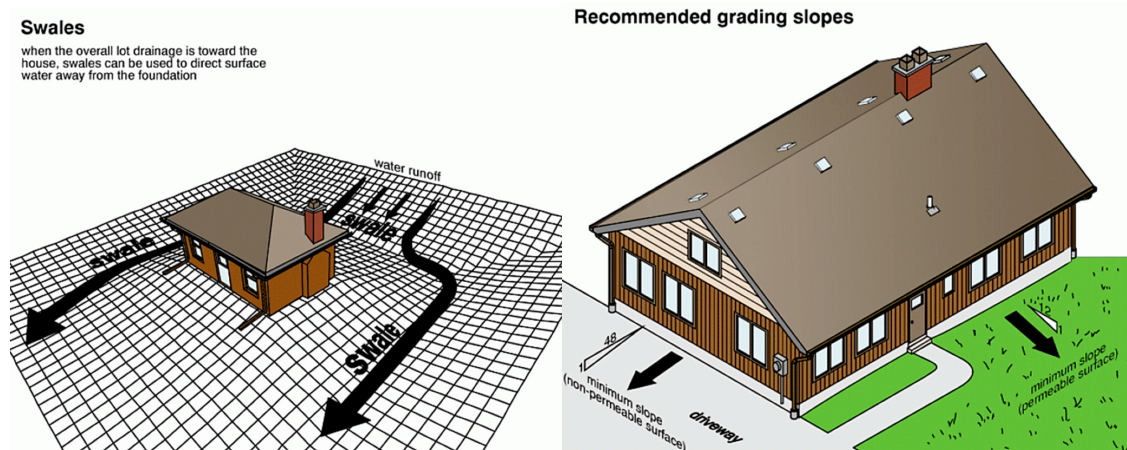
2.21.1 Grading  
**POOR GRADING**  
FRONT OF HOME

It is recommended that the grading around the structure be positive; meaning that it should slope away. This helps prevent water penetration into the structure. Fill areas that have settled next to the structure with clay—not topsoil— with a positive slope away from the structure (10 per cent is recommended). It should be noted that rock, gravel, mulch, etc. drains water down the exterior wall and not away. It is unknown what the grading is below these materials.

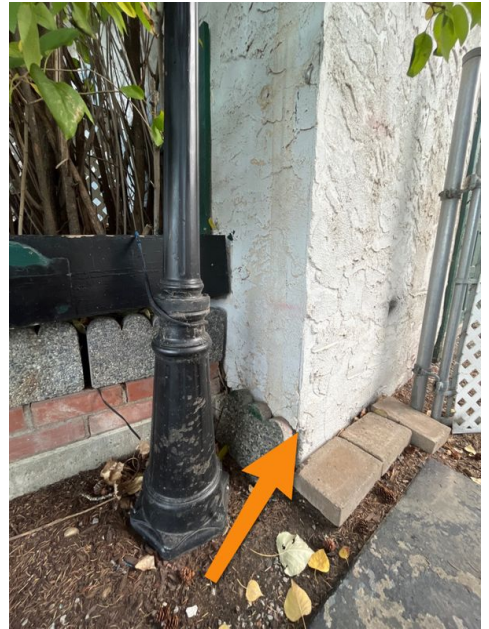
### 2.31.1 Siding

#### **CRACKS IN STUCCO**

Some cracks in the stucco were found at the exterior walls of the structure. All cracks and openings should be sealed and monitored for further expansion as they may indicate an ongoing issue.

#### Recommendation

Contact a qualified siding specialist.

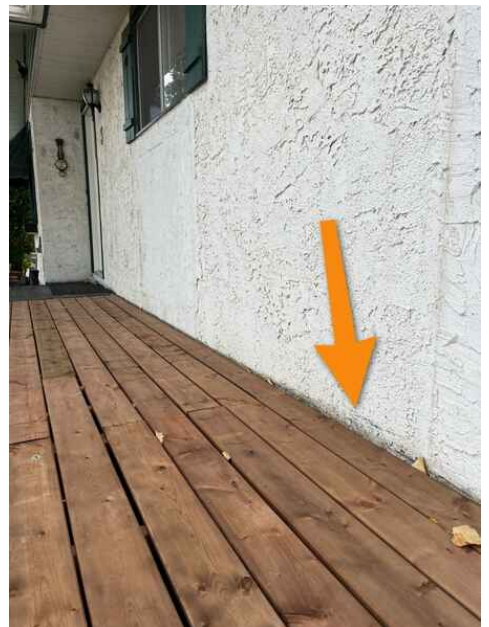
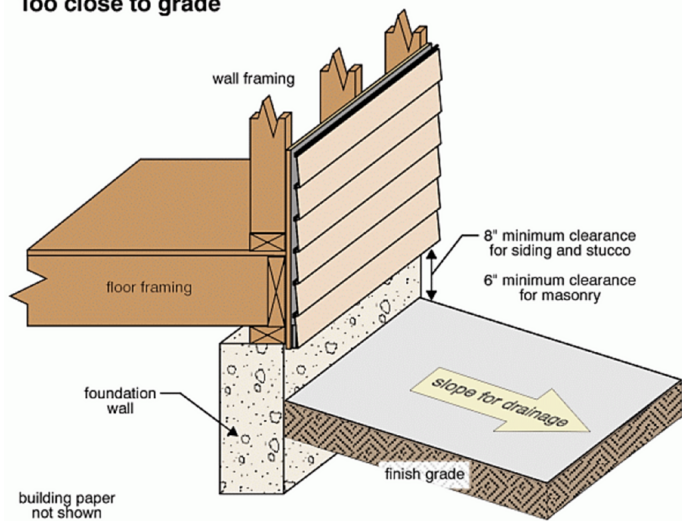
### 2.31.2 Siding

#### **GROUND CLEARANCE**

**Too close to grade**

Recommendation

Contact a qualified siding specialist.

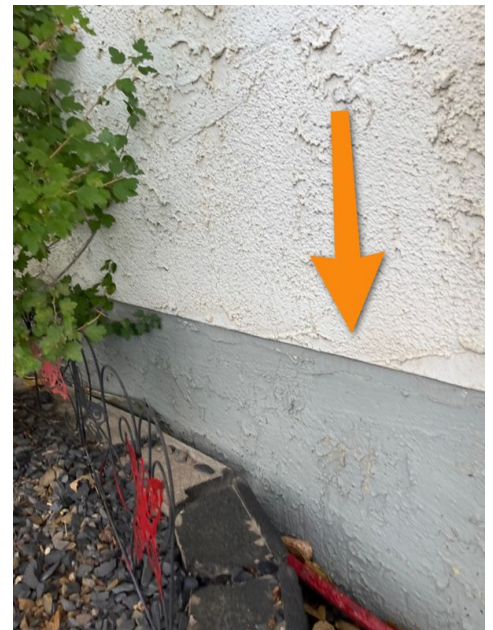
## 2.31.3 Siding

**MISSING FLASHING - SUBSTRATE**

It is recommended to install drip edge flashing when there is a change in cladding substrate.

## Recommendation

Contact a qualified siding specialist.

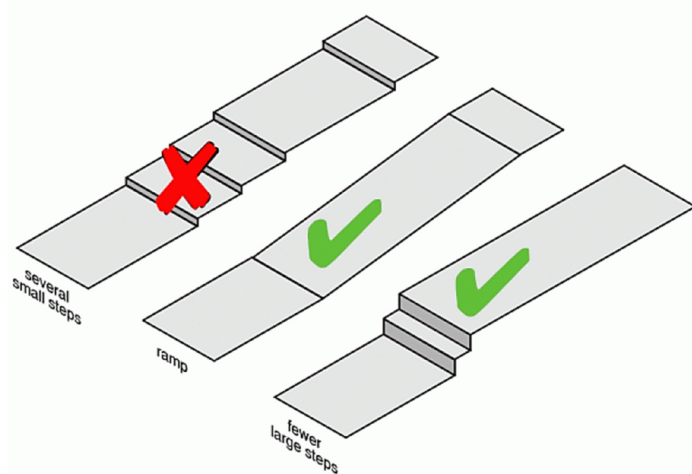
It is recommended to have level walkways to prevent tripping hazards.

#### Walkway steps

#### Recommendation

Contact a qualified landscaping contractor

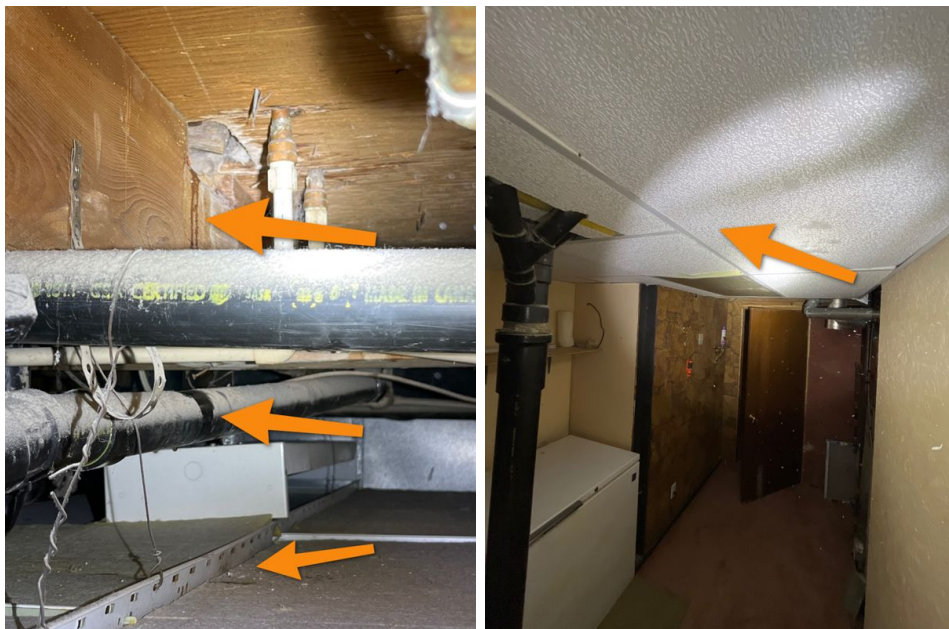
#### 6.4.4 Fixtures

##### **LEAK**

##### Recommendation

Contact a qualified plumbing contractor.

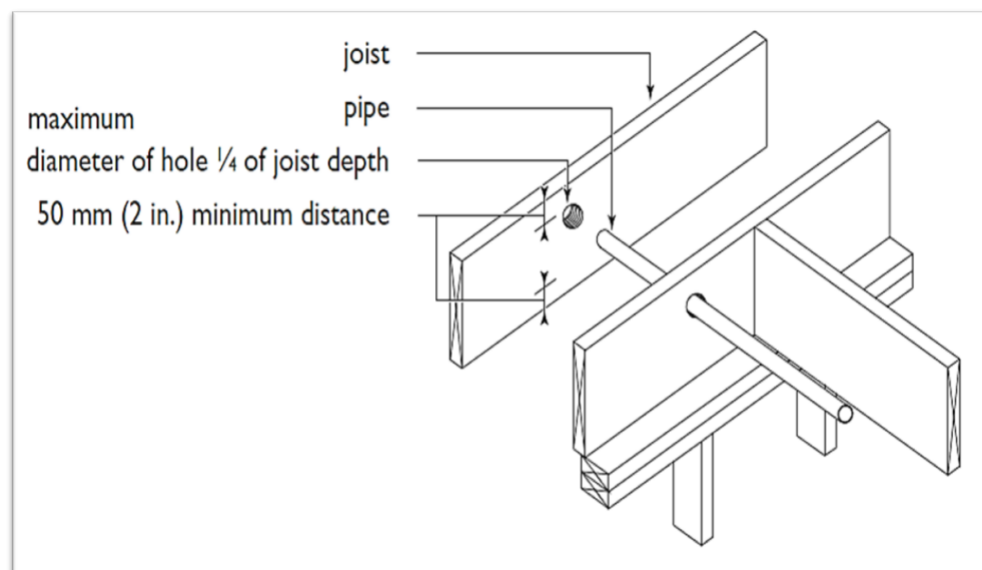
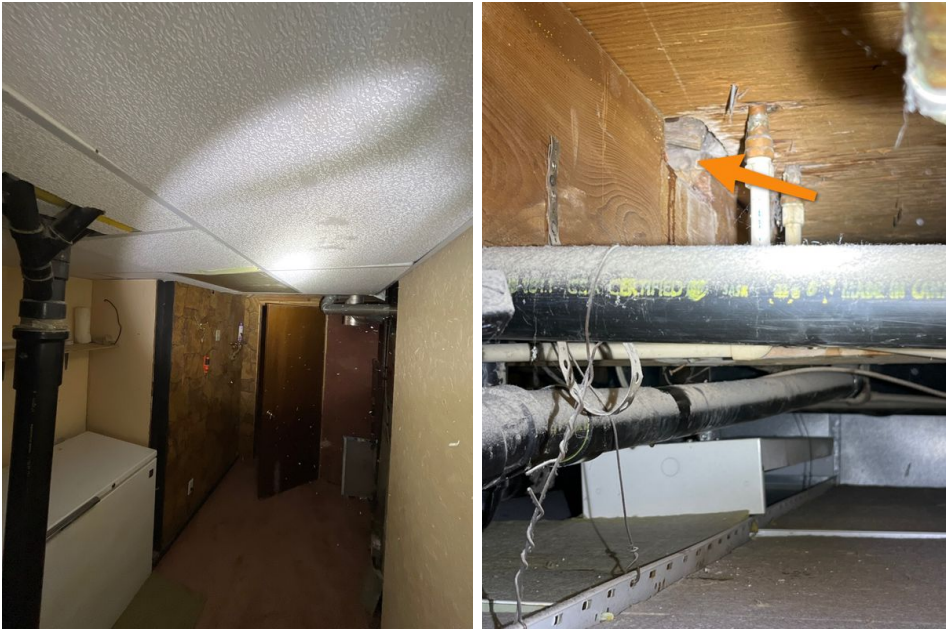
#### JOISTS NOTCHES / ALTERATIONS

One or more of the joists were noted to be notched in the flooring system. It is recommended that a qualified carpenter further assess these areas.

Recommendation

Contact a qualified carpenter.

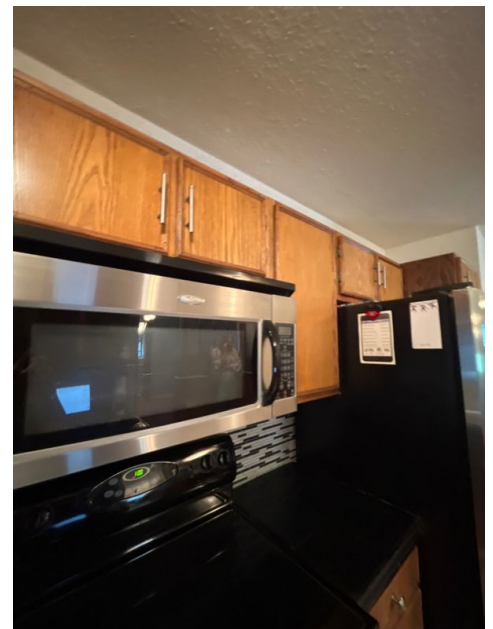
#### **DOES NOT DISCHARGE OUT OF STRUCTURE**

It is recommended that exhaust fans be vented out of structures.

Recommendation

Contact a qualified roofing professional.

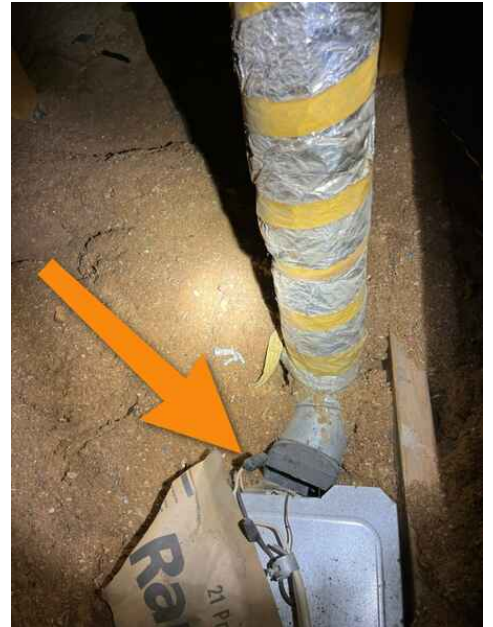
## 9.2.2 Exhaust Systems

**DUCTS LOOSE**

Ductwork in the attic is loose or disconnected. Recommend repair.

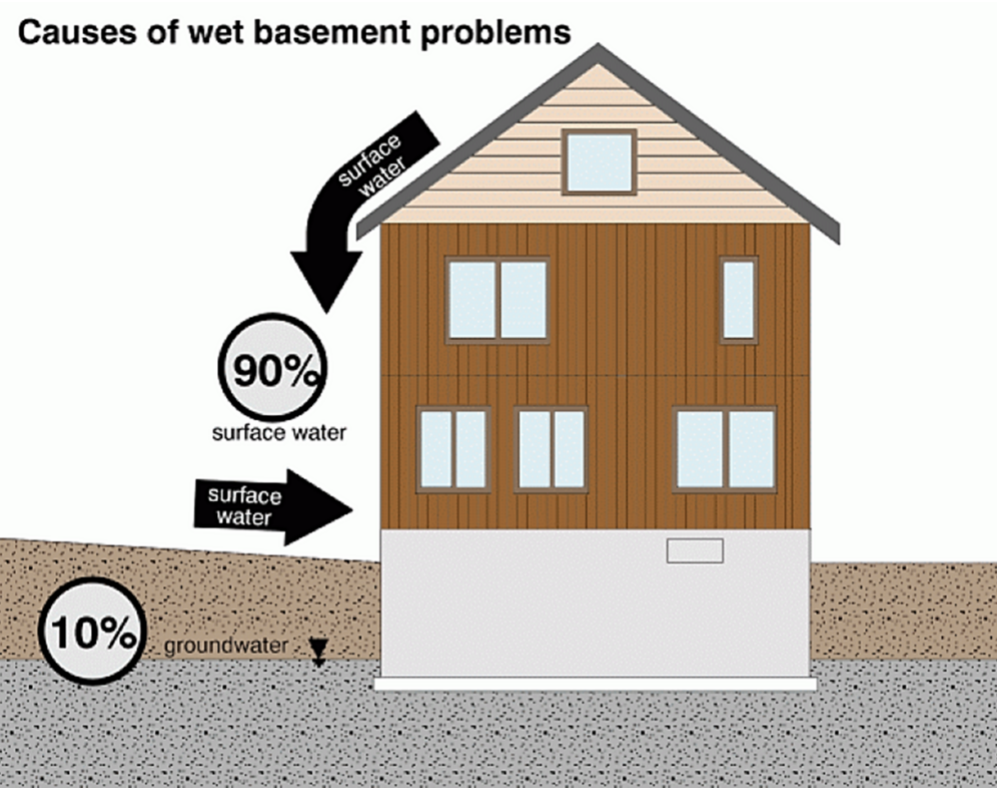
It appears that water damage was noted in the following area(s). While no active leaks or moisture was present at the time of the inspection, it is recommended to inquire with the current occupants as to the history of the event and to monitor the area.

Recommendation  
Contact a qualified professional.
