PROPERTY REPORT

1234 Main Street
Calgary, AB T3K3V9

Buyer Name
09/17/2024 9:00AM

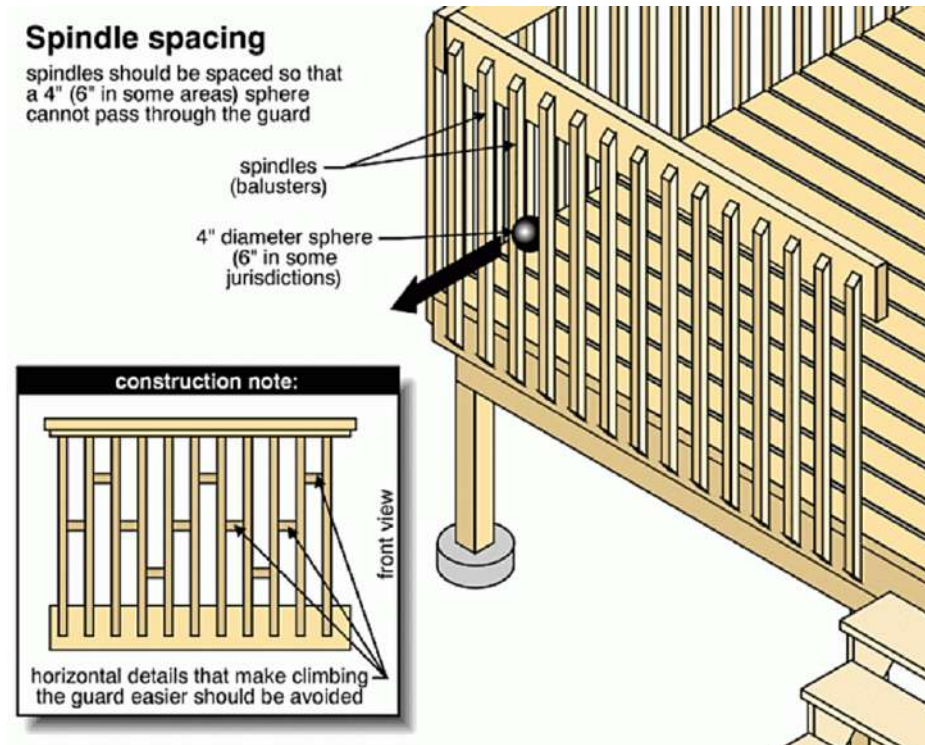
BALUSTERS MISSING

Structures over 24" in height should have handrails and balusters to help prevent falling incidents.

Recommendation

Contact a qualified carpenter.

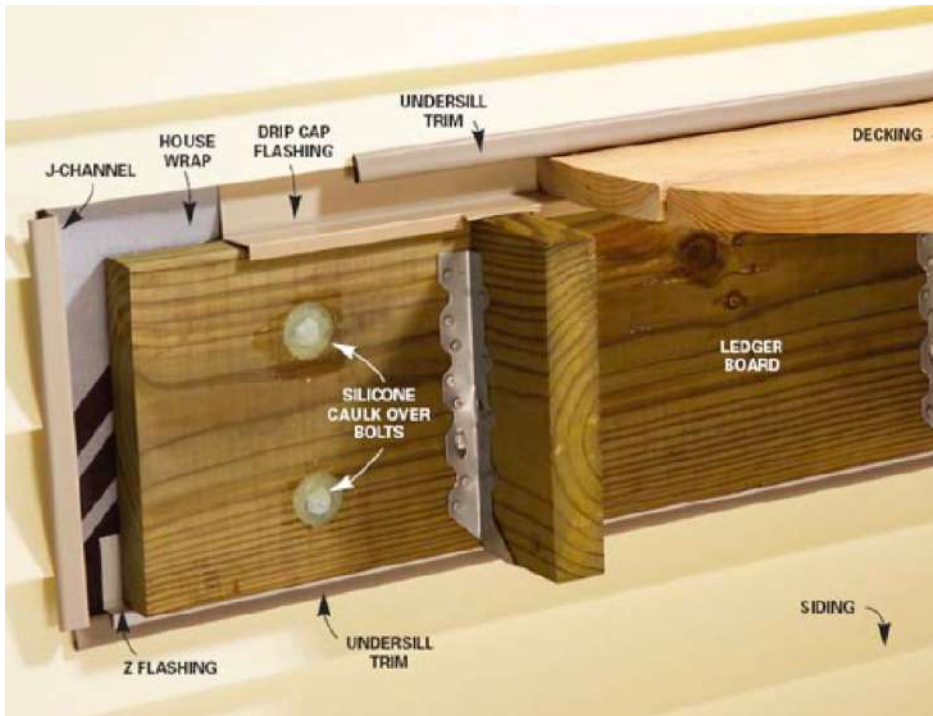
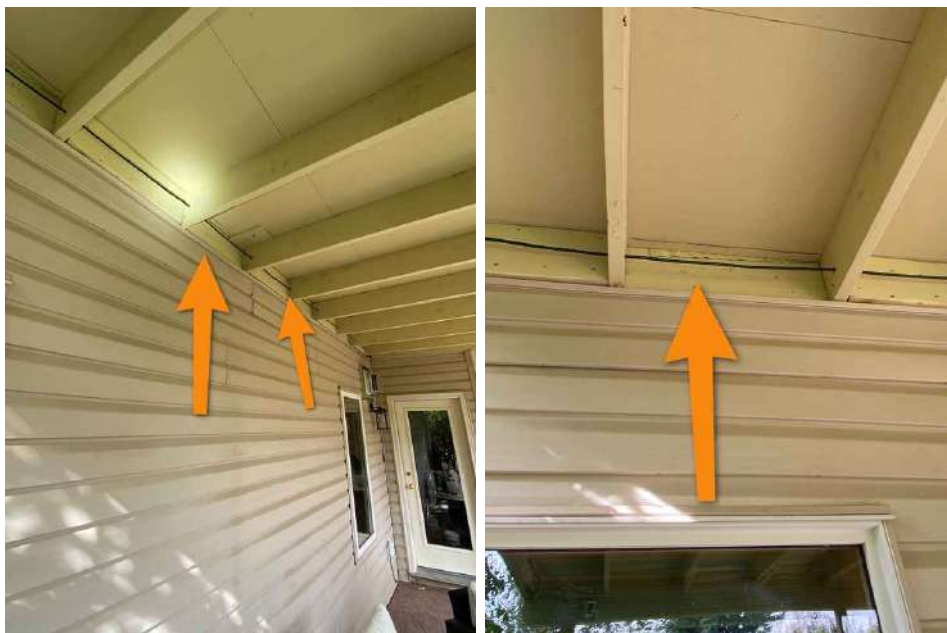
LEDGER BOARD - MISSING

It is recommended to have ledger boards for decks to provide structural security.

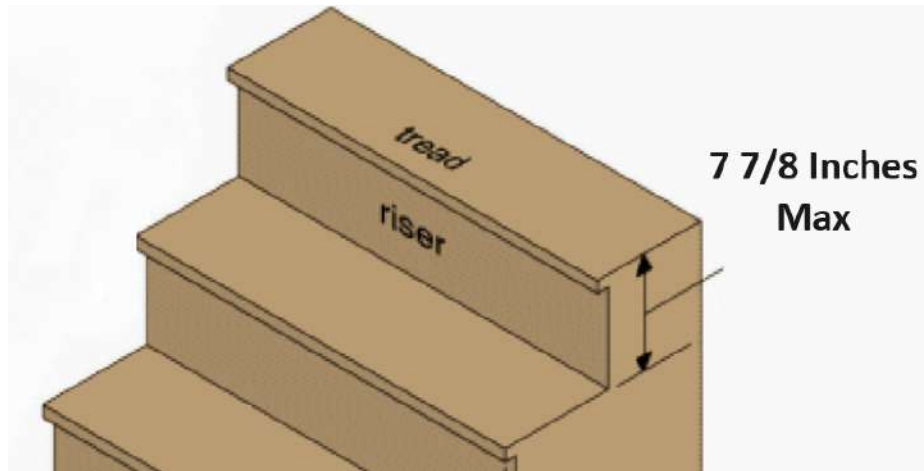
Risers should not be more than 7 and 7/8 inches. A qualified carpenter should rectify this.

Recommendation
Contact a qualified carpenter.

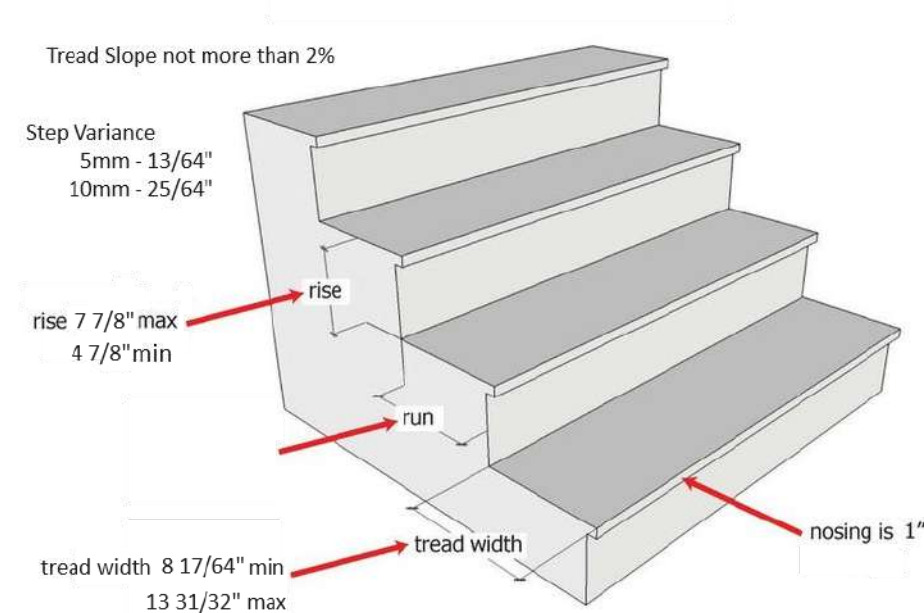
Riser height should be within 13/64 to 25/64 inches on steps to prevent tripping accidents.

Recommendation
Contact a qualified carpenter.

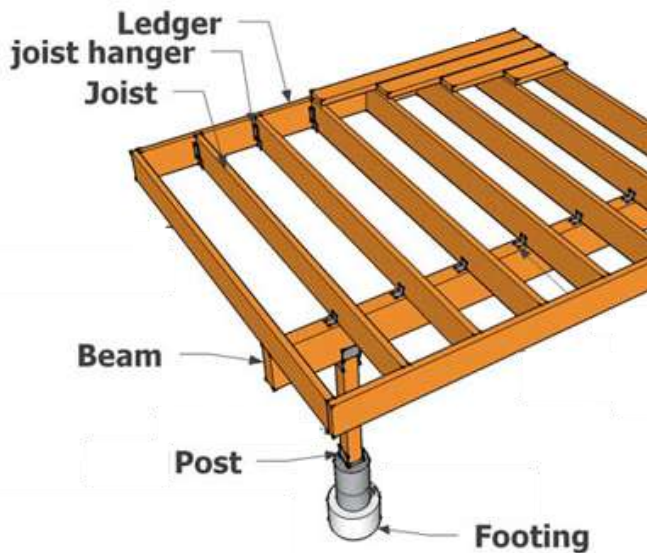
2.7.9 Deck(s)

Unconventional framing methods were noted with the structure. Typically the beam would rest on top of support posts.

Recommendation
Contact a qualified carpenter.

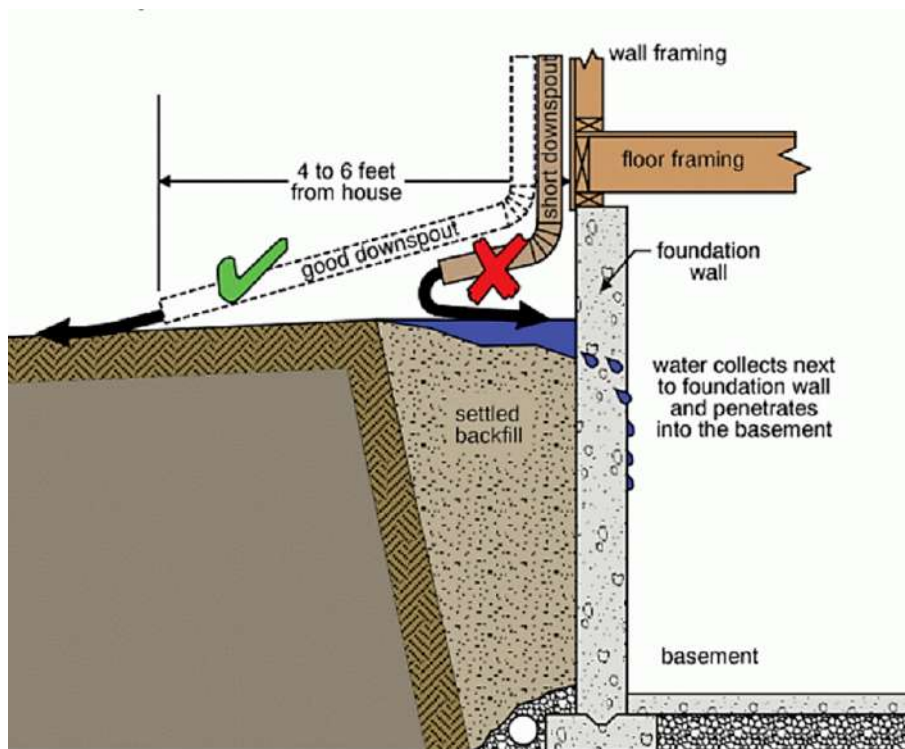
Downspouts should always be deployed to aid in water expulsion away 6 feet from the structure. Downspout extensions should be secured to downspouts and extended away from the building. This helps to prevent water migrating into the building. Downspouts should be checked for leaks and sealed or replaced if found.

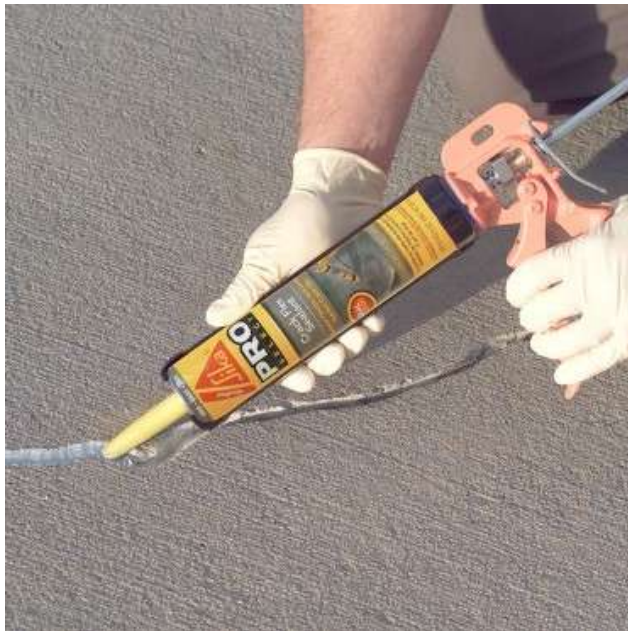
2.10.1 Driveway(s)

CRACKS - CONCRETE

Cracking and or spalling was found at the driveway. A masonry sealant for concrete driveways, such as Sikaflex, can be used which may help prevent further expansion of the cracks by preventing water penetration and further cracking when it freezes in colder temperatures. For asphalt driveways, it is recommended to seal openings with an approved sealant.

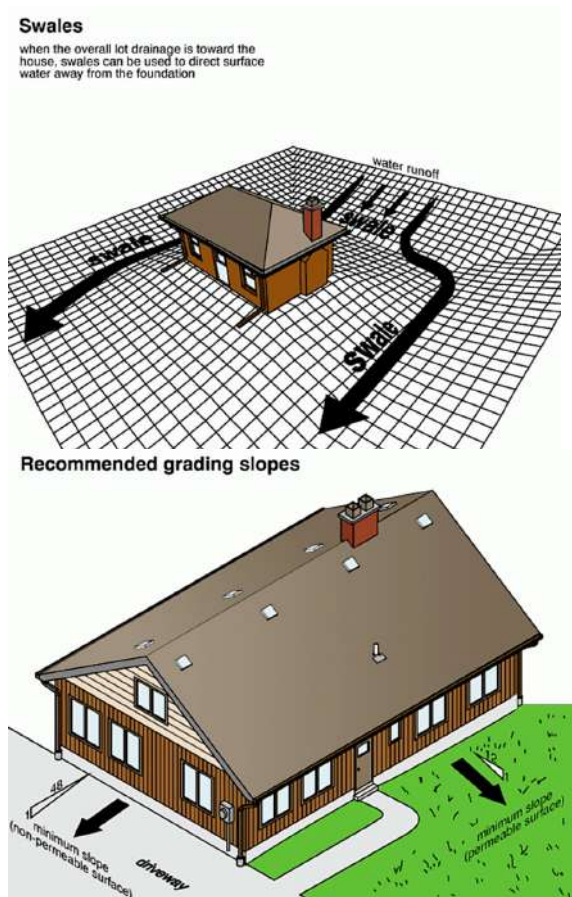
It is recommended that the grading around the structure be positive; meaning that it should slope away. This helps prevent water penetration into the structure. Fill areas that have settled next to the structure with clay—not topsoil— with a positive slope away from the structure (10 per cent is recommended). It should be noted that rock, gravel, mulch, etc. drains water down the exterior wall and not away. It is unknown what the grading is below these materials.

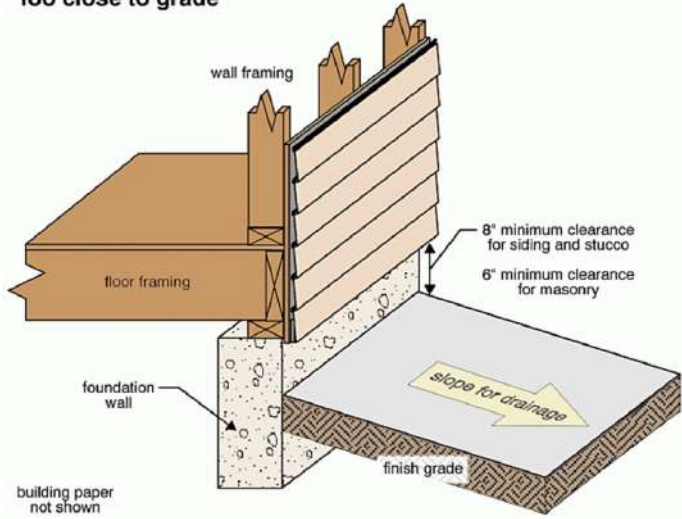
Too close to grade

It is recommended to have a minimum 6" clearance between the siding and the grading of the structure to allow the air to wick away any water on the exterior wall. Siding that is adversely affected by moisture requires 8" clearance from grade. In addition, this helps mitigate damaging the siding from freezing water.

Recommendation
Contact a qualified siding specialist.

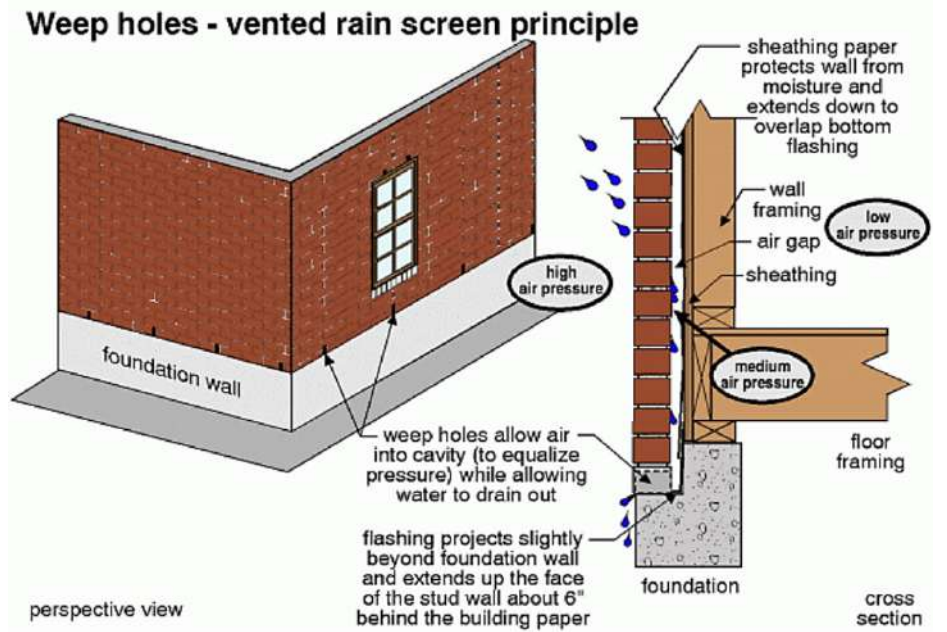
WEEP HOLES MISSING

Weep holes were noted to be missing. It is recommended these be added every 32" at a minimum to allow water drainage from between the brick and the structure.

Recommendation

Contact a qualified masonry professional.

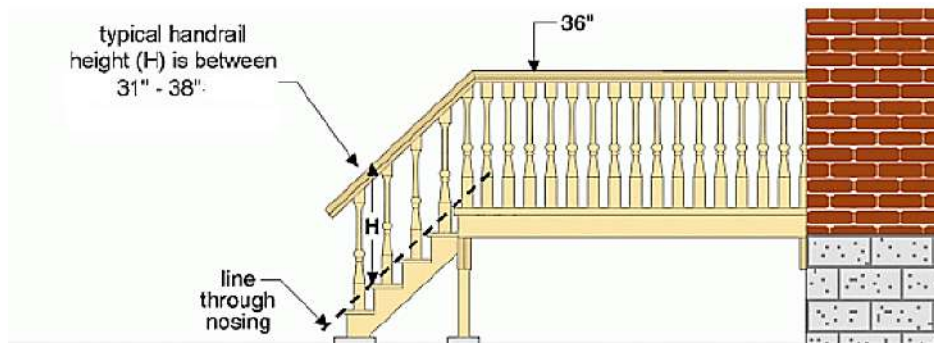
HANDRAILS RECOMMENDED

It is recommended to install handrails and balusters to help prevent falling incidents.

Recommendation

Contact a qualified carpenter.

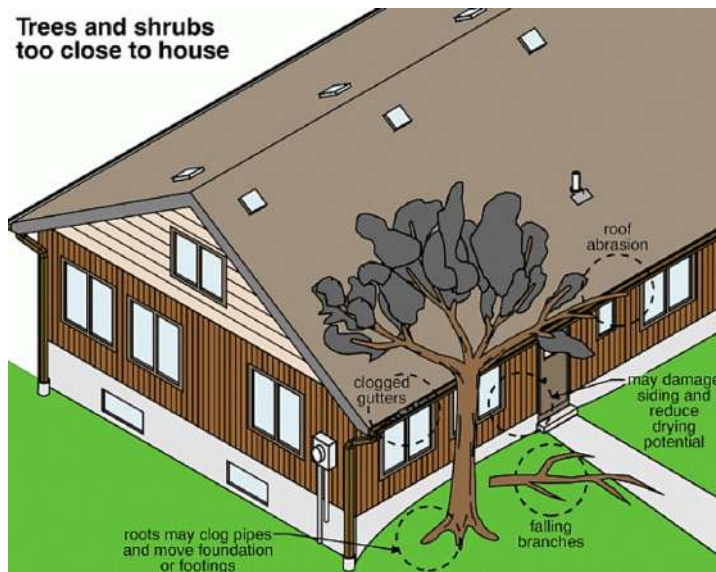
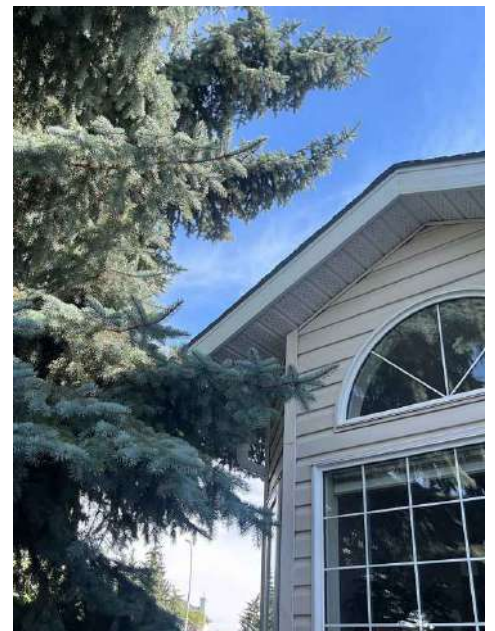
Trees and shrubs should be kept away 12 inches from structures as they can damage them. In addition, vegetation gives off lots of moisture and often harbours critters.

Recommendation

Contact a handyman or DIY project

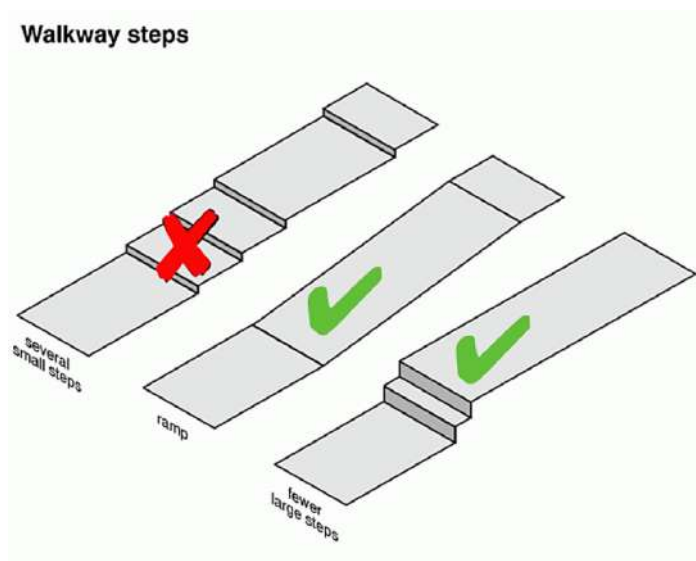
It is recommended to have level walkways to prevent tripping hazards.

Recommendation
Contact a qualified landscaping contractor

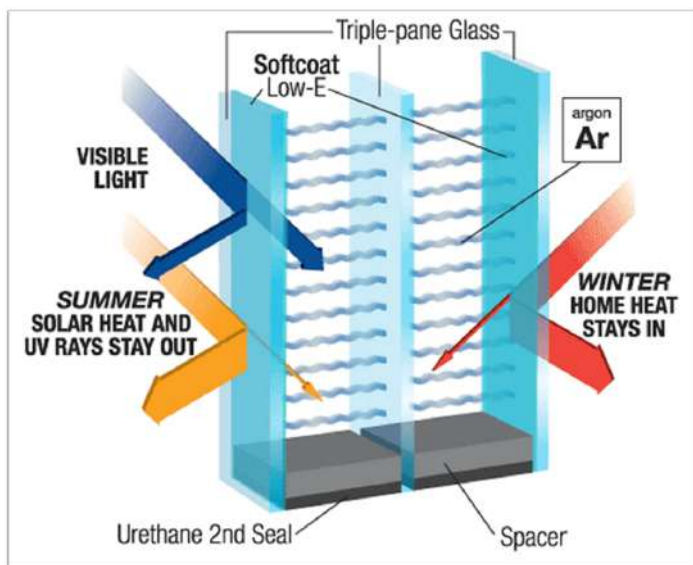
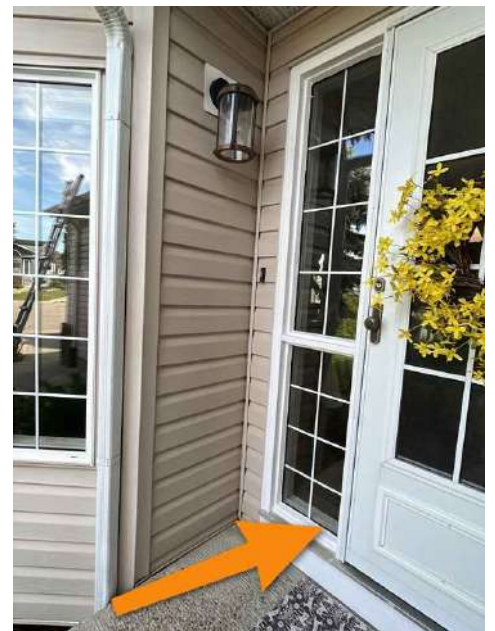
2.44.2 Windows

One or more windows appear to have a failed glazing / seal. Although often considered a cosmetic issue, mold and wood rot may be a side product in the future. It is recommended to budget to replace the unit.

Recommendation
Contact a qualified window

repair/installation contractor.

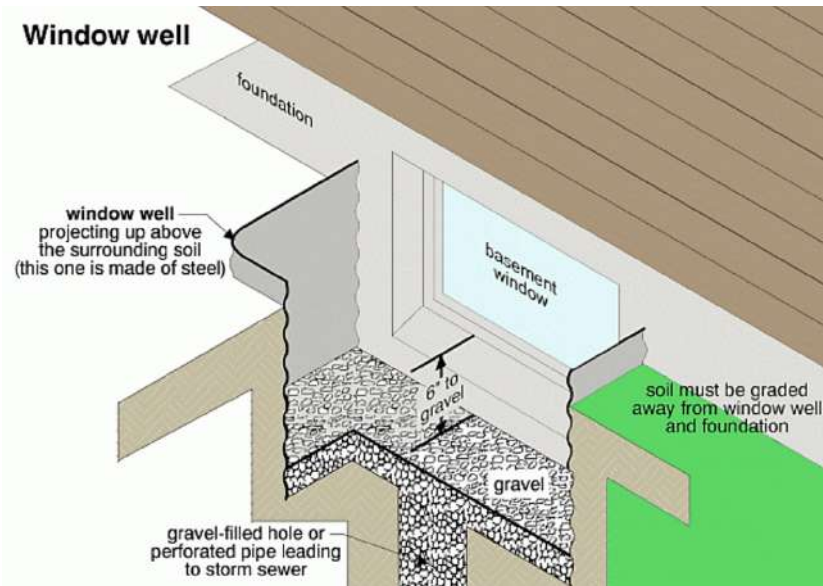
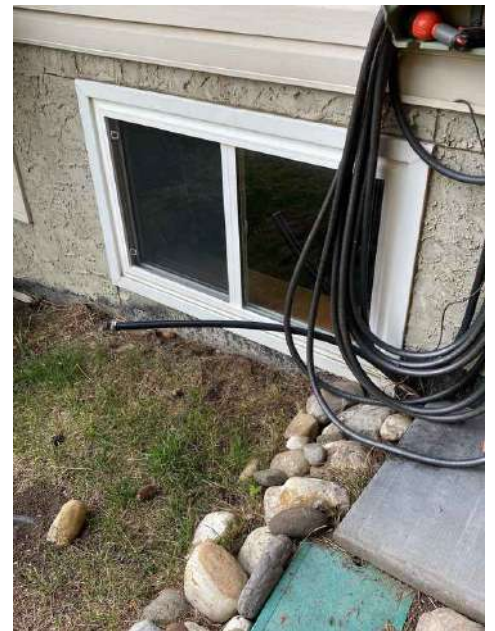
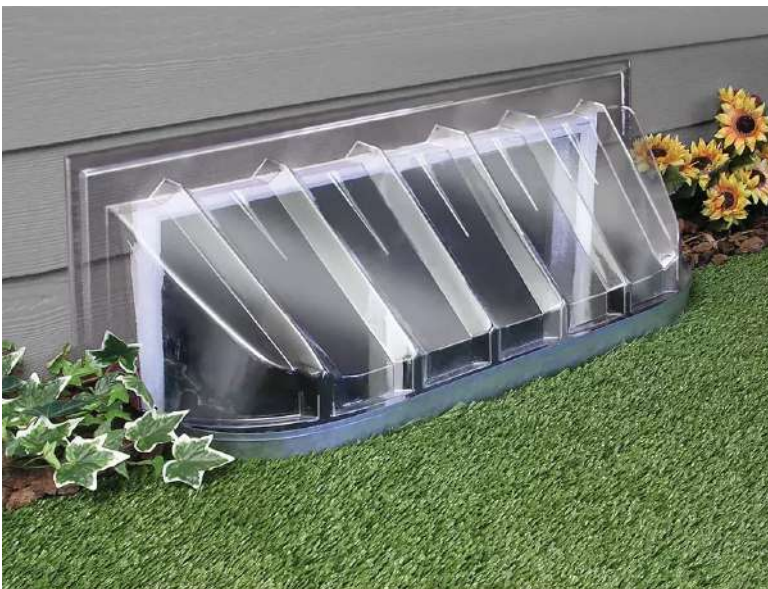
2.44.3 Windows

It is recommended to have window wells around basement windows to prevent water intrusion and deterioration around the framing. It is recommended to install window well covers to reduce the amount of moisture intrusion and to increase the energy efficiency of windows. It should be noted that the cover should not be affixed / secured to the structure for egress purposes.

Recommendation
Contact a qualified carpenter.

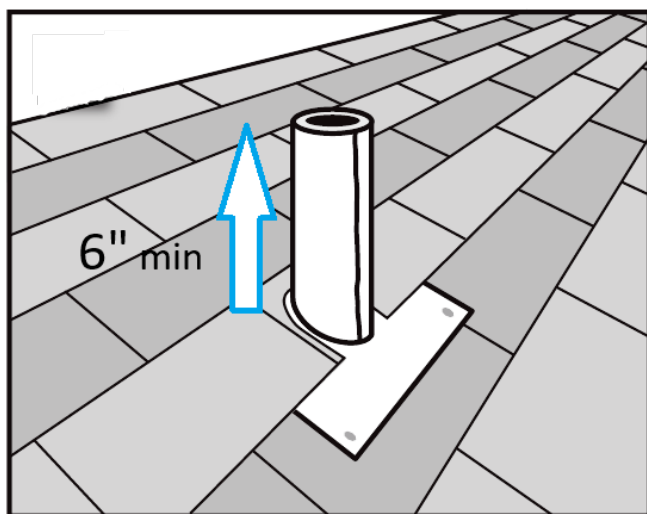
It is recommended to upsize the following vent termination to mitigate frost enclosure during the colder season.

Recommendation

Contact a qualified plumbing contractor.

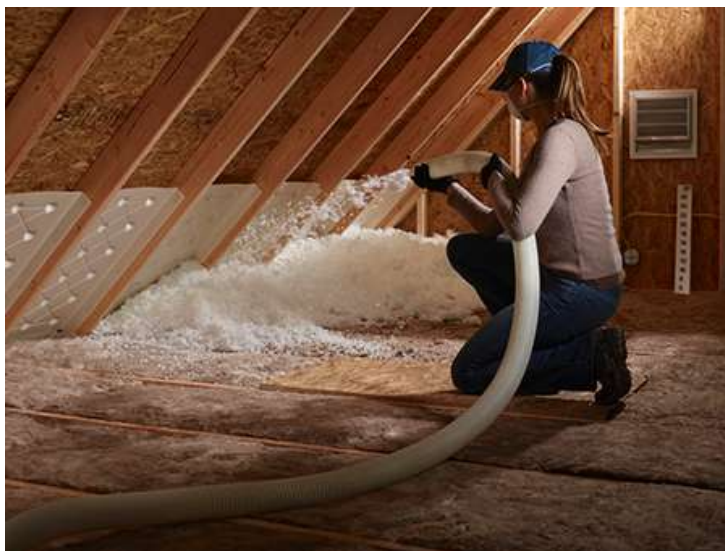
The attic was found to have less than today's standard in one or more areas. Today's standards is R 50 - 60. It is recommended to top up the insulation for better energy efficiency.

Recommendation
Contact a qualified insulation contractor.

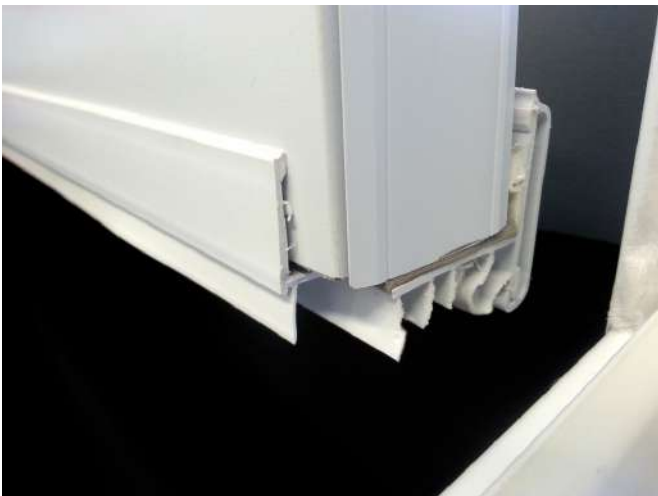
One or more door sweeps should be replaced as they are beyond the service life. These help keep the outside weather from entering the building.

Recommendation

Contact a qualified door repair/installation contractor.

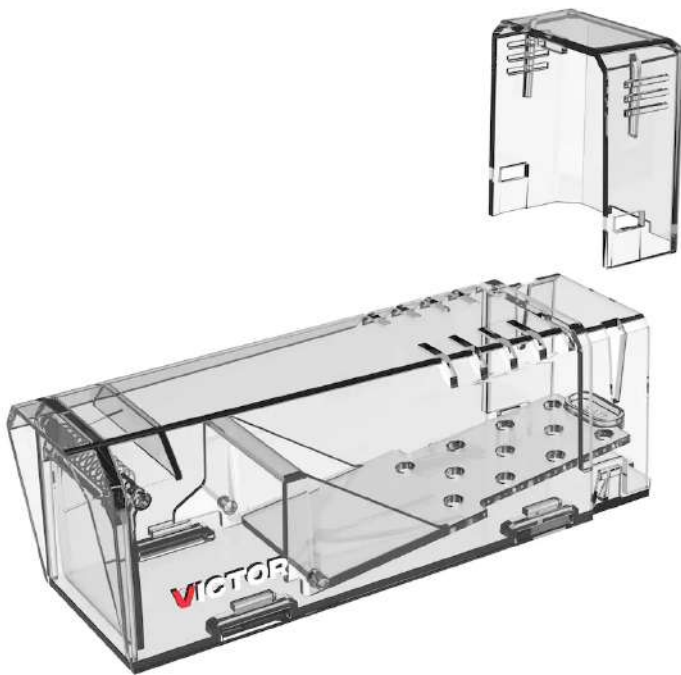
Evidence of pests were noted in the structure. It is recommended to inquire on the history of any events.

Recommendation
Contact a qualified professional.

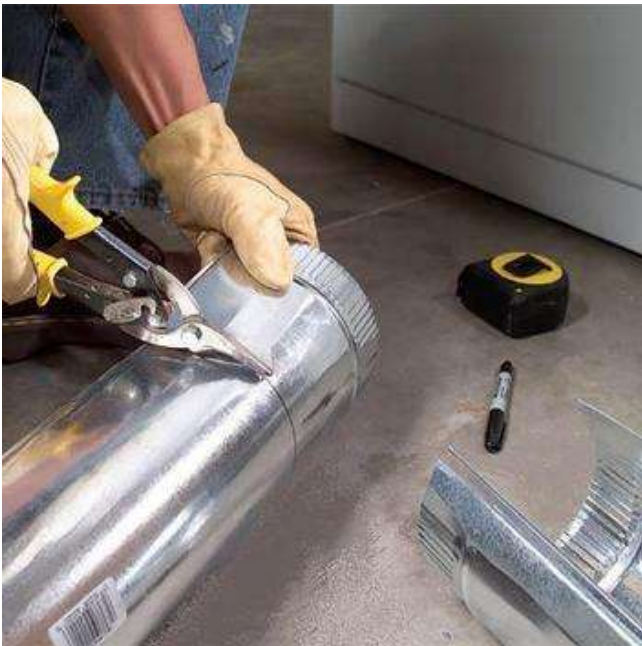
It is recommended to use smooth metal vent lines rather than corrugated ones as the lint may get stuck to the corrugations.

Recommendation
