# CERTA INSPECTIONS

The Ultimate Home  
Buyer's Guide

AT CERTA PROPERTY INSPECTIONS, WE HAVE CREATED THIS SIMPLE GUIDE WHEN SHOPPING FOR YOUR HOME.

ILLUMINATING COSTLY AND PROBLEMATIC BUILDING MATERIALS FOUND THROUGH VARIOUS ERAS OF HOMES.

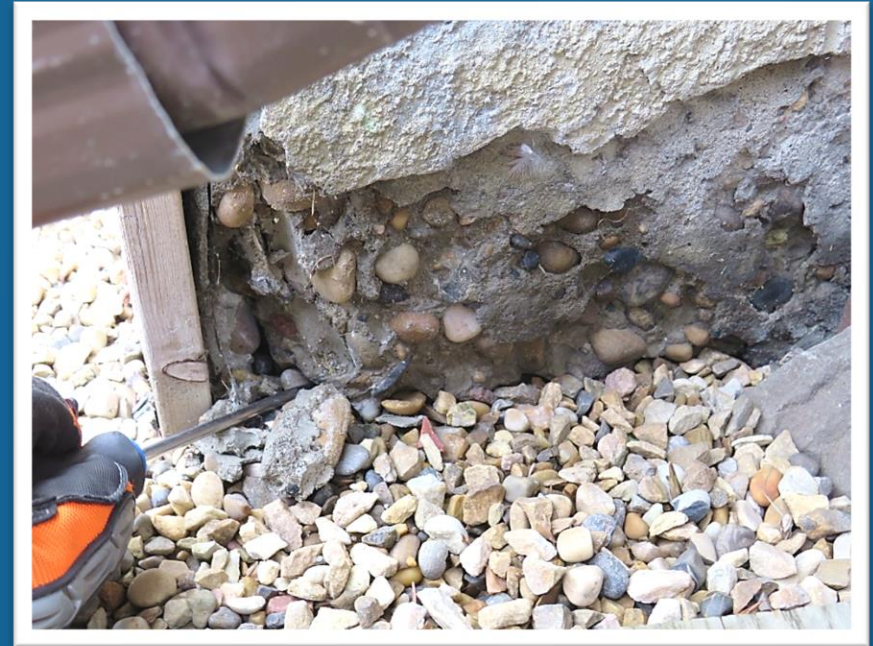
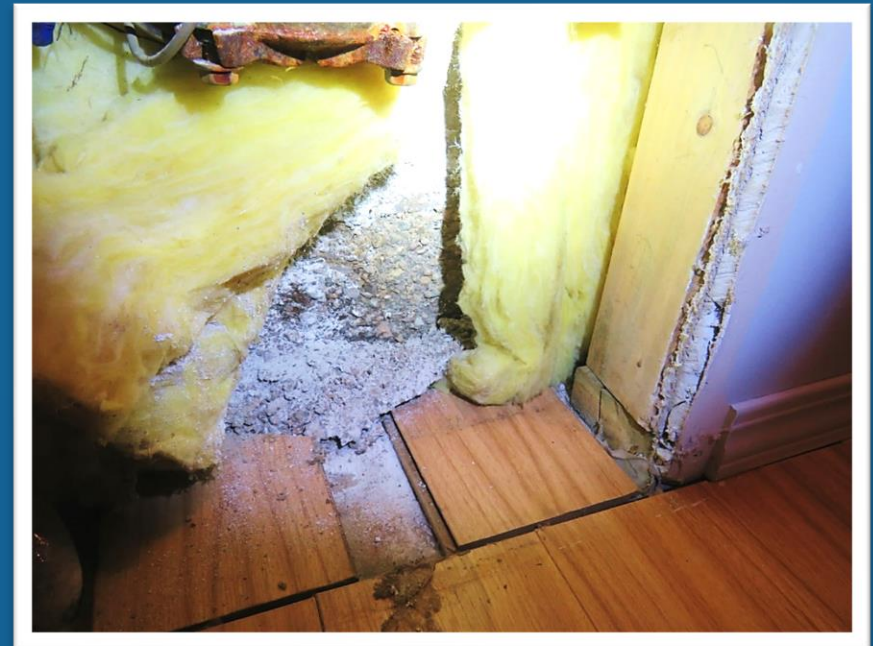
MANY HOMES BUILT BEFORE THE 60S OFTEN SUFFER FROM WHAT IS KNOWN AS "SULPHIDE DECAY". THIS RESULTS IN THE CONTINUOUS DETERIORATION OF THE CONCRETE FOUNDATION WHICH CAN INCREASE THE LIKELIHOOD OF WATER INTRUSION AND STRUCTURAL DEGRADATION.

DUE TO THE PRIMITIVE METHODS OF OLDER CONSTRUCTION PRACTICES; LARGE AGGREGATES (STONE), UNFILTERED WATER, LACK OF SULPHATE RETARDERS, AND OTHER POOR PRACTICES OFTEN LEAD TO SUBSTANDARD FOUNDATIONS.

WHEN YOU ARE LOOKING AT PURCHASING OLDER HOMES, HAVE A LOOK AT THE EXTERIOR FOUNDATION (IF EXPOSED) AND AT THE BASEBOARDS AROUND THE FOUNDATION WALL FOR SIGNS OF WATER DAMAGE.

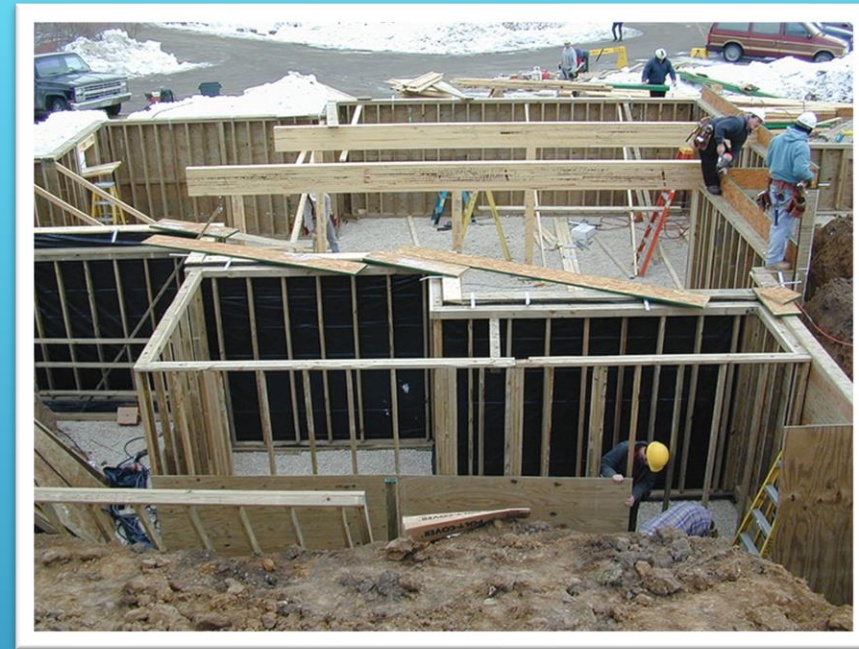
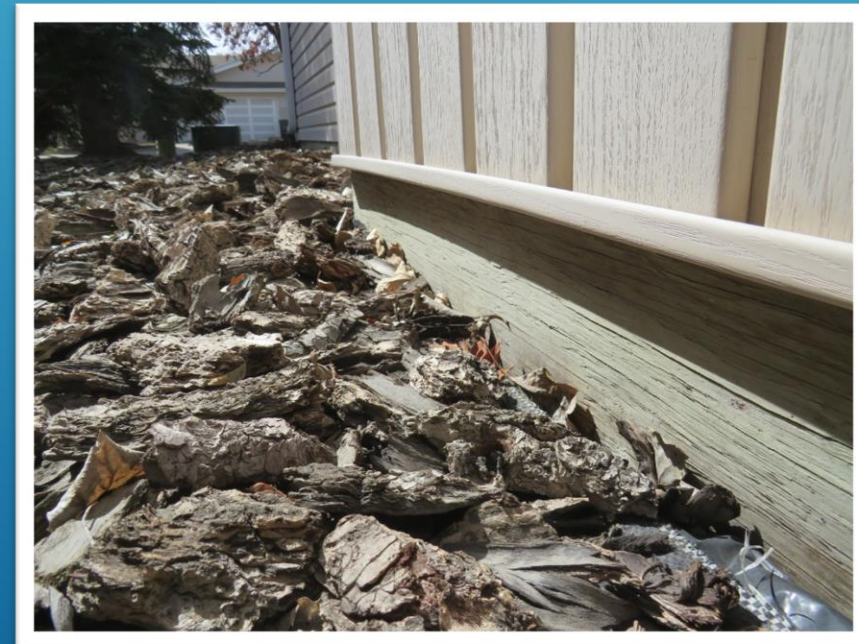
FIRST EXPERIMENTED BY THE CANADIAN MILITARY IN NORTHERN CANADA (1950S), HOMES BUILT WITH A PWF CAN PROVIDE GREAT COMFORT WHILE PROVIDING THE STRUCTURAL SUPPORT NEEDED TO BEAR THE WEIGHT OF THE HOME.

WHEN YOU ARE LOOKING AT PURCHASING A HOME, LOOK AT THE EXTERIOR FOUNDATION (IF EXPOSED) AND IN THE BASEMENT BELOW STAIRS OR AROUND THE ELECTRICAL PANEL IF YOU CAN SEE THE DARK GREEN COLORED SHEATHING.

THERE ARE SEVERAL WAYS TO DETERMINE IF A HOME IS BUILT WITH A PWF INCLUDING "THUMPING" THE FOUNDATION WITH YOUR HAND. A HALLOW FEELING OR SOUND OFTEN INDICATES A PWF WHILE CONCRETE WILL BE DENSER.

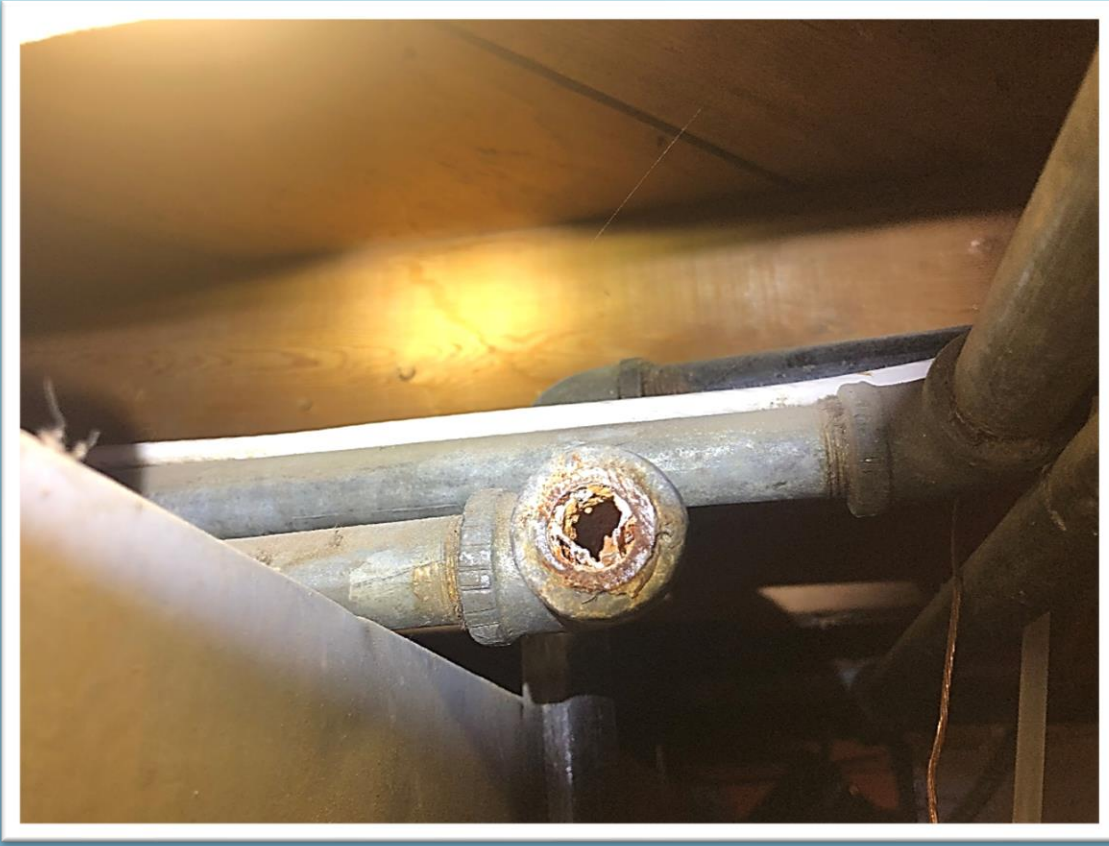
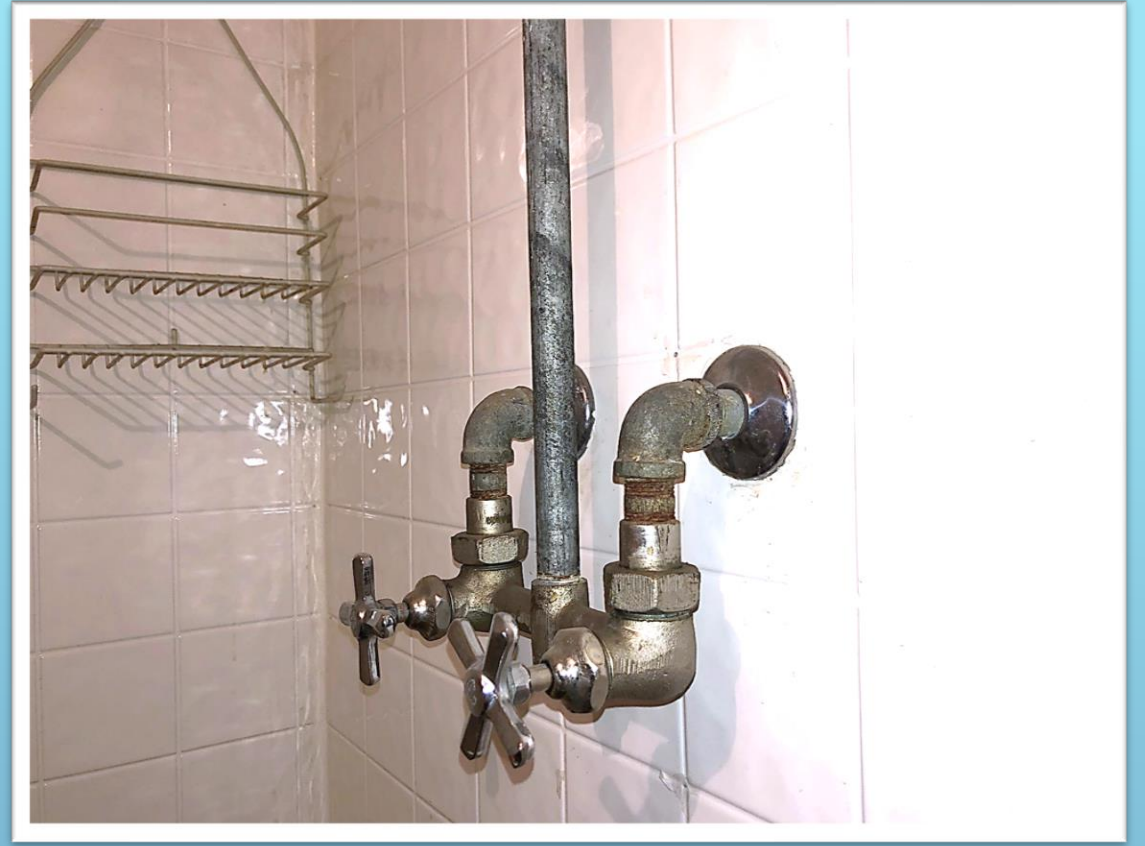
OFTEN FOUND IN HOMES BUILT BEFORE THE 70S, GALVANIZED PIPING WAS THE PRECURSOR TO COPPER. MANY INSURANCE PROVIDERS REQUEST THAT GALVANIZED PIPING BE REMOVED AS IT HAS A HIGHER CHANCE OF LEAKING DUE TO CORRODING FROM THE INSIDE OUT. BE CAREFUL TO NOT CONFUSE GALVANIZED WATER PIPING WITH BLACK STEEL GAS PIPING! IF IN DOUBT, FOLLOW THE PIPE TO WHERE IT STARTS. YOUR REALTOR MAY BE ABLE TO HELP YOU WITH THIS.

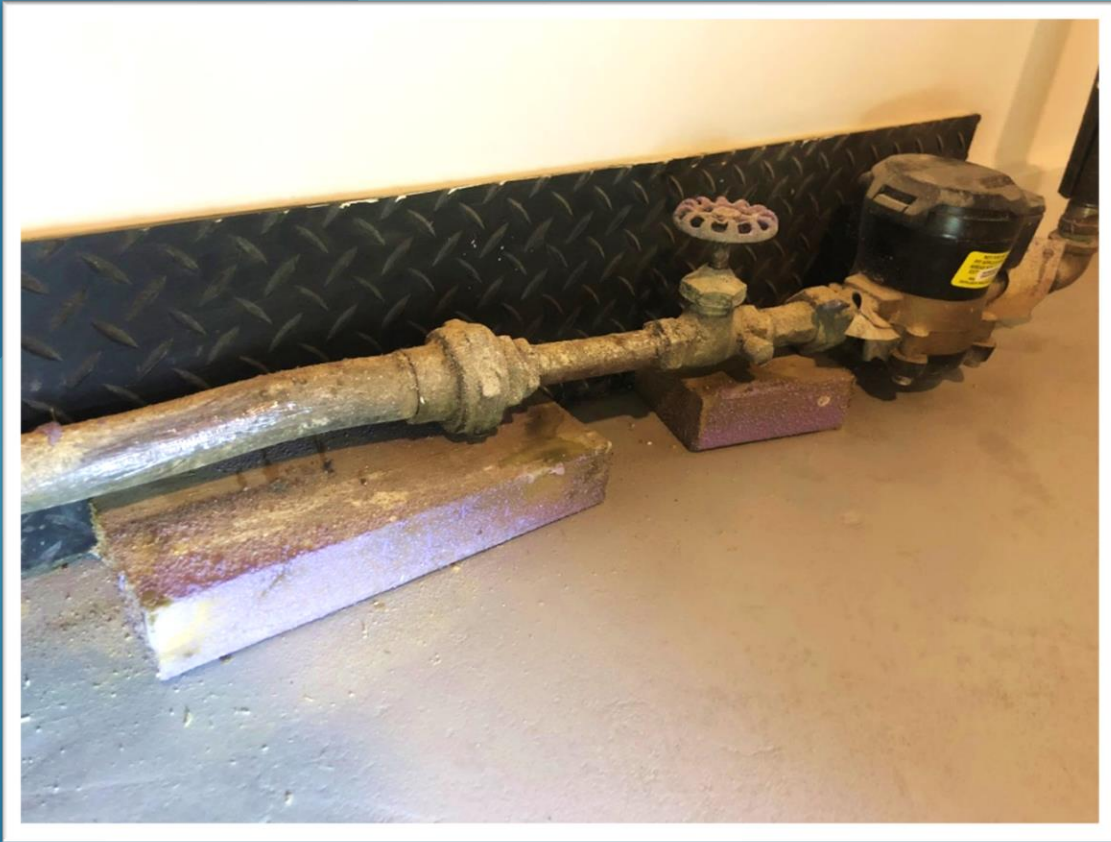
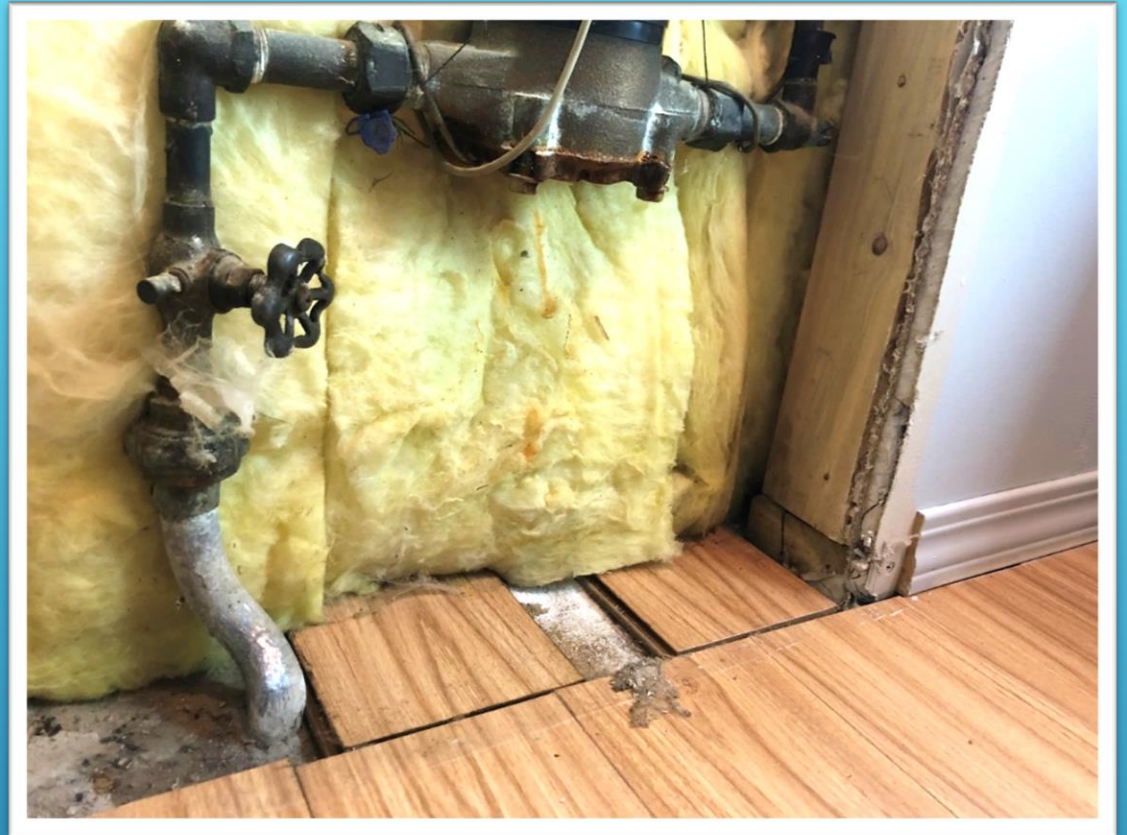
IT GOES WITHOUT SAYING THAT LEAD PIPING IS NOT SOMETHING WE WANT TO HAVE IN OUR HOME WATER SUPPLY LINES. TYPICALLY LEAD PIPING WAS USED UNTIL THE 60S EITHER THROUGHOUT THE WATER SUPPLY LINES OR THE MAIN WATER SERVICE FROM THE MUNICIPALITY TO THE HOME.

THE EASIEST WAY TO DETERMINE IF THE WATER PIPE IS MADE OF LEAD IS BY GENTLY SCRATCHING IT WITH KEYS OR A FLAT HEAD SCREWDRIVER. IF IT TURNS FROM A DULL TO A SHINY GREY (AND IS A SOFT METAL), CHANCES ARE IT IS MADE OF LEAD.

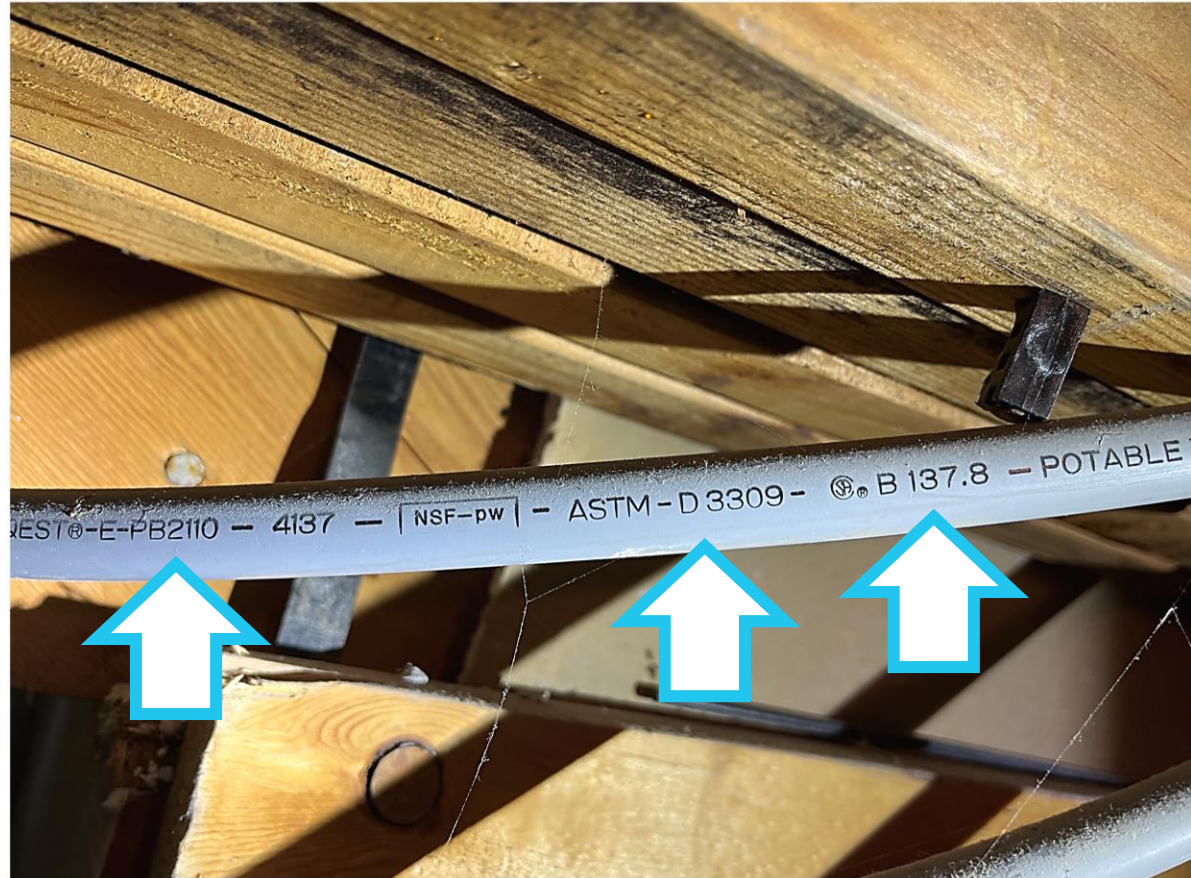
POLY-B WAS THE SUCCESSOR TO COPPER WATER PIPING WHICH LED TO GREAT DESIGNS SUCH AS HOME-RUN MANIFOLDS (THIS RESULTED IN CONTINUOUS PRESSURE FOR YOUR SHOWER) AMONGST OTHER ITEMS. UNFORTUNATELY, THE MATERIAL WAS PROBLEMATIC FOR A VARIETY OF REASONS WHICH LED TO FAILURES IN SOME INSTALLATIONS. DEPENDING ON THE AREA, TYPICALLY POLY-B WAS FOUND DURING THE MID 1980S – TO MID 1990S.

WHILE SOME INSURANCE PROVIDERS MAY NOT INSURE THE HOME, OTHERS MAY INCREASE THE PREMIUM OR REQUIRE THE INSTALLATION OF WATER LEAKAGE DEVICES. LOOK OUT FOR SOME OF THE FOLLOWING IDENTIFIERS ON THE PIPE SUCH AS PB2110, ASTM D3309, OR CSA-B 137.8. WHILE TYPICALLY POLY-B IS GREY IN COLOR, IT MAY BE BLUE AND EVEN BLACK!

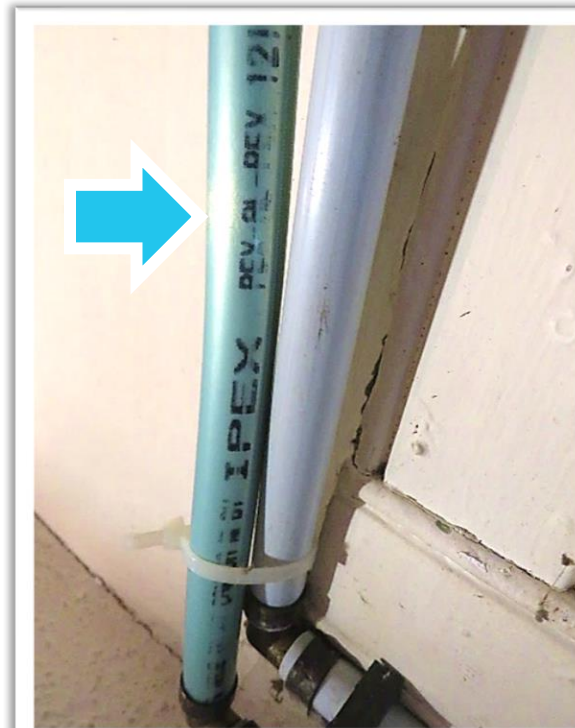
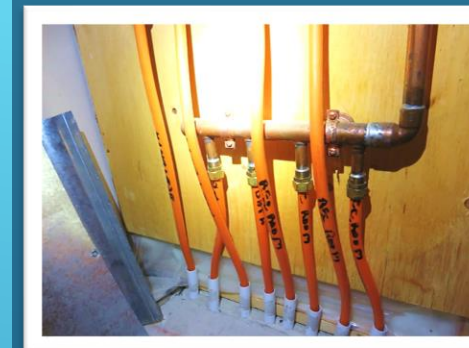
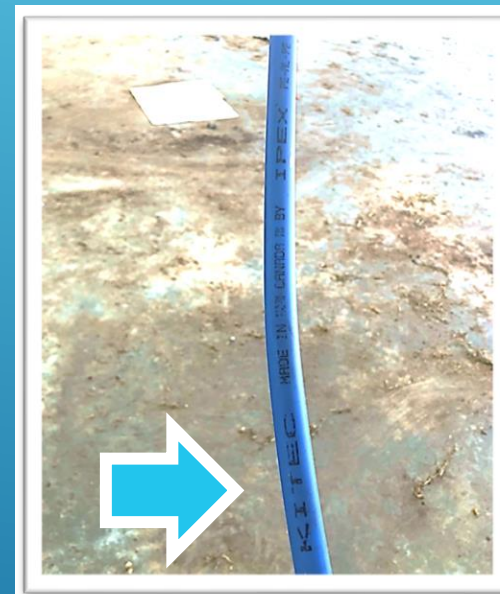
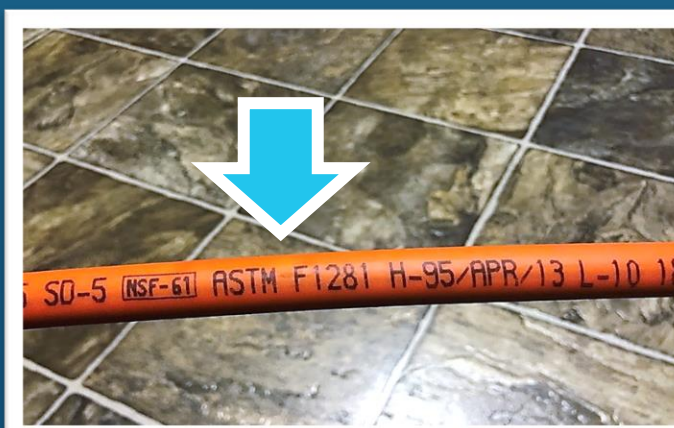
TYPICALLY FOUND IN HOMES BUILT BETWEEN THE MID-1990S AND 2000S, KITEC (PEX-AL-PEX OR PE-AL-PE) IS KNOWN TO FAIL WHEN USED FOR HYDRONIC HEATING. THIS OFTEN INCLUDES BOILER LINES AND IN-FLOOR HEATING. A CLASS ACTION LAWSUIT WAS SETTLED IN 2020 FOR \$125,000,000 AND NO ADDITIONAL CLAIMS CAN BE MADE.

TYPICALLY, KITEC IS ORANGE IN COLOR BUT MAY ALSO BE BLUE. THE TELLTALE SIGNS ARE THE ASTM 1281 OR 1282 MARKING ON THE PIPE.

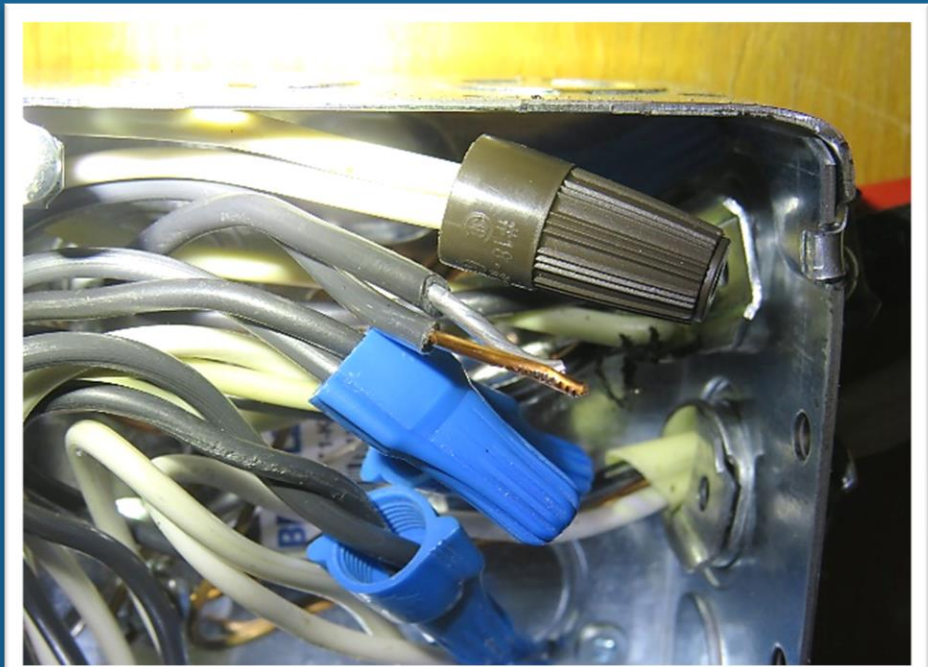
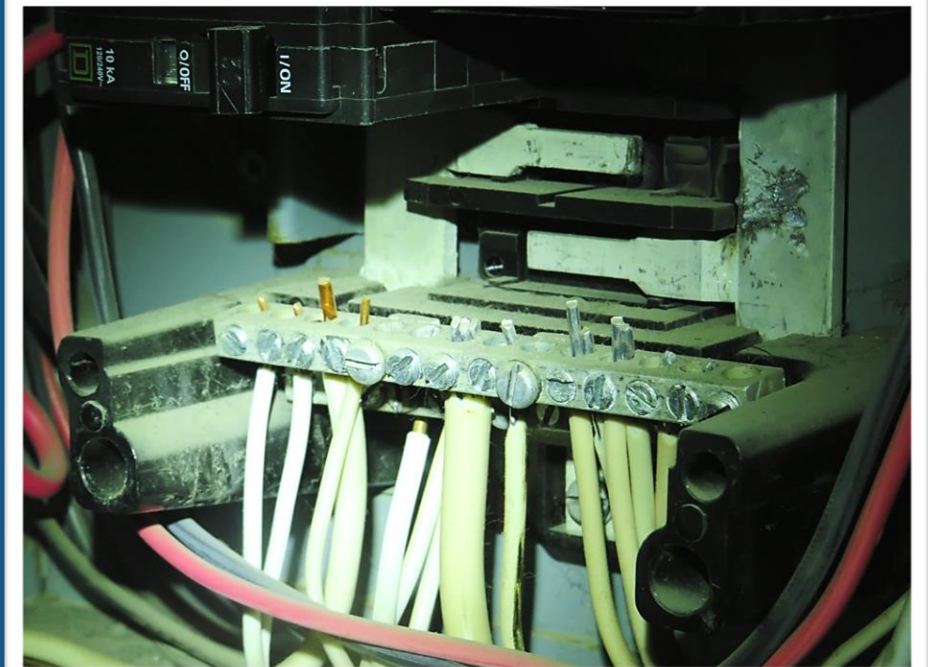
WHILE ALUMINUM WIRING IS SAFE, POOR IN INCOMPATIBLE TERMINATION CONNECTIONS AT ENDPOINTS SUCH AS WALL SWITCHES, LIGHTS, AND PLUGS (RECEPTACLES) BEGAN FAILING RESULTING IN HOME FIRES. NOT EVERY HOME BUILT IN THIS ERA WILL HAVE ALUMINUM WIRING (AA-1350 WIRING SPECIFICALLY)

IF ALUMINUM WIRING IS FOUND DURING THE HOME INSPECTION, THERE ARE SOLUTIONS SUCH AS PIGTAILING WHICH CAN BE PERFORMED BY A QUALIFIED ELECTRICIAN.

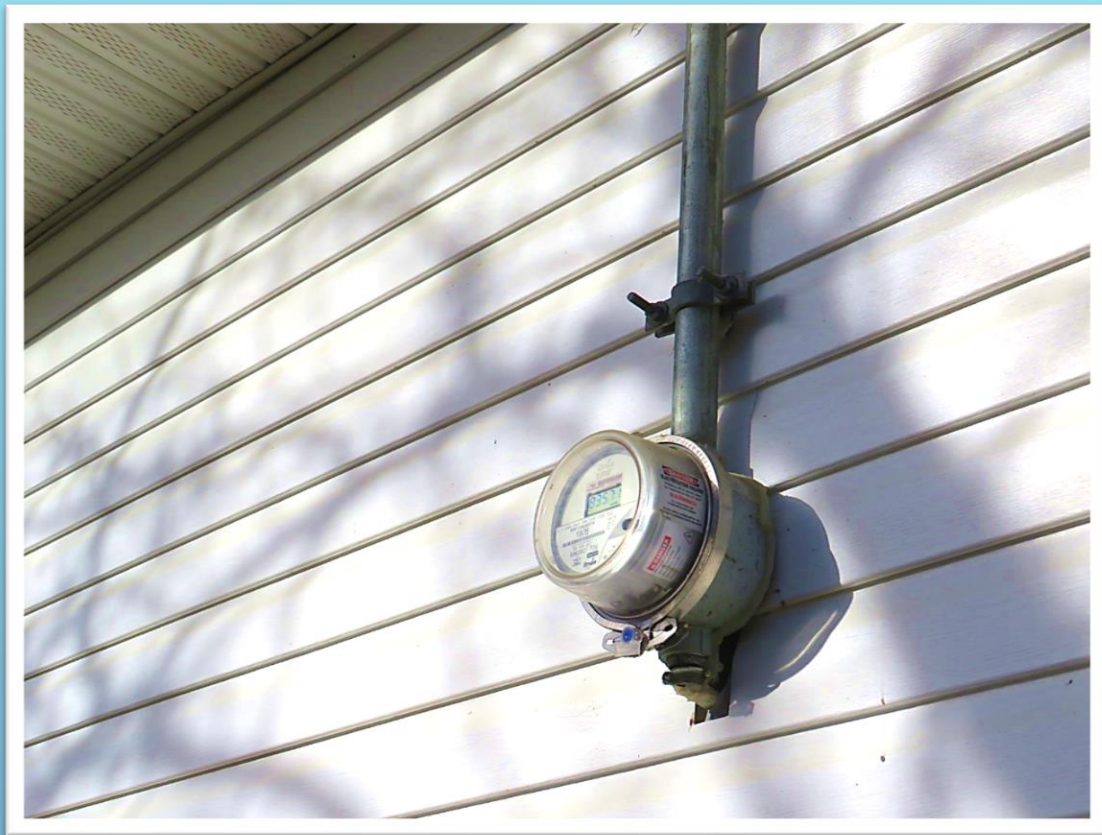
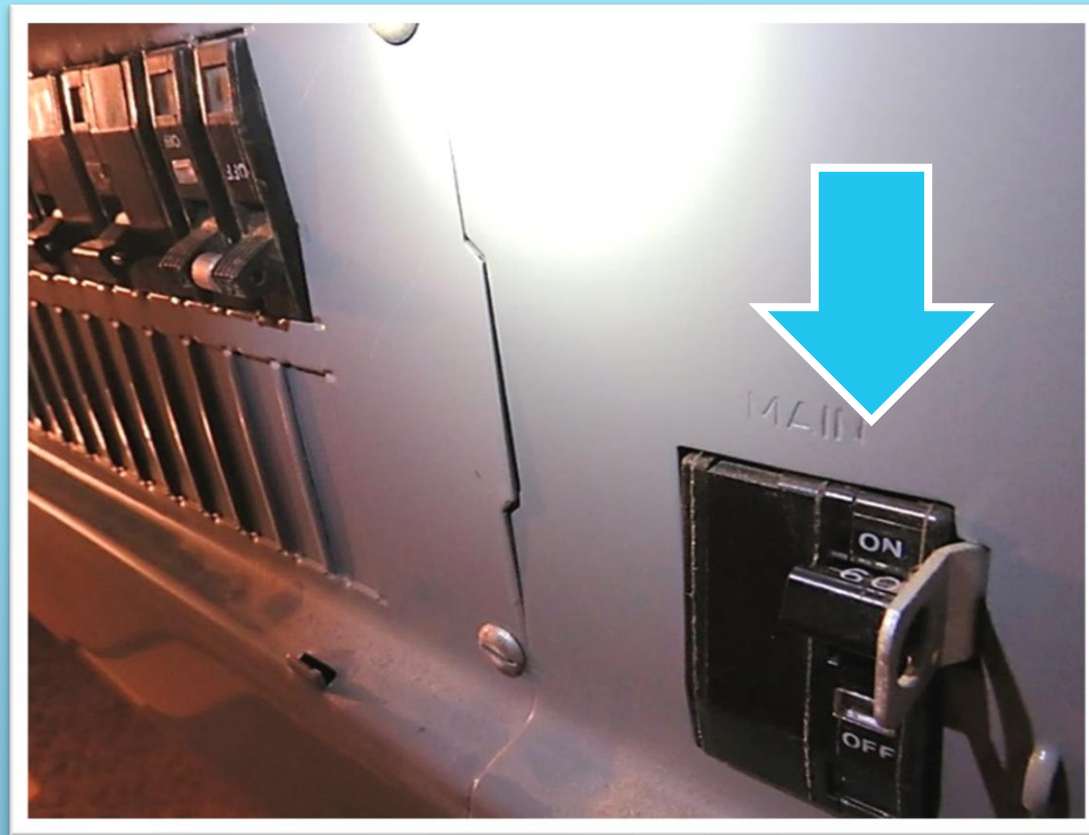
SOME HOMES, TYPICALLY PRE-1960S, MAY HAVE LESS ELECTRICAL SERVICE THAN HOMES BUILT TODAY. BEFORE THE 60S, THERE WAS LESS ELECTRICAL DEMAND AND MANY HOMES WERE BUILT WITH LESS THAN 100-AMP SERVICE. WHILE THIS IS NOT NECESSARILY AGAINST THE ELECTRICAL CODE (IN SOME CIRCUMSTANCES), MANY INSURANCE PROVIDERS REQUIRE THAT HOMEOWNERS UPGRADE THE SERVICE TO TODAY'S STANDARD OF 100 AMPS.

TWO POSSIBLE INDICATIONS OF MARGINAL SERVICE ARE THE MAIN DISCONNECT BREAKER RATING OR A ROUND ELECTRICAL METER BASE.

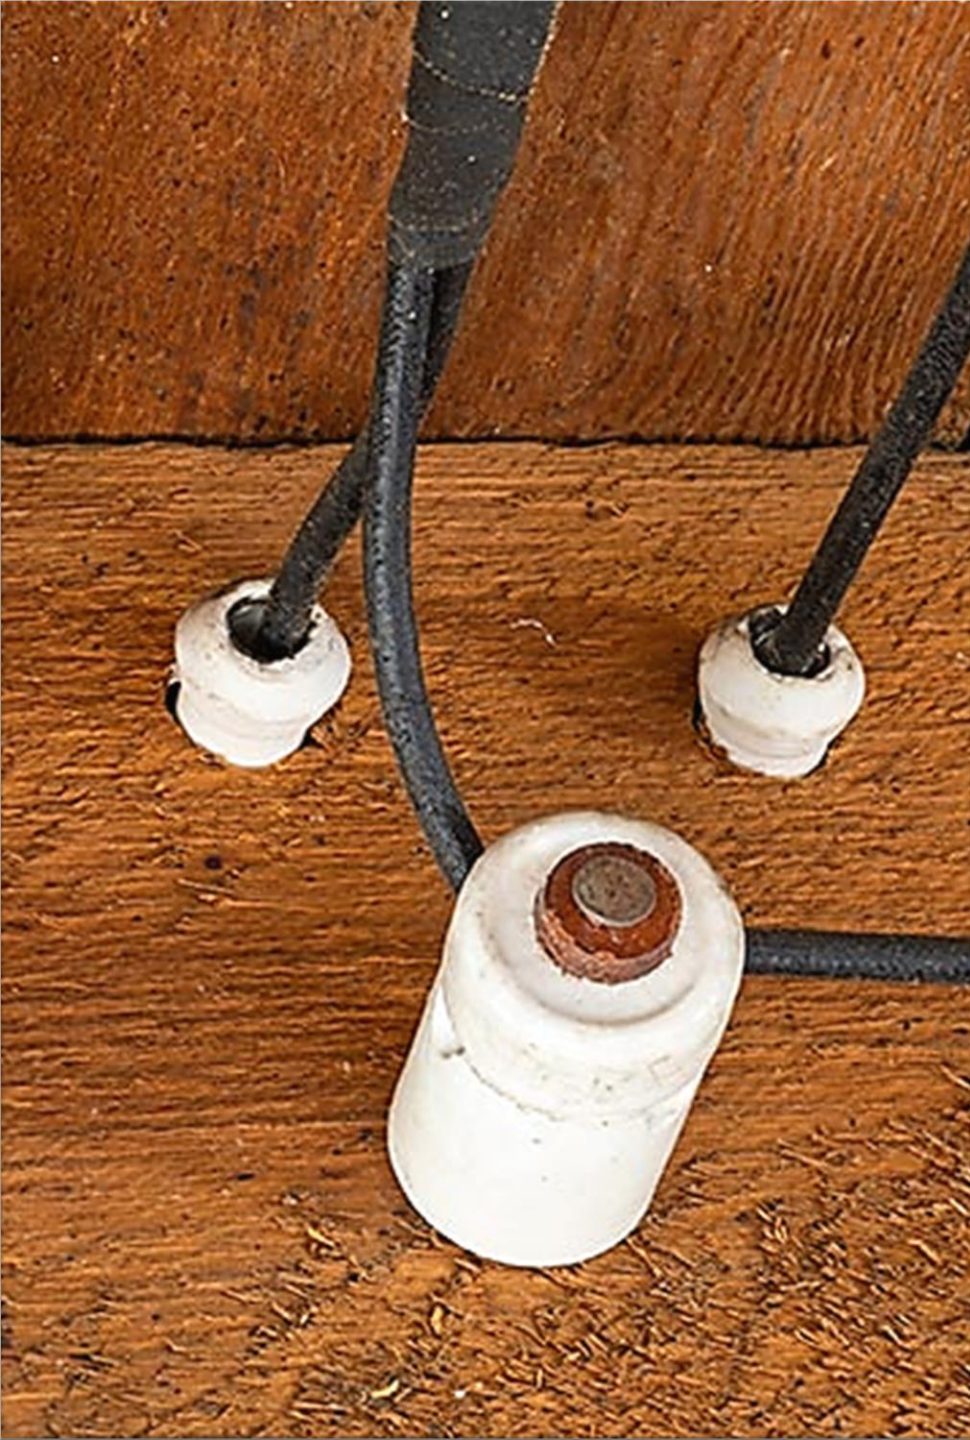
THE FIRST ELECTRICAL WIRING METHODS IN HOMES CONSISTED OF KNOBS AND TUBES. THE TUBES ALLOWED PASSAGE OF THE CONDUCTORS (WIRE) THROUGH BUILDING MATERIALS SUCH AS JOISTS WHILE THE KNOBS PROVIDED SUPPORT.

WHILE IT IS STILL ACCEPTABLE BY TODAY'S ELECTRICAL CODE (KNOWN AS OPEN-WIRING), MOST INSURANCE PROVIDERS WILL REQUEST THE MATERIAL BE REMOVED.

HOWEVER, DON'T BE FOOLED IF YOU SEE KNOB IN TUBE IN HOMES BUILT IN PRE 1950S AS IT MAY HAVE ALREADY BEEN DE-ENERGIZED BUT SIMPLY NOT REMOVED.

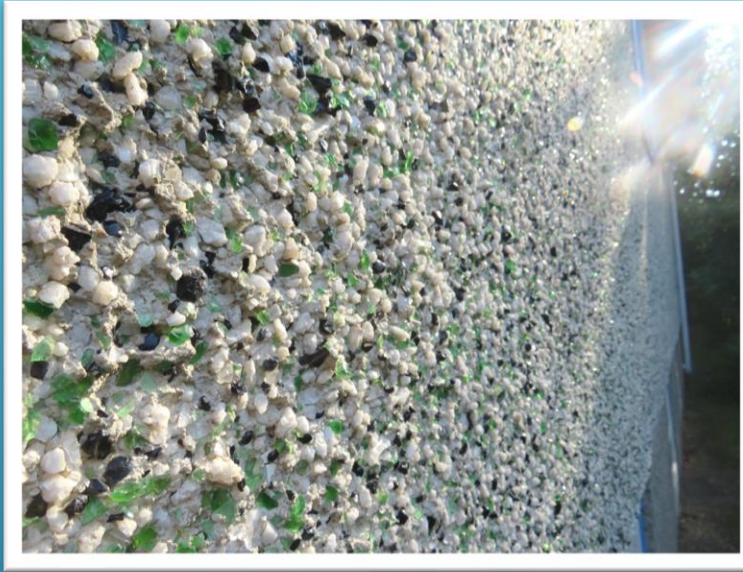
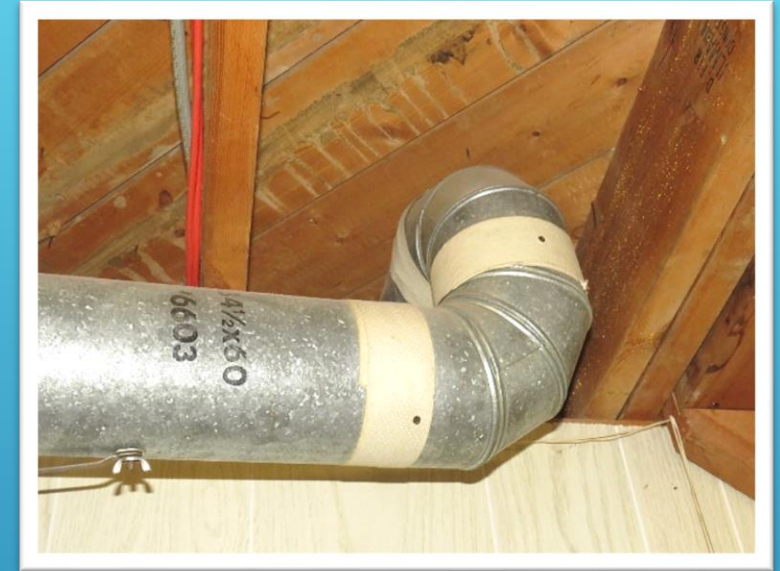
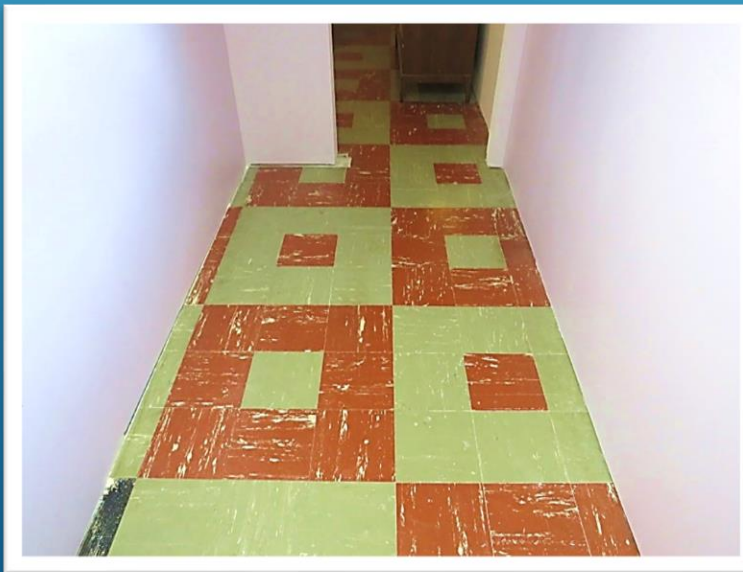
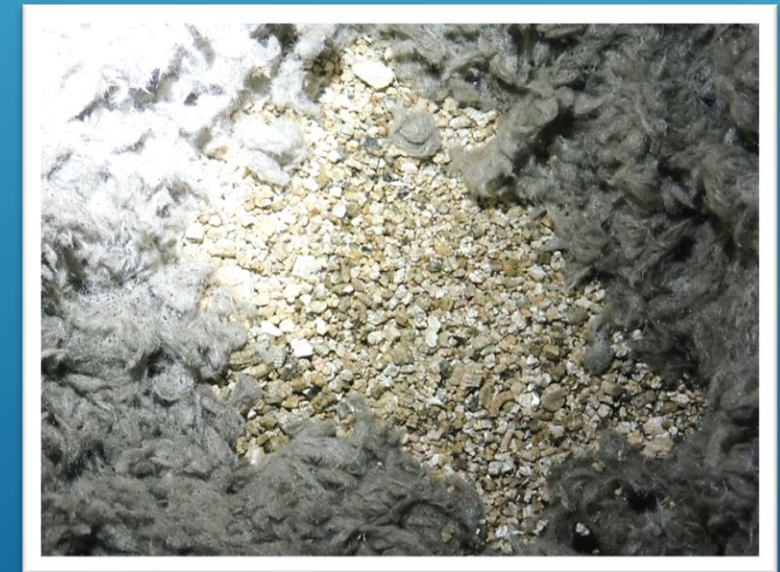
ORIGINALLY REGARDED AS A MIRACLE PRODUCT, ASBESTOS WAS USED UNTIL THE 1990S IN A VARIETY OF BUILDING MATERIALS SUCH AS DRYWALL MUD COMPOUND, HVAC DUCT AND BOILER WRAPS, DASH STUCCO, VERMICULITE INSULATION, FLOORING, ADHESIVES, AND OTHERS.

WHILE DETERMINING WHETHER A MATERIAL HAS ASBESTOS CAN ONLY BE DETERMINED BY A QUALIFIED LAB, THERE ARE SEVERAL BUILDING MATERIALS THAT HAVE A HIGH PROBABILITY OF CONTAINING ASBESTOS.

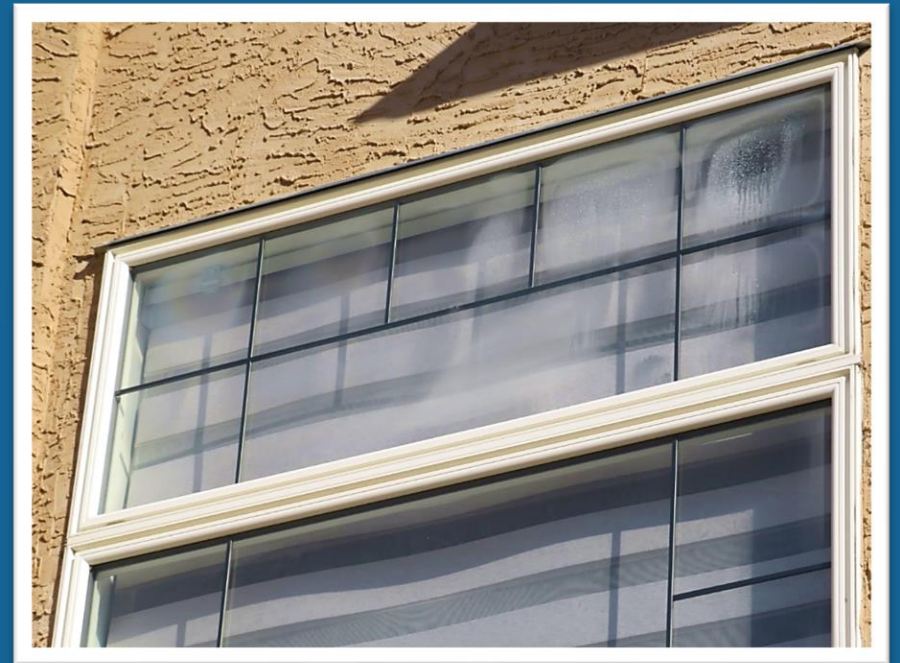
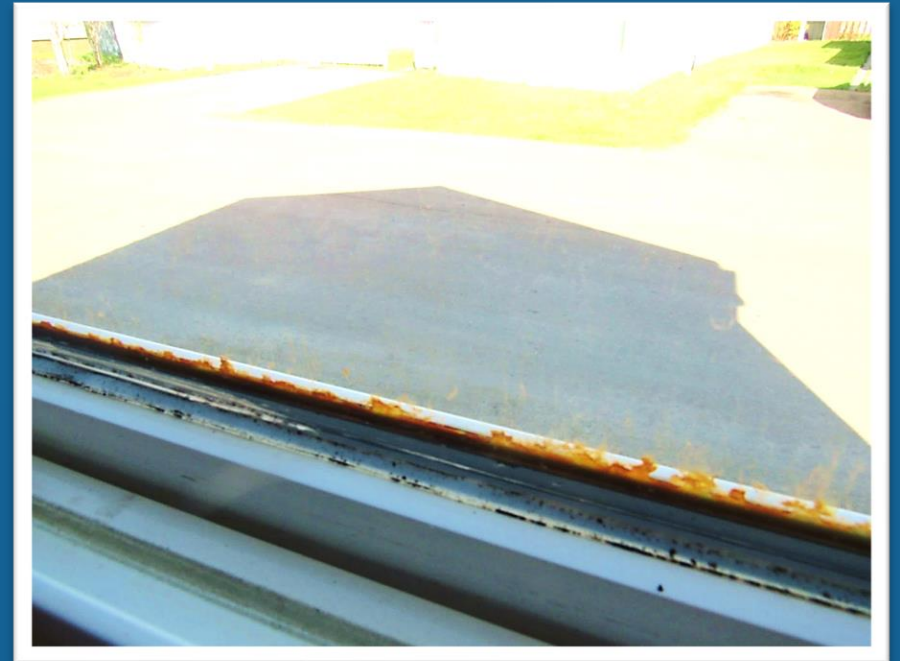
IF YOU SEE RUST, CONDENSATION, OR WATER STREAKS BETWEEN THE PANES THAT YOU CANNOT WIPE OFF FROM BOTH THE INTERIOR AND EXTERIOR PANEL; THIS GENERALLY INDICATES A FAILED SEAL.

WHILE FAILED WINDOW SEALS ARE GENERALLY NOT AN IMMEDIATE CAUSE OF CONCERN, YOU SHOULD BUDGET ACCORDINGLY. WINDOW SEALS OFTEN HAVE A LIFE SPAN OF 25 -30 YEARS.
