CERTA PROPERTY INSPECTIONS

PROPERTY REPORT

345 Demo Street
Calgary, AB T2N 3C7

JULY 24, 2023

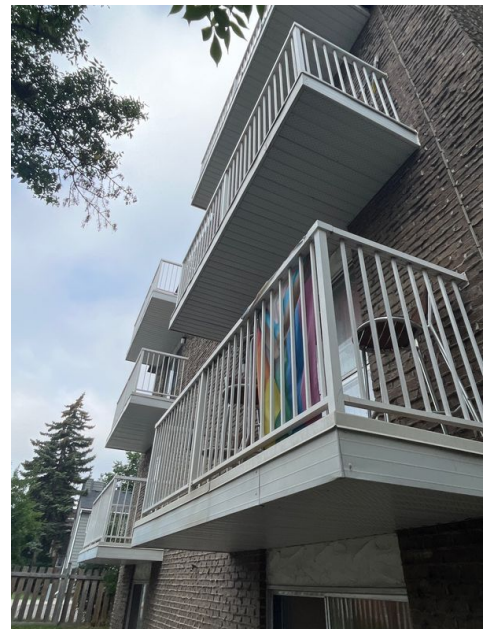
Balcony(ies)

LIMITED OR NO ACCESS

Due to the limited access, the inspector was unable to inspect below the structure to inspect the construction.

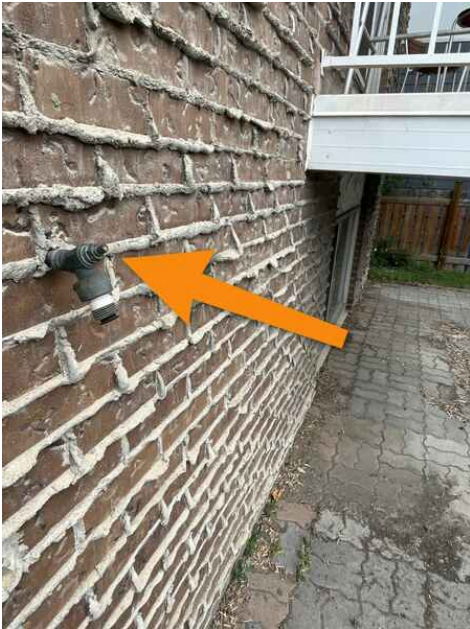
Hose Bib

NOT TESTED

One or more hose bibs were not tested.

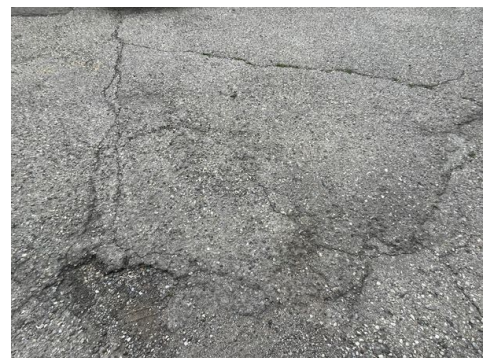
DRIVEWAY CRACKS

Cracking and or spalling was found at the driveway. A masonry sealant for concrete driveways, such as Sikaflex, can be used which may help prevent further expansion of the cracks by preventing water penetration and further cracking when it freezes in colder temperatures. For asphalt driveways, it is recommended to seal openings with an approved sealant.

Contact a qualified driveway contractor.

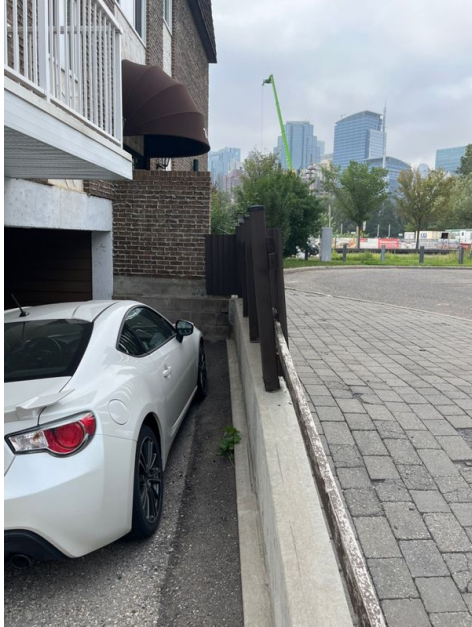
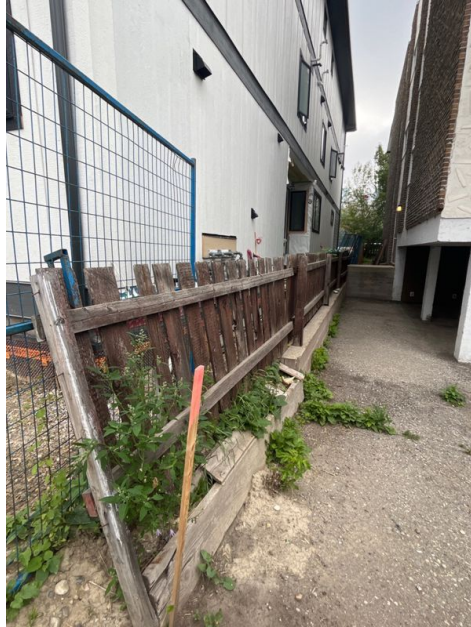
2.13.1 Fence

LEANING

One or more areas of the fence line were noted to be leaning. It is recommended that a qualified contractor repairs this.

Contact a qualified carpenter.

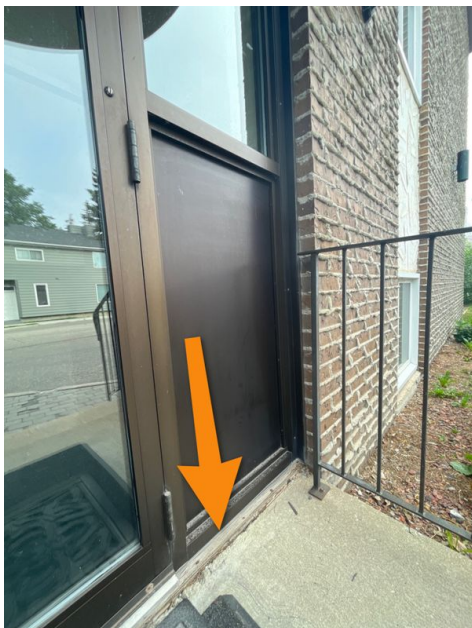
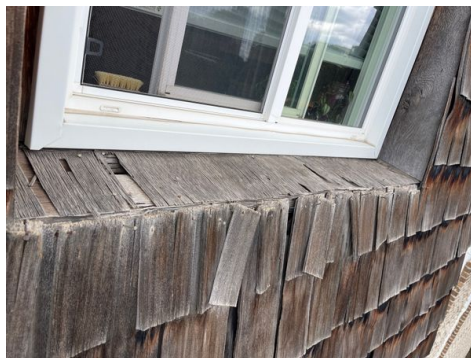
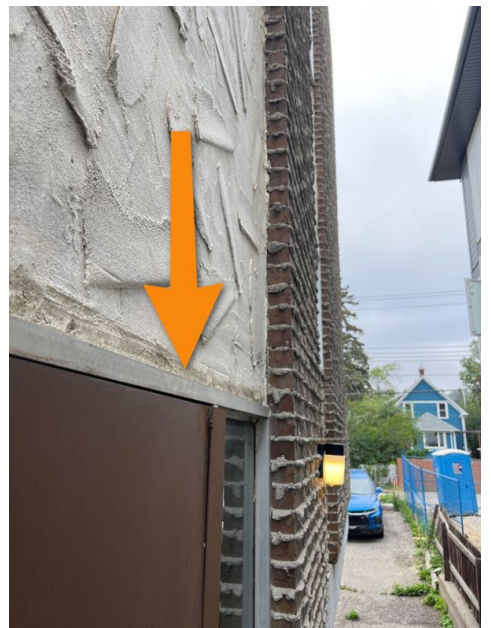
2.14.1 Flashing & Trim

FLASHING MISSING

It is recommended to have flashing installed to prevent weather and vermin intrusion.

Contact a qualified siding specialist.

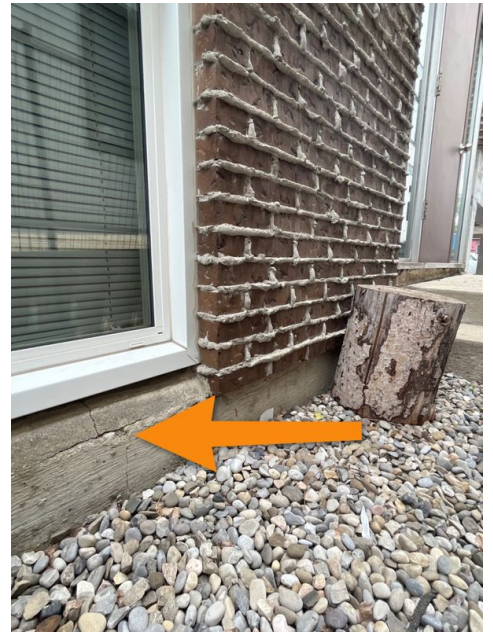
2.15.1 Foundation

CRACK(S) IN FOUNDATION - VERTICAL

One or more cracks in the foundation walls were found. Cracks should be monitored for water penetration and growth. It is recommended that all cracks and fissures be sealed to prevent water migration. An epoxy resin injection should be used on clean dry cracks while a polyurethane foam injection can be used in active and or dirty cracks. It should be noted that the epoxy injection provides structural bearing while the polyurethane foam does not.

Contact a foundation contractor.

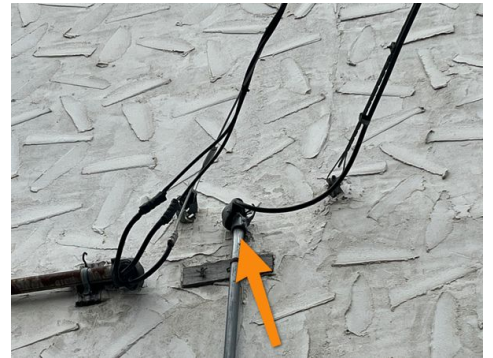
2.29.1 Service Entrance Conductors

WEATHERHOOD DAMAGE

Contact a qualified professional.

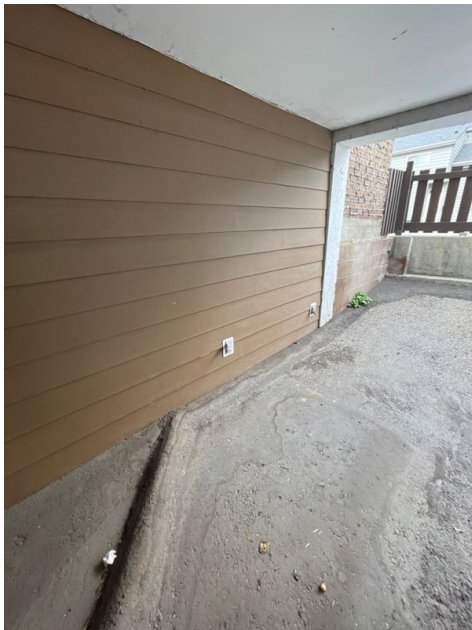
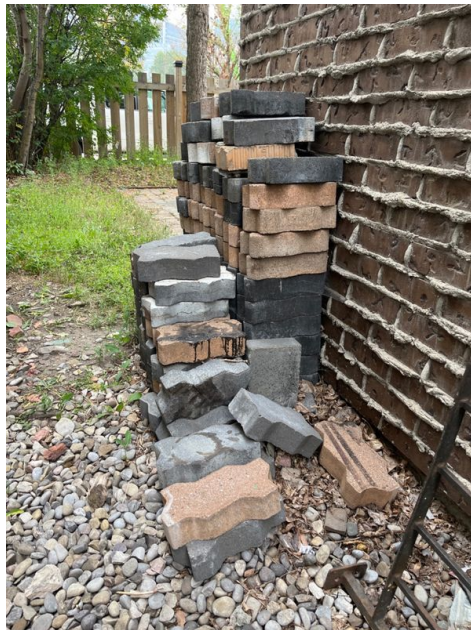
Too close to grade

Contact a qualified siding specialist.

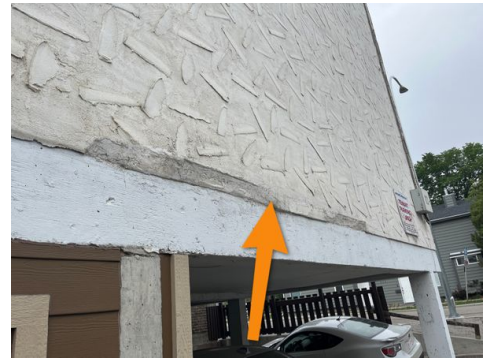
2.30.4 Siding

INCOMPLETE SIDING

Contact a qualified siding specialist.

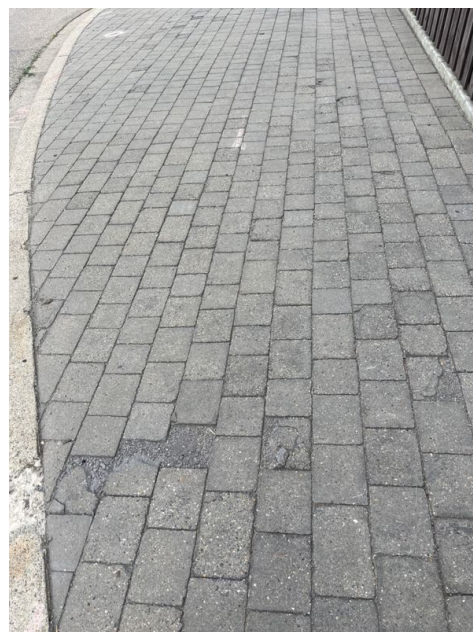
2.39.1 Walkway(s)

CRACKS / DAMAGE

Contact a qualified landscaping contractor

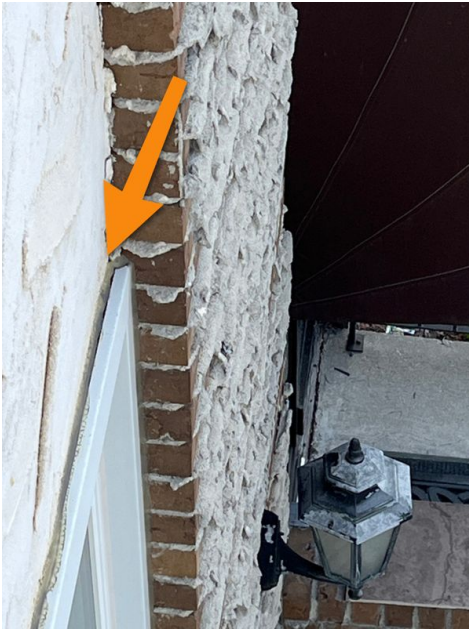
2.40.1 Windows

DETERIORATED CAULKING

Contact a handyman or DIY project

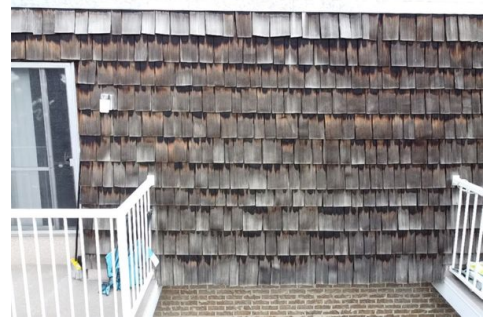
2.41.1 Wood Products

It is recommended to maintain exterior wood products on a regular basis; this consists of removing old and damaged paint / stain, priming and reapplying new products. This will prolong the lifespan of the wood product.

Contact a qualified handyman.

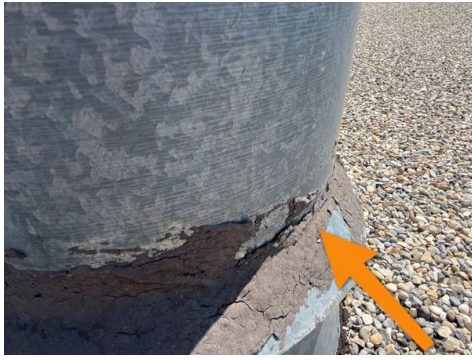
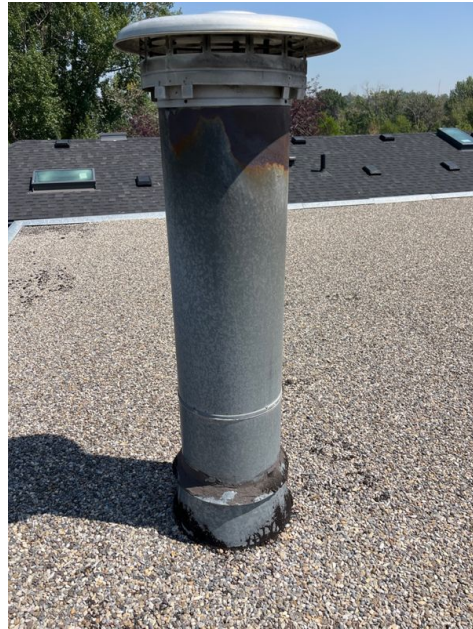
3.1.1 Chimneys

SEALANT MISSING / DETERIORATED

It is recommended to seal openings to keep the weather out.

Contact a qualified professional.

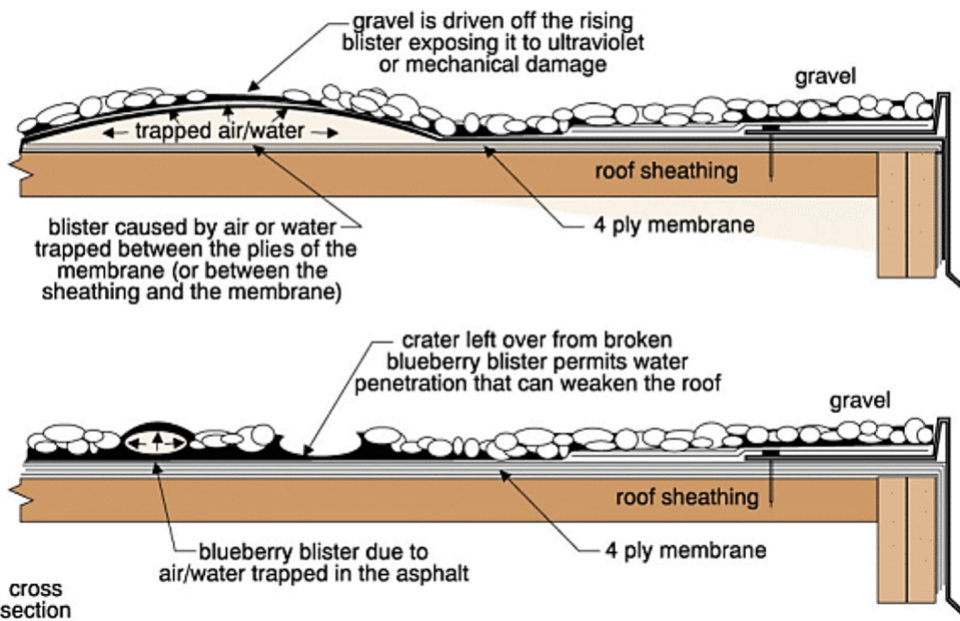
3.2.1 Coverings

BUILT UP ROOFING DEFECT(S)

Exposed areas of the membrane were noted along with cracking / alligatoring. It is recommended to replace the missing ballast and monitor the areas for leakage. No active leaks were noted in these areas at the time of the inspection.

Blisters in built up roofing membranes

Recommendation
Contact a qualified roofing professional.

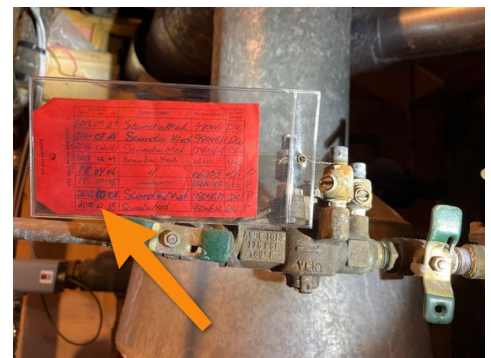
5.1.1 Backwater Valve

SERVICE RECOMMENDED

It is recommended to service back flow prevention devices annually.

Contact a qualified professional.

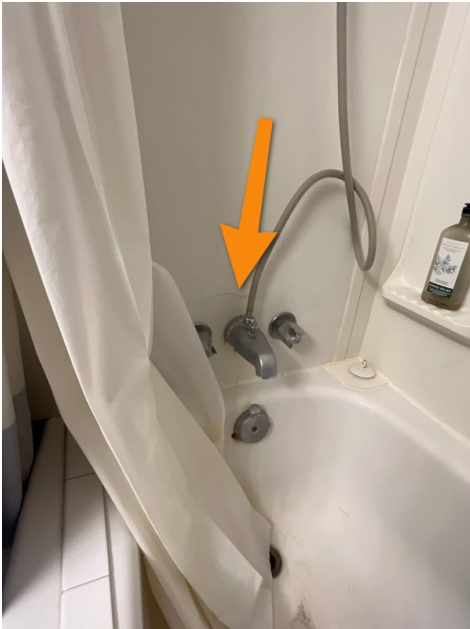
5.4.1 Fixtures

DAMAGE

Damage was noted at one or more fixture. It is recommend to repair or replace the affected components.

Contact a qualified plumbing contractor.

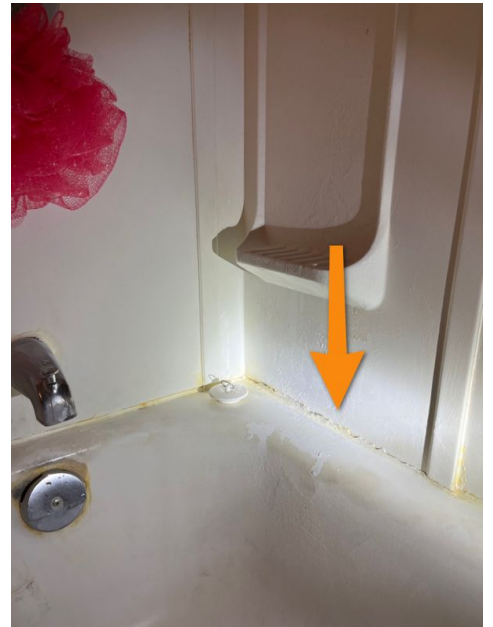
5.4.2 Fixtures

DETERIORATED OR MISSING CAULKING

One or more locations at the structure exhibited missing or caulking past its life expectancy. Caulking helps prevent water migration into areas not designed to contain water. It is recommended to rectify this.

Contact a qualified professional.

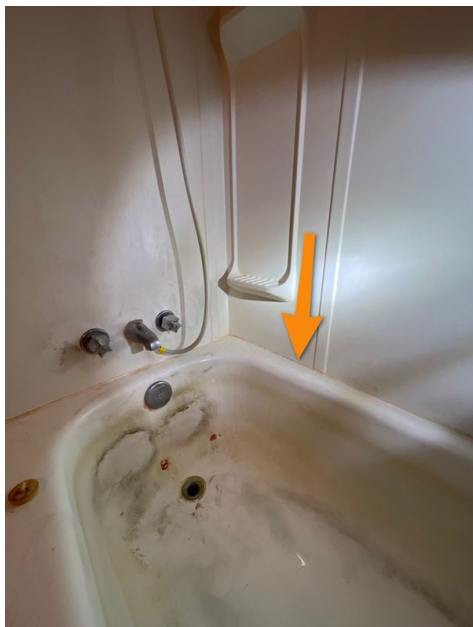
5.4.3 Fixtures

DETERIORATED OR MISSING CAULKING

One or more locations at the structure exhibited missing or caulking past its life expectancy. Caulking helps prevent water migration into areas not designed to contain water. It is recommended to rectify this.

Contact a qualified professional.

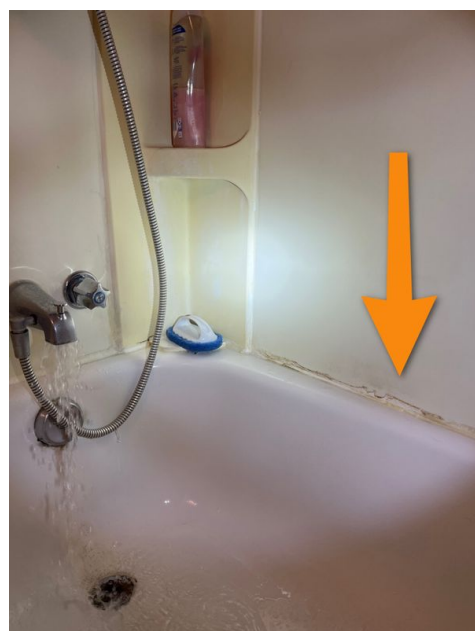
5.4.4 Fixtures

DETERIORATED OR MISSING CAULKING

One or more locations at the structure exhibited missing or caulking past its life expectancy. Caulking helps prevent water migration into areas not designed to contain water. It is recommended to rectify this.

Contact a qualified professional.

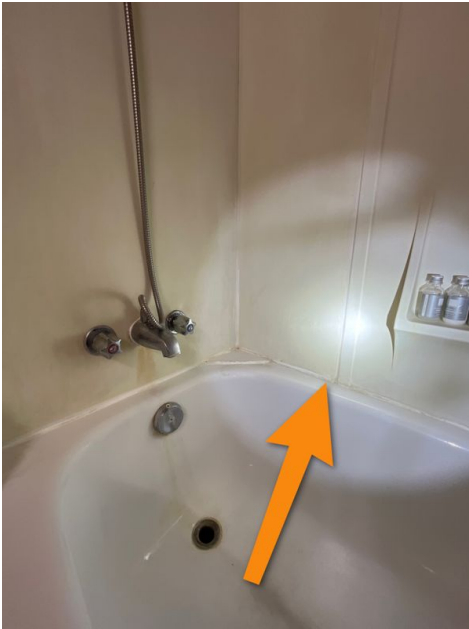
5.4.5 Fixtures

DETERIORATED OR MISSING CAULKING

One or more locations at the structure exhibited missing or caulking past its life expectancy. Caulking helps prevent water migration into areas not designed to contain water. It is recommended to rectify this.

Contact a qualified professional.

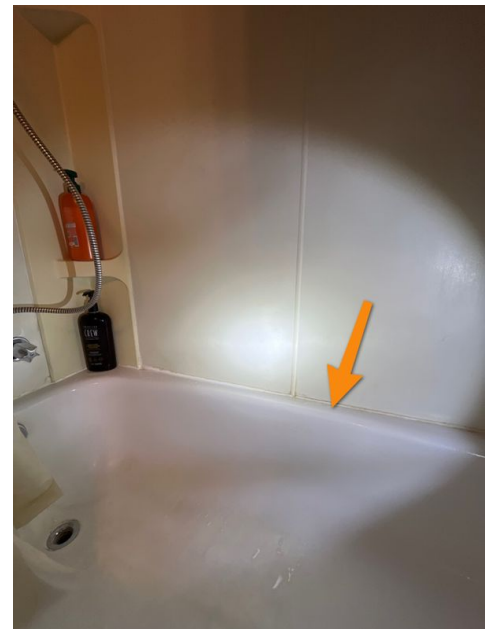
5.4.6 Fixtures

DETERIORATED OR MISSING CAULKING

One or more locations at the structure exhibited missing or caulking past its life expectancy. Caulking helps prevent water migration into areas not designed to contain water. It is recommended to rectify this.

Contact a qualified professional.

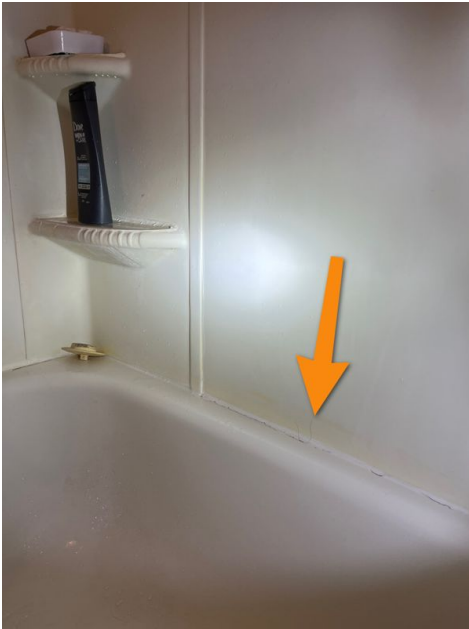
5.4.7 Fixtures

DETERIORATED OR MISSING CAULKING

One or more locations at the structure exhibited missing or caulking past its life expectancy. Caulking helps prevent water migration into areas not designed to contain water. It is recommended to rectify this.

Contact a qualified professional.

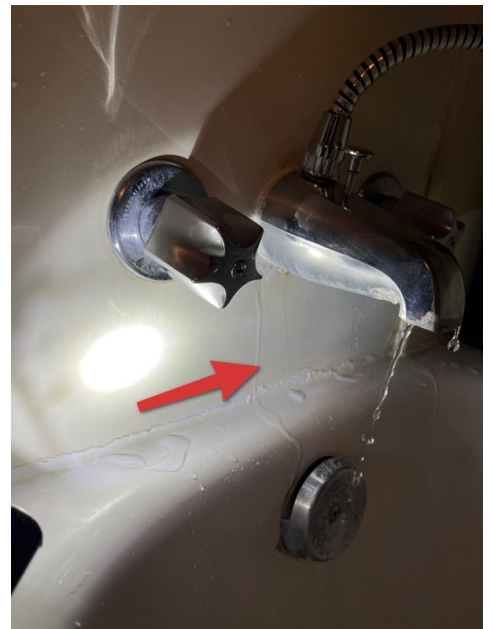
5.4.8 Fixtures

LEAK

One or more leak(s) was noted at the following fixture(s). It is recommended that this be repaired by a qualified professional.

Contact a qualified plumbing contractor.

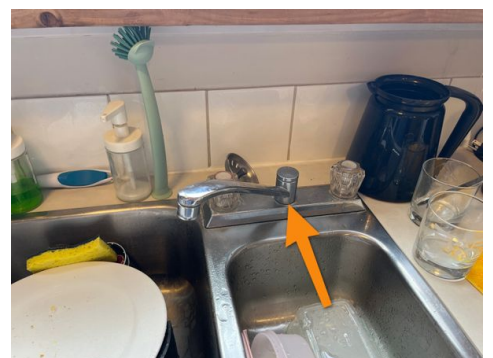
5.4.9 Fixtures

LEAK

One or more leak(s) was noted at the following fixture(s). It is recommended that this be repaired by a qualified professional.

Contact a qualified plumbing contractor.

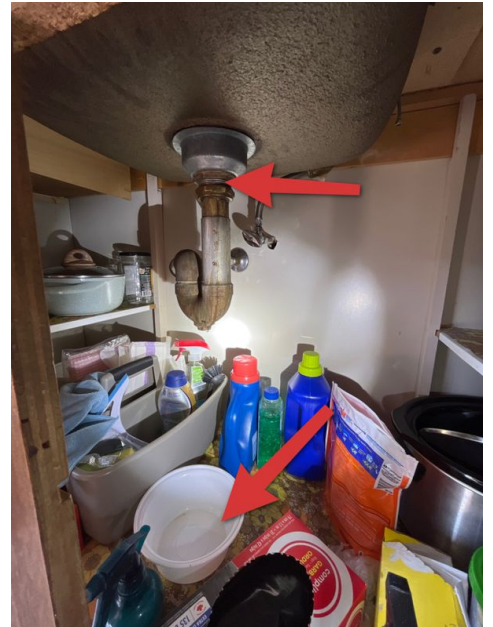
5.4.10 Fixtures

**LEAK**

One or more leak(s) was noted at the following fixture(s). It is recommended that this be repaired by a qualified professional.

Contact a qualified plumbing contractor.

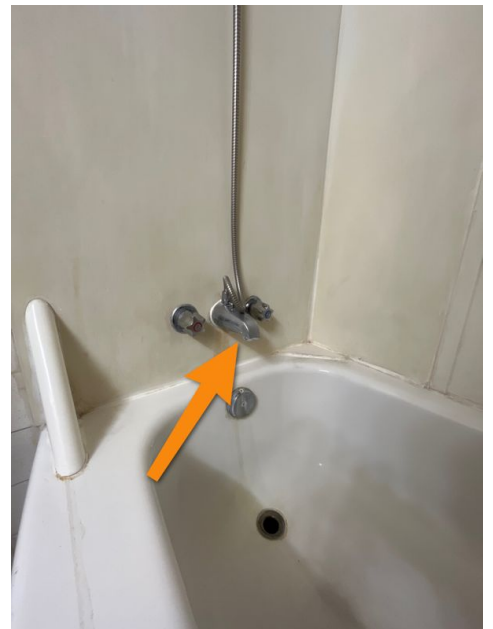
5.4.11 Fixtures

NUISANCE DRIP

A nuisance drip was found at the following fixture.

Contact a qualified plumbing contractor.

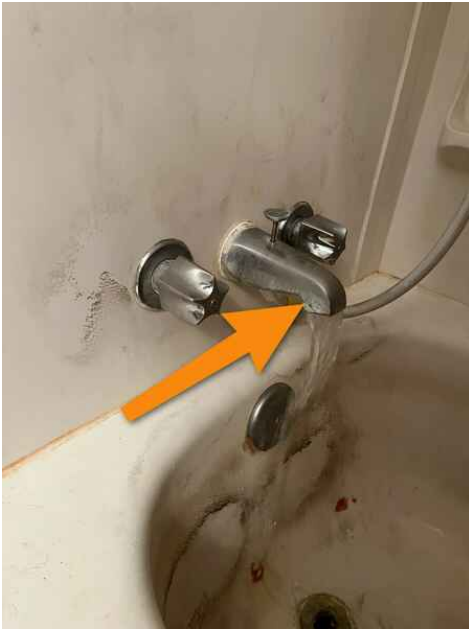
5.4.12 Fixtures

SHOWER DIVERTER

The following shower diverter does not function as well as it is intended. Repair or replacement may be needed if increased enjoyment is desired.

Contact a qualified plumbing contractor.

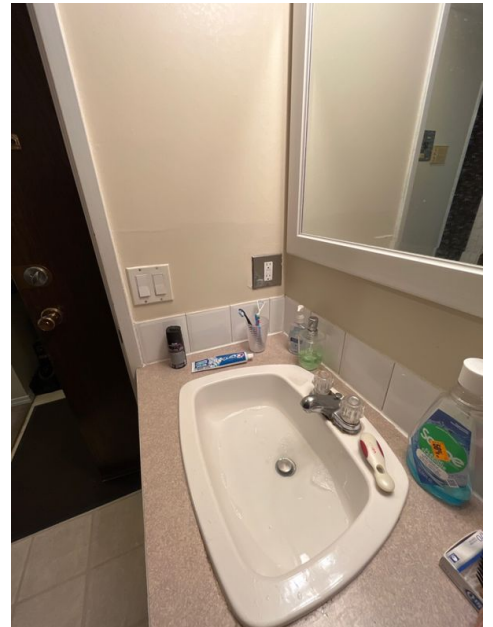
5.4.13 Fixtures

SLOW DRAIN(S)

One or more fixtures were noted to have a slow drain; this should be serviced to provide adequate drainage. Pouring baking soda followed by vinegar may help break up obstructions down hole if debris is the culprit.

Contact a qualified plumbing contractor.

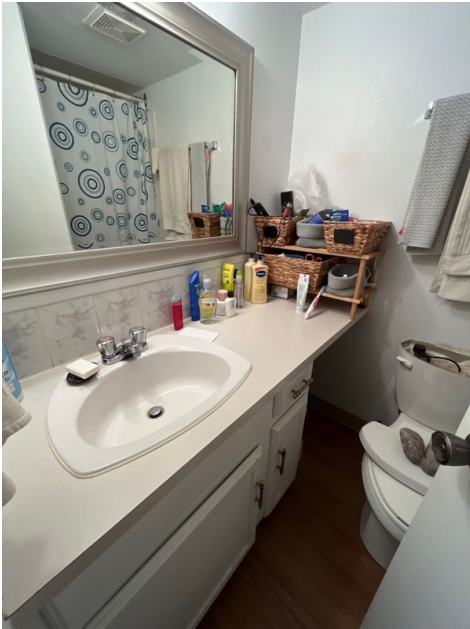
One or more fixtures were noted to have a slow drain; this should be serviced to provide adequate drainage. Pouring baking soda followed by vinegar may help break up obstructions down hole if debris is the culprit.

Contact a qualified plumbing contractor.

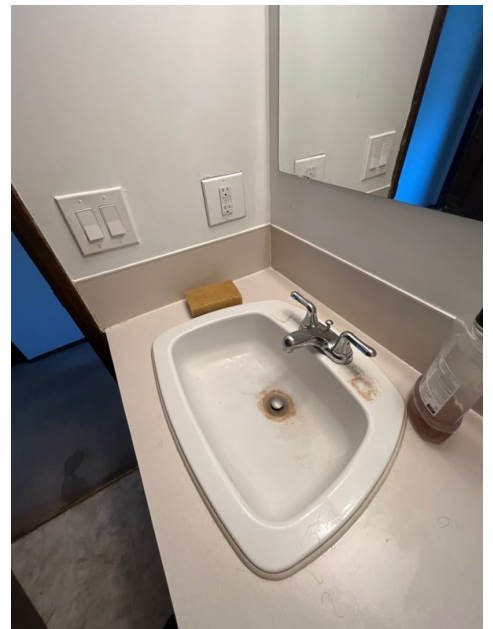
5.4.15 Fixtures

SLOW DRAIN(S)

One or more fixtures were noted to have a slow drain; this should be serviced to provide adequate drainage. Pouring baking soda followed by vinegar may help break up obstructions down hole if debris is the culprit.

Contact a qualified plumbing contractor.

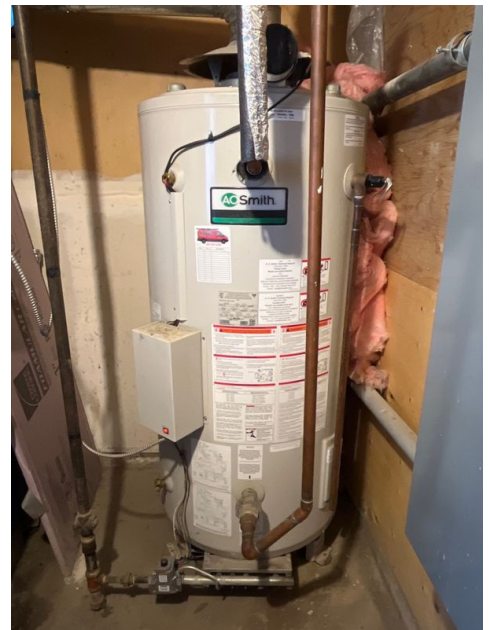
Due to the age of the water heater, it is recommended that the client(s) begin budgeting for a replacement unit. Proper maintenance of the unit, such as annual drainage along with bi-annual rod replacement have shown to increase the life span of these systems. If the structure has been vacant for more than 4 weeks, it is recommended to flush the water from water heater to mitigate any exposure of waterborne pathogens.

Contact a qualified plumbing contractor.

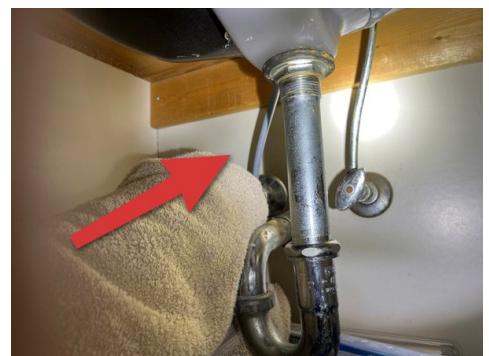
5.14.1 Water Supply, Distribution Systems

POLYBUTYLENE SUPPLY PIPES

Polybutylene piping was found in the structure. This type of piping was prone to leak at the connection joints. It is recommended that this pipe be monitored for leaks. It is recommended that the potential buyer(s) inquire with the insurance provider to see if this material poses a concern for insuring the structure. This material was typically used between 1985 - 1995.

Contact a qualified plumbing contractor.

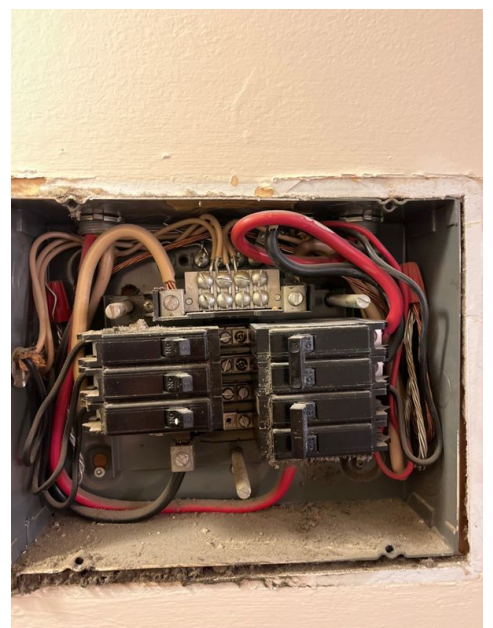
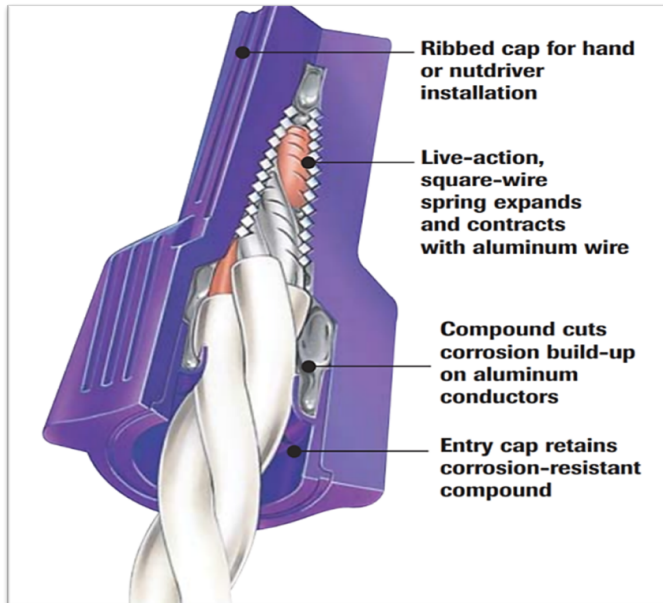
Some of the branch circuit wiring was found to be made of aluminum. It is recommended that the potential buyer contact their home insurance provider to see if any additional information is required prior to insuring the structure.

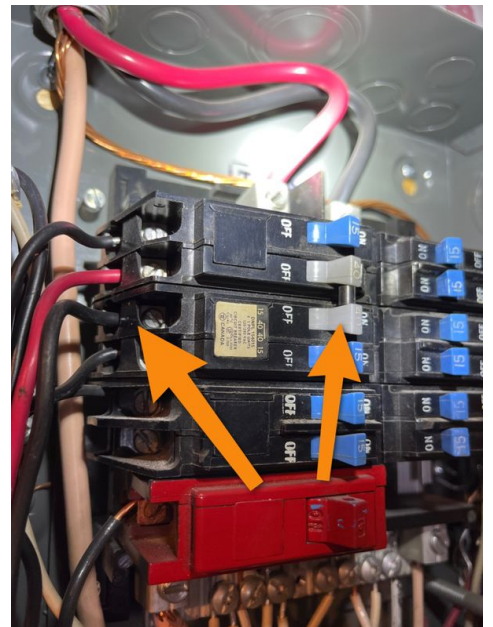
6.1.2 Branch Wiring

INADEQUATE WIRING SIZE

Contact a qualified electrical contractor.

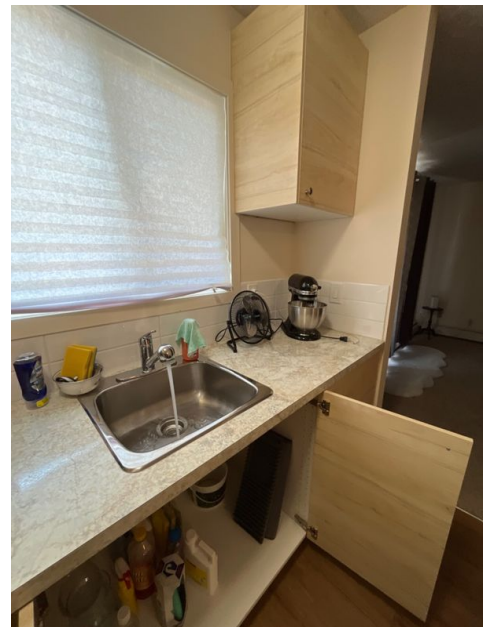
It is recommended that GFI protected receptacles be installed within 6 feet of any water sources as well as receptacles found outside below 2.5 meters. It is recommended to have a qualified electrician install these.

Contact a qualified electrical contractor.

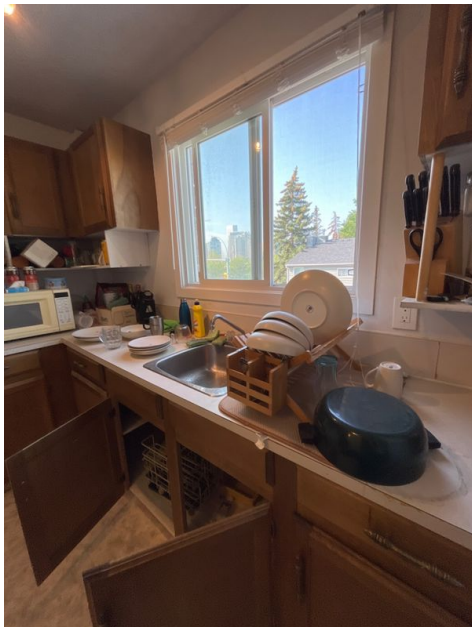
6.5.3 GFCI & AFCI

NO GFCI PROTECTION INSTALLED

It is recommended that GFI protected receptacles be installed within 6 feet of any water sources as well as receptacles found outside below 2.5 meters. It is recommended to have a qualified electrician install these.

Contact a qualified electrical contractor.

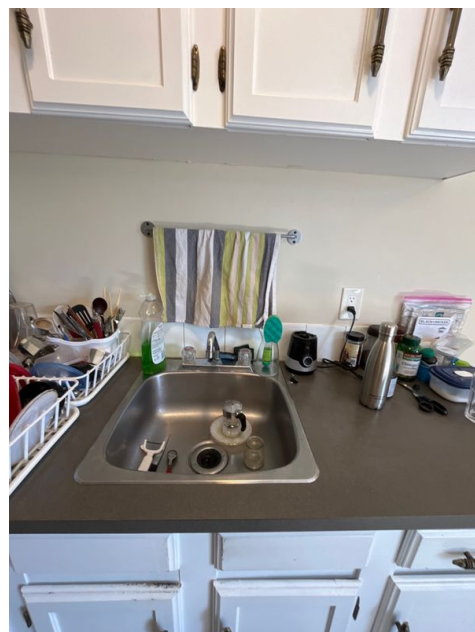
6.5.4 GFCI & AFCI

NO GFCI PROTECTION INSTALLED

It is recommended that GFI protected receptacles be installed within 6 feet of any water sources as well as receptacles found outside below 2.5 meters. It is recommended to have a qualified electrician install these.

Contact a qualified electrical contractor.

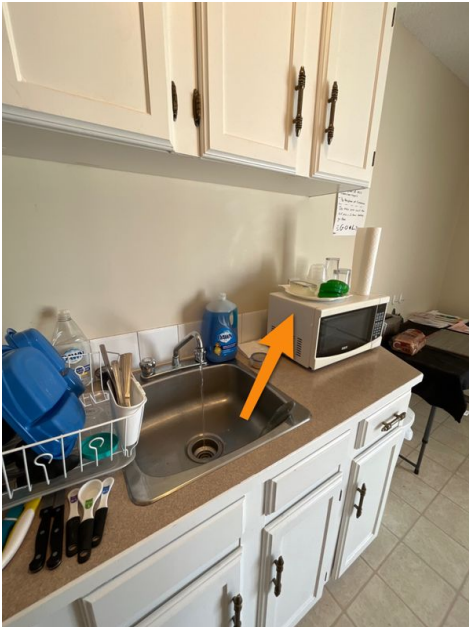
6.5.5 GFCI & AFCI

NO GFCI PROTECTION INSTALLED

It is recommended that GFI protected receptacles be installed within 6 feet of any water sources as well as receptacles found outside below 2.5 meters. It is recommended to have a qualified electrician install these.

Contact a qualified electrical contractor.

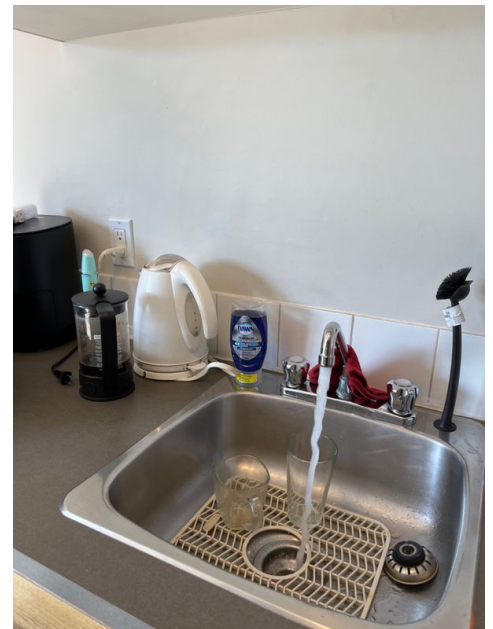
6.5.6 GFCI & AFCI

NO GFCI PROTECTION INSTALLED

It is recommended that GFI protected receptacles be installed within 6 feet of any water sources as well as receptacles found outside below 2.5 meters. It is recommended to have a qualified electrician install these.

Contact a qualified electrical contractor.

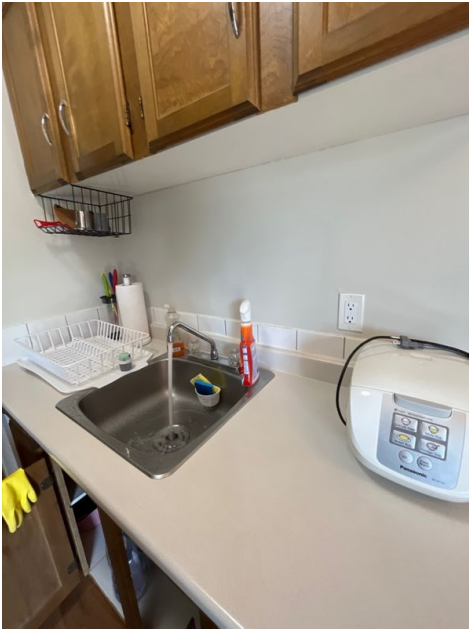
6.5.7 GFCI & AFCI

NO GFCI PROTECTION INSTALLED

It is recommended that GFI protected receptacles be installed within 6 feet of any water sources as well as receptacles found outside below 2.5 meters. It is recommended to have a qualified electrician install these.

Contact a qualified electrical contractor.

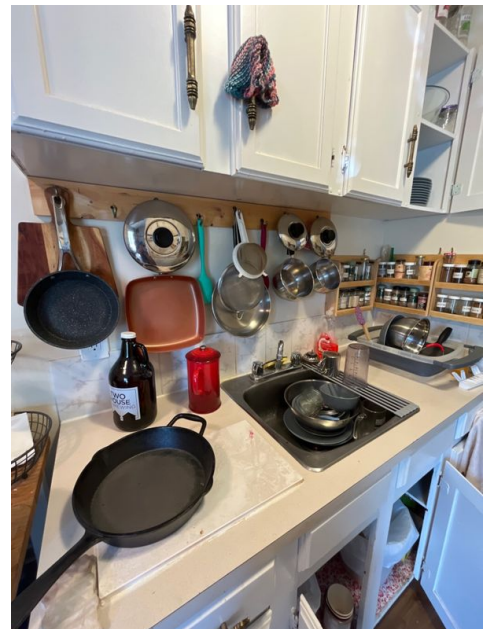
6.5.8 GFCI & AFCI

NO GFCI PROTECTION INSTALLED

It is recommended that GFI protected receptacles be installed within 6 feet of any water sources as well as receptacles found outside below 2.5 meters. It is recommended to have a qualified electrician install these.

Contact a qualified electrical contractor.

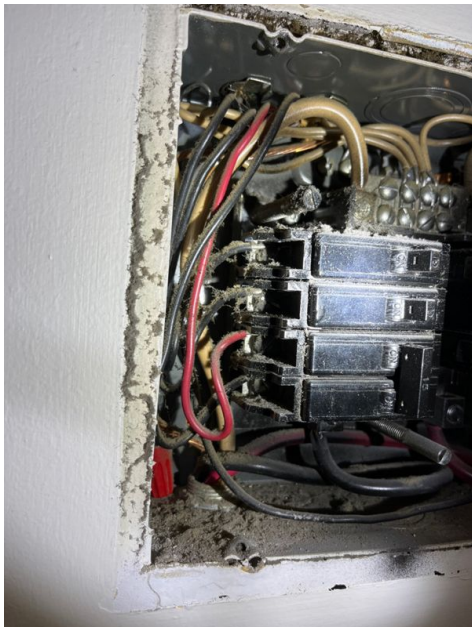
6.9.1 Sub Panel

DEBRIS

Debris was noted in the following panelboard(s). It is recommended that the debris be removed to prevent a chance of overheating.

Contact a qualified electrical contractor.

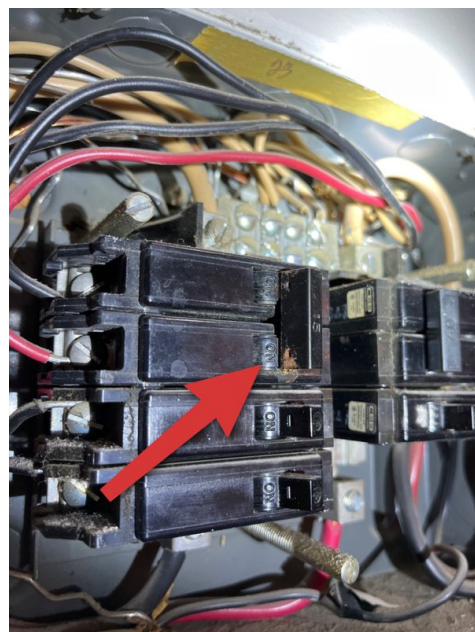
6.9.2 Sub Panel

RUST

Corrosion was noted inside the panelboard. It is recommended a qualified electrician further investigates this.

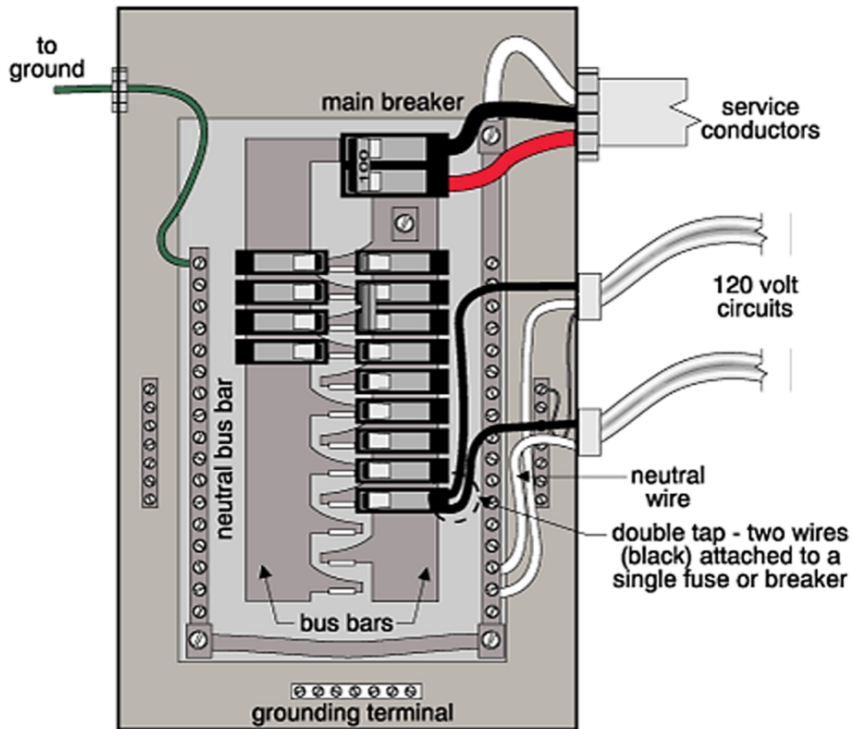
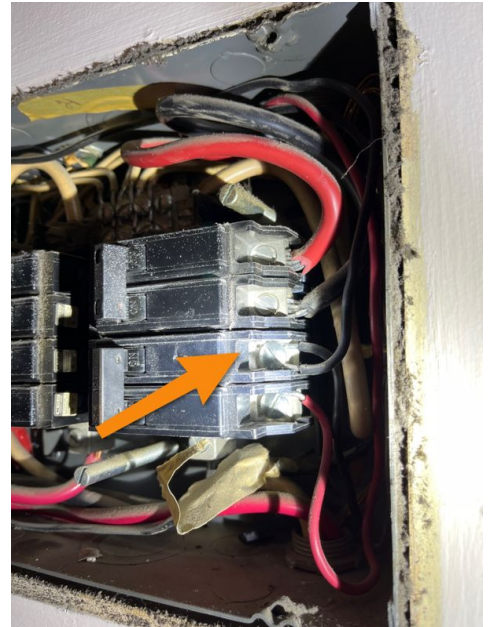
6.11.1 Overcurrent Protection Devices (Breakers / Fuses)

DOUBLE LUGGING

Breakers are typically designed to only have one wire connected to them. Additional wiring may cause arcing which can cause a fire. This should be remedied by a qualified electrician.

Double lugging

Contact a qualified electrical contractor.

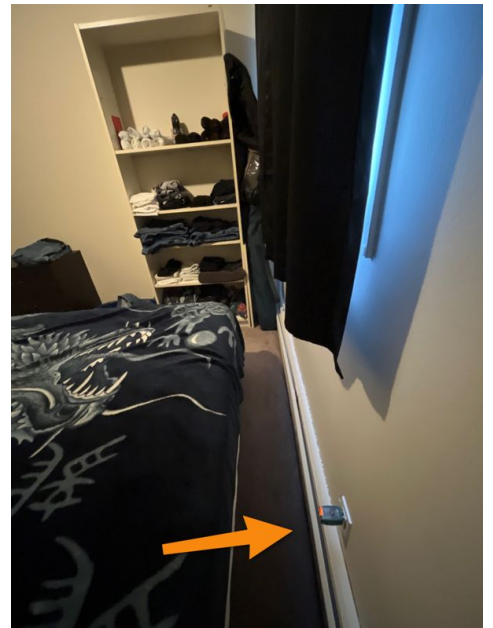
One or more receptacles were noted to be miswired.

Contact a qualified electrical contractor.

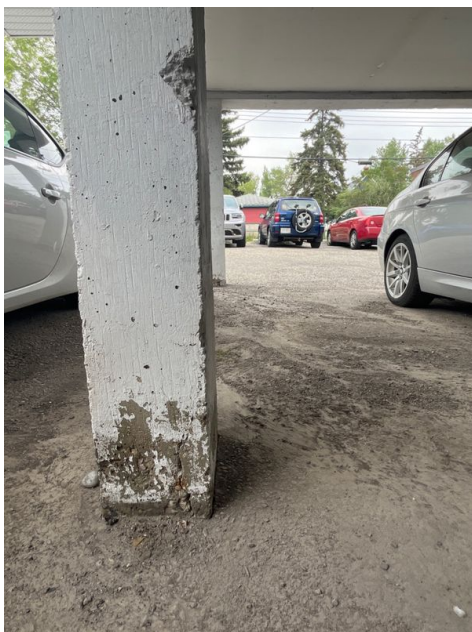
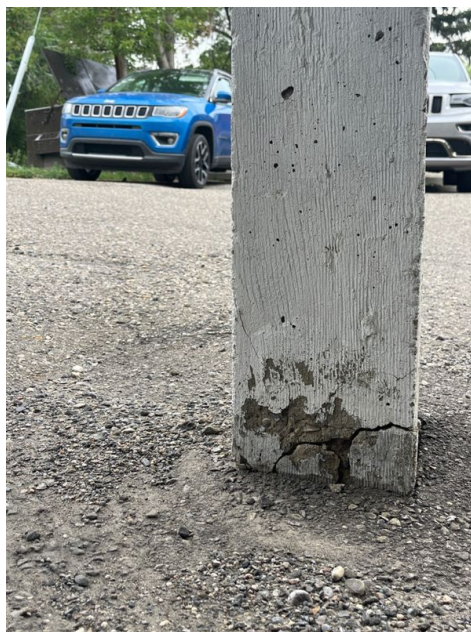
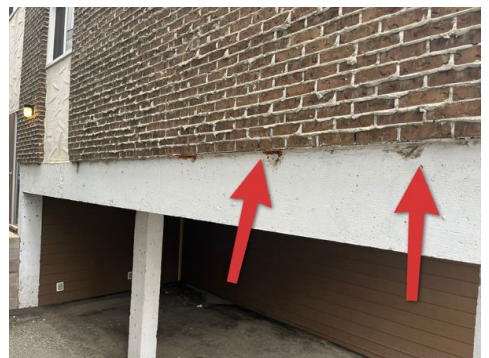
7.9.1 Foundation

DETERIORATION

Areas of deterioration were noted at the foundation. It is recommended these be repaired by a qualified professional.

Contact a foundation contractor.

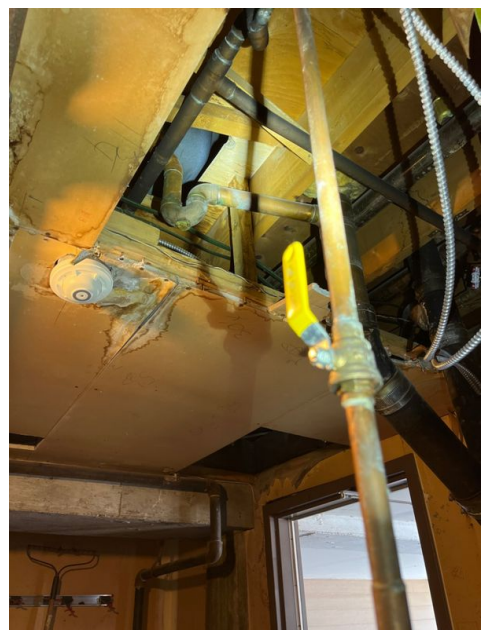
7.10.1 Wall Structure

NO FIRE SEPARATION

It is recommended to have fire separation between the adjoining unit(s).

Contact a qualified professional.

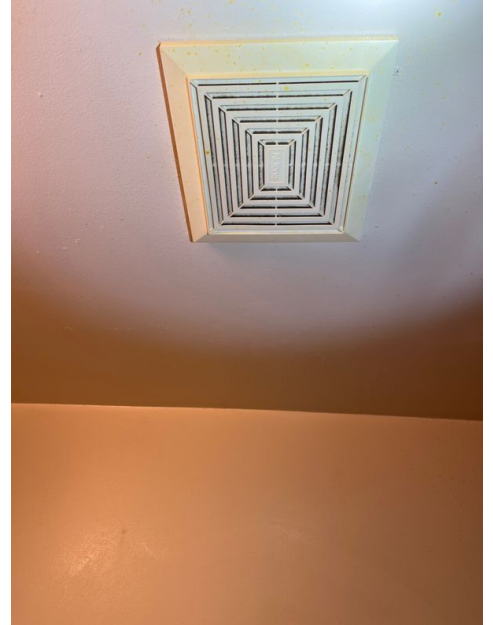
Some of the grills for the exhaust fans were found to be dirty; resulting in a loss of air flow. It is recommended to have these cleaned; using the dishwasher is a simple and quick method.

Contact a handyman or DIY project

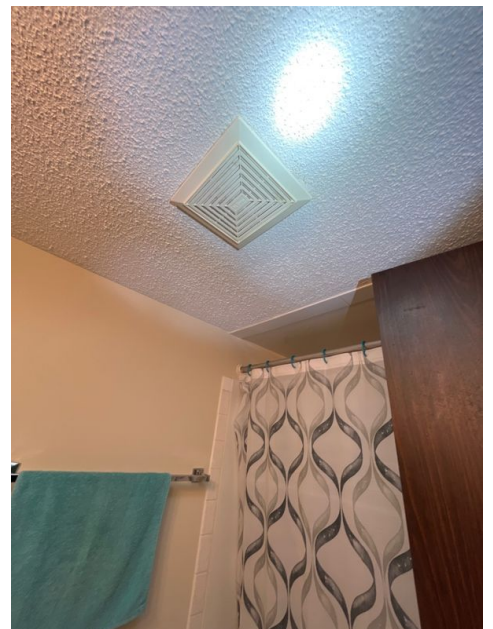
8.2.2 Exhaust Systems

DIRTY EXHAUST FAN COVER(S)

Some of the grills for the exhaust fans were found to be dirty; resulting in a loss of air flow. It is recommended to have these cleaned; using the dishwasher is a simple and quick method.

Contact a handyman or DIY project

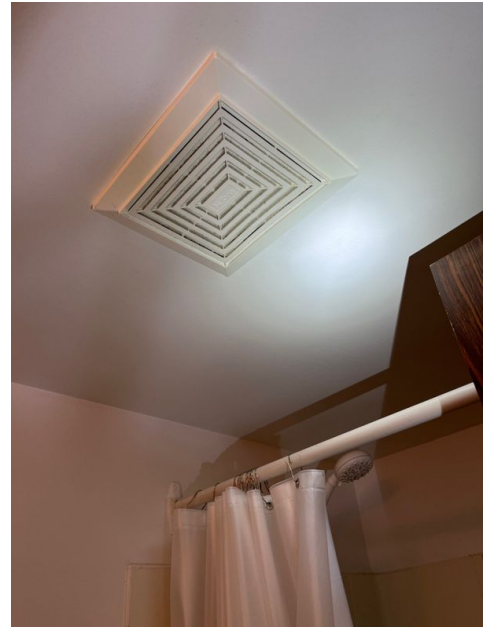
8.2.3 Exhaust Systems

DIRTY EXHAUST FAN COVER(S)

Some of the grills for the exhaust fans were found to be dirty; resulting in a loss of air flow. It is recommended to have these cleaned; using the dishwasher is a simple and quick method.

Contact a handyman or DIY project

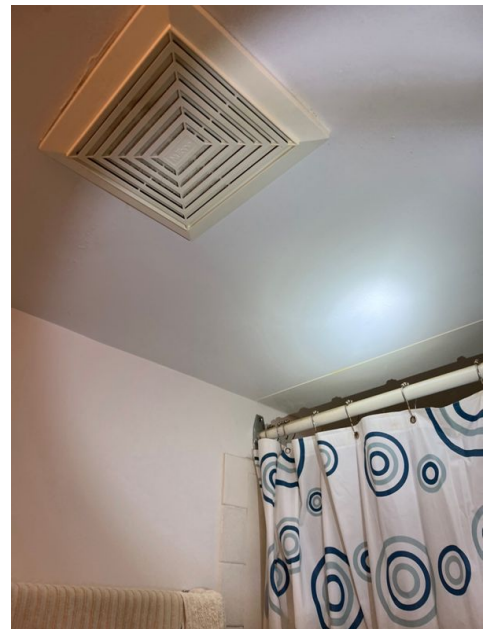
8.2.4 Exhaust Systems

DIRTY EXHAUST FAN COVER(S)

Some of the grills for the exhaust fans were found to be dirty; resulting in a loss of air flow. It is recommended to have these cleaned; using the dishwasher is a simple and quick method.

Contact a handyman or DIY project

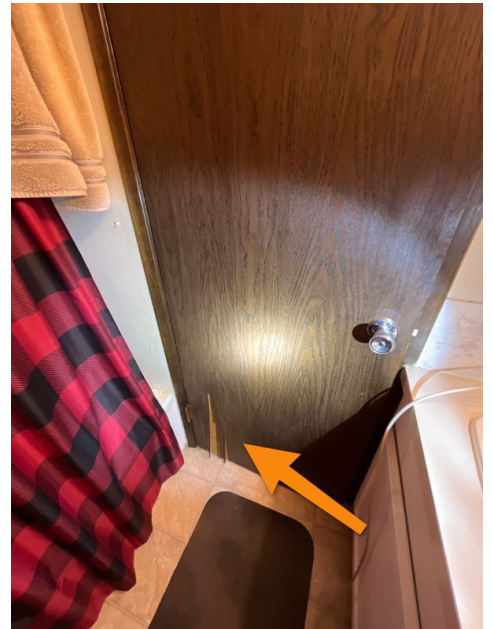
9.4.1 Doors

DAMAGE

One or more doors were noted to have damage.

Contact a qualified door repair/installation contractor.

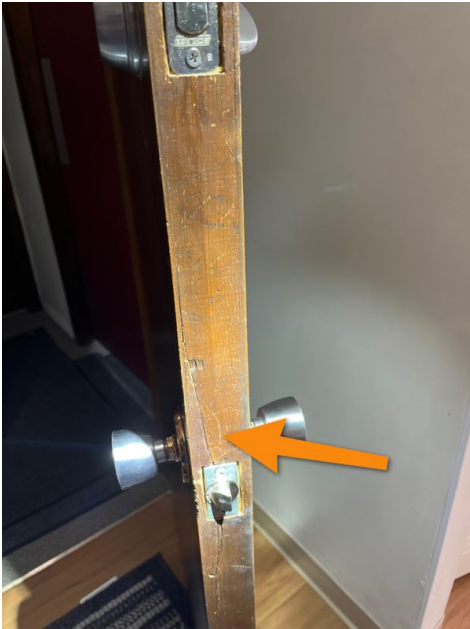
9.4.2 Doors

DAMAGE

One or more doors were noted to have damage.

Contact a qualified door repair/installation contractor.

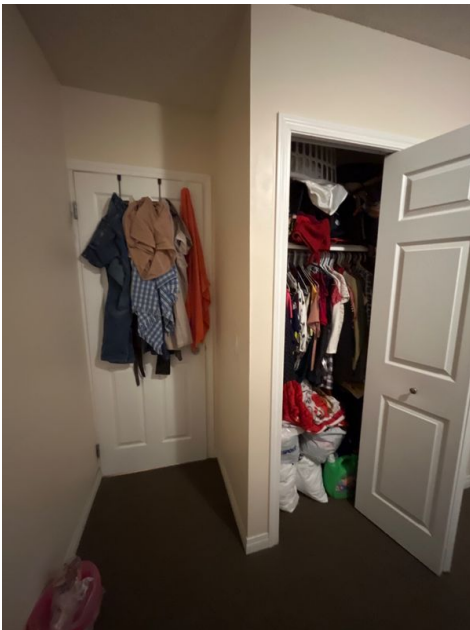
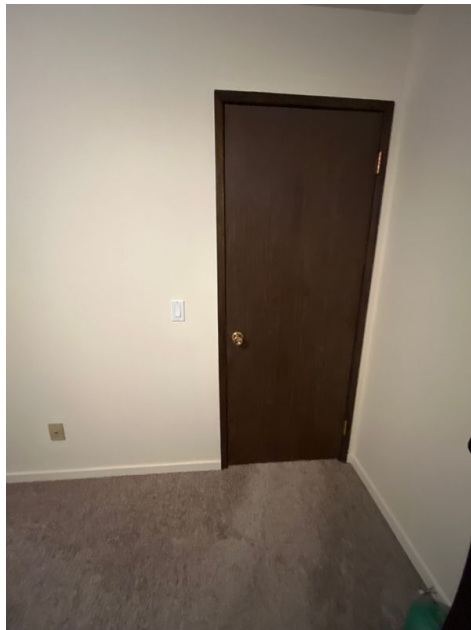
9.4.3 Doors

DOESN'T LATCH

One or more doors did not latch well. A servicing is recommended for smoother operation.

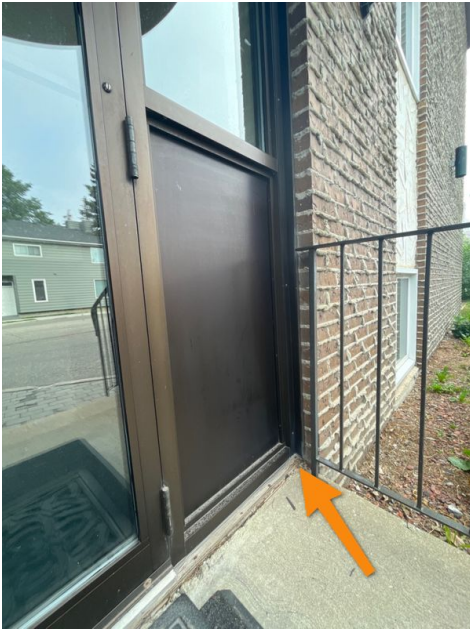
ROT

Signs of wood rot were noted at the following door(s). All affected components should be replaced with rot resistant lumber. With any renovations, water marks and potential rot / mold should be expected.

Contact a qualified carpenter.

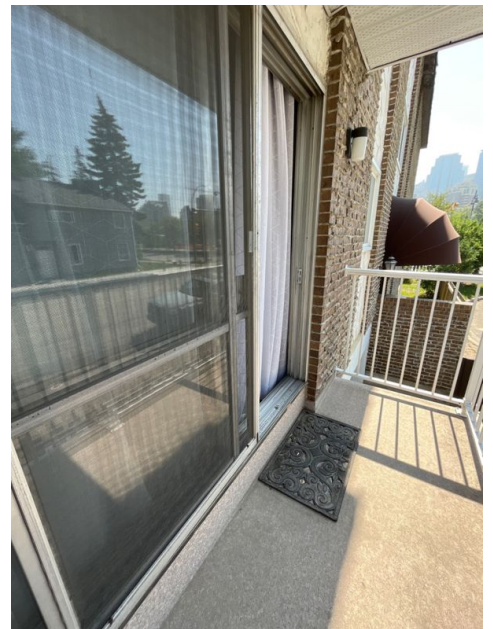
9.4.7 Doors

SERVICING RECOMMENDED

Contact a qualified door repair/installation contractor.
