CERTA PROPERTY INSPECTIONS

PROPERTY REPORT

345 Demo Street
Calgary, AB T2N 3C7

JULY 24, 2023

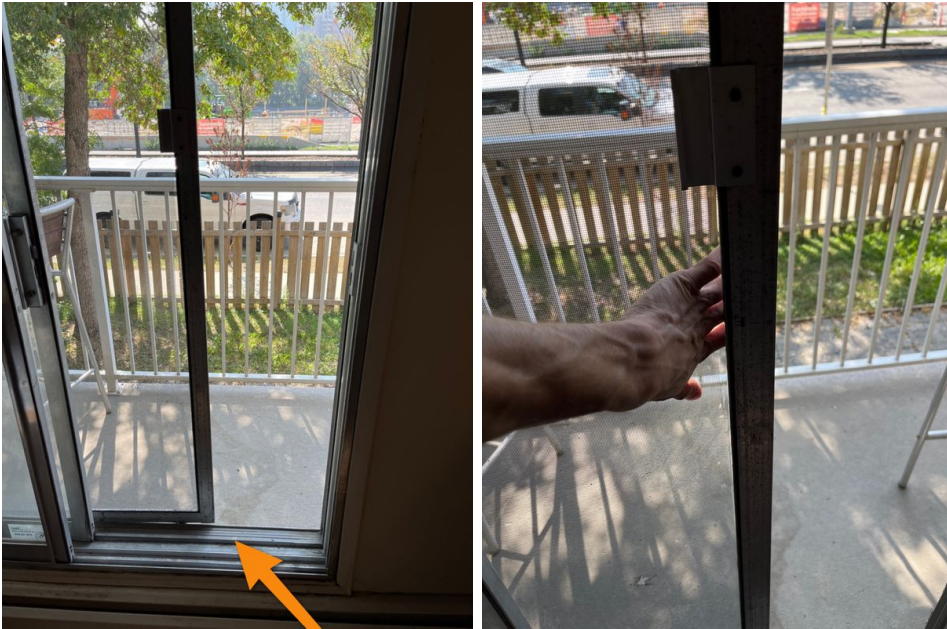
9.4.8 Doors

SERVICING RECOMMENDED

Contact a qualified door repair/installation contractor.

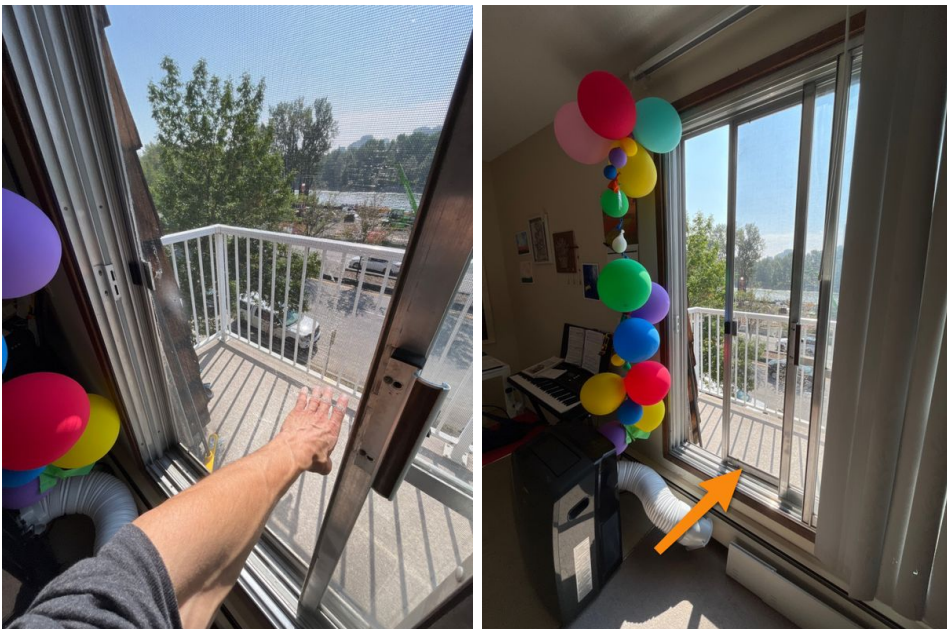
9.4.9 Doors

SERVICING RECOMMENDED

Contact a qualified door repair/installation contractor.

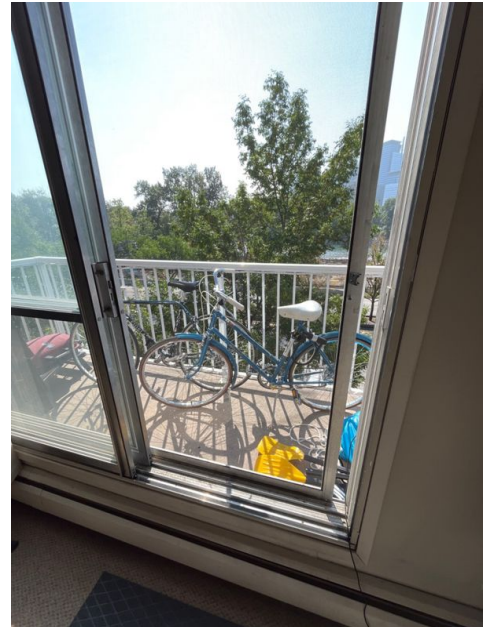
9.4.10 Doors

SERVICING RECOMMENDED

Contact a qualified door repair/installation contractor.

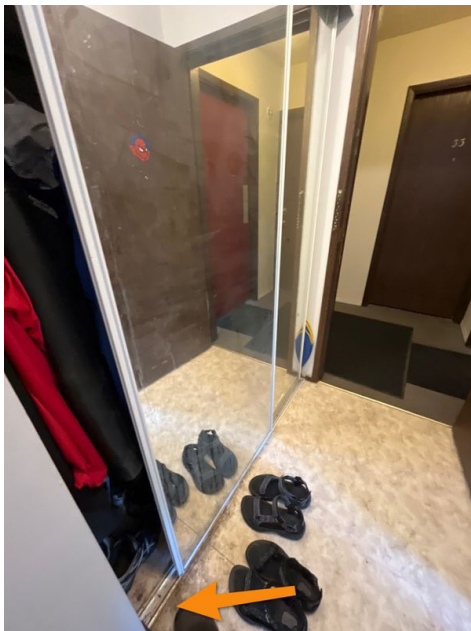
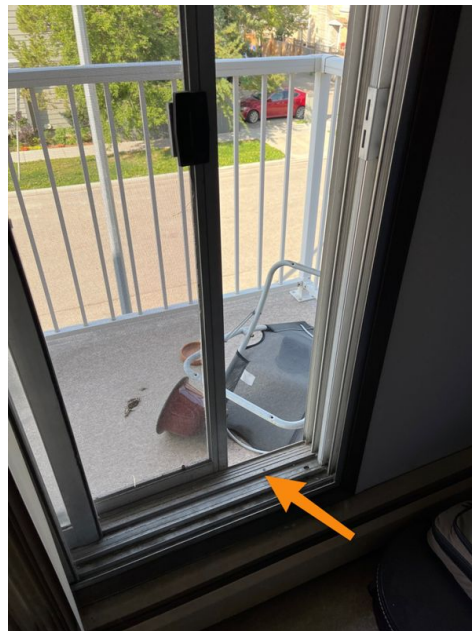
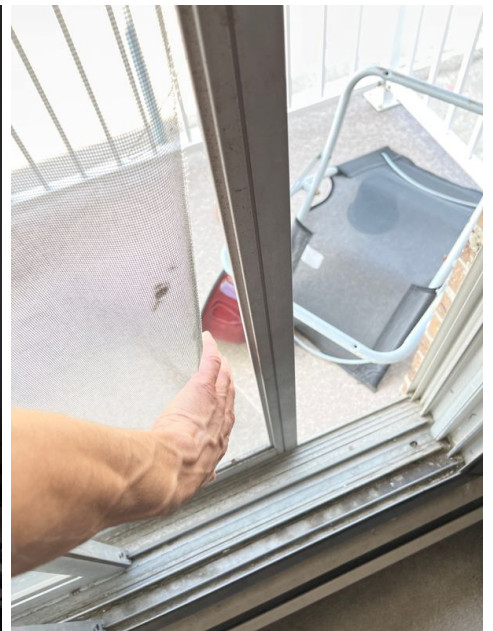
9.4.11 Doors

SERVICING RECOMMENDED

Contact a qualified door repair/installation contractor.

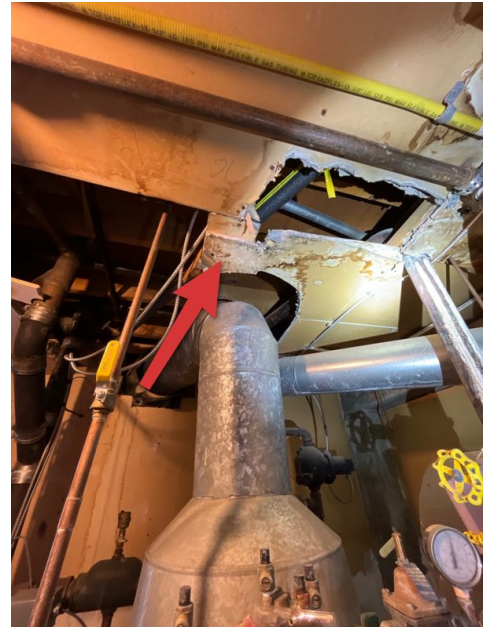
9.7.1 Hazardous Materials

POSSIBLE ORGANIC GROWTH

One or more areas were found to have, what appears to be organic growth. It is recommended to remove this by either using a mold killing agent or replacing the building material. With any renovations, additional signs of water damage may be found.

Contact a qualified mold remediation contractor

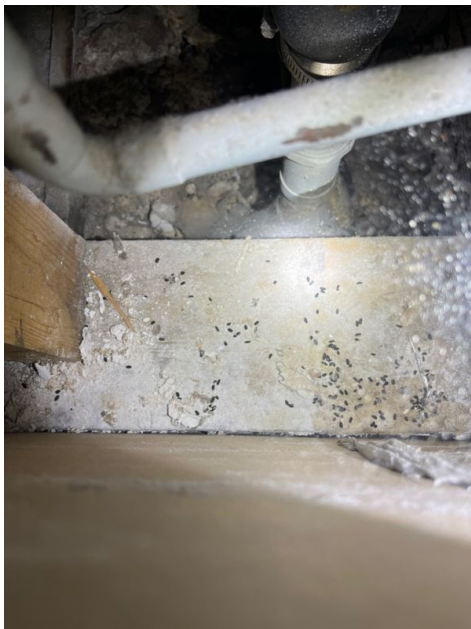
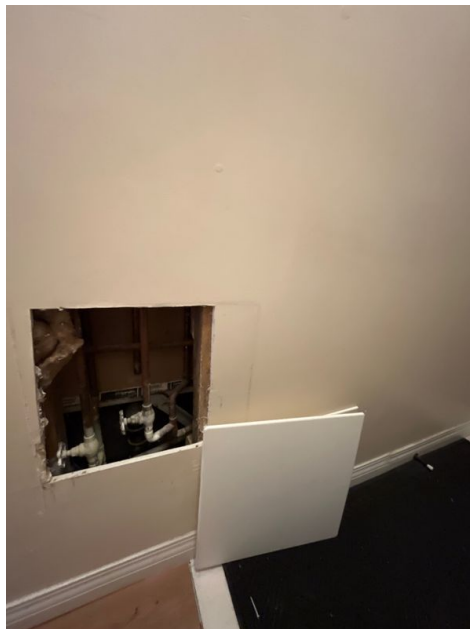
9.10.1 Rodents / Vermin

EVIDENCE OF RODENTS / VERMIN

Evidence of pests were noted in the structure. It is recommended to remove the debris and to employ traps or call a pest control specialist.

Contact a qualified professional.

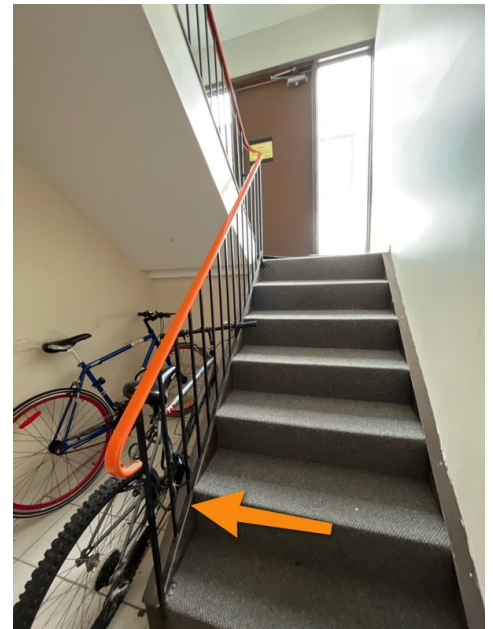
9.13.1 Steps, Stairways & Railings

HANDRAIL(S) LOOSE

One or more of the handrails were noted to be loose and should be better secured.

Contact a qualified carpenter.

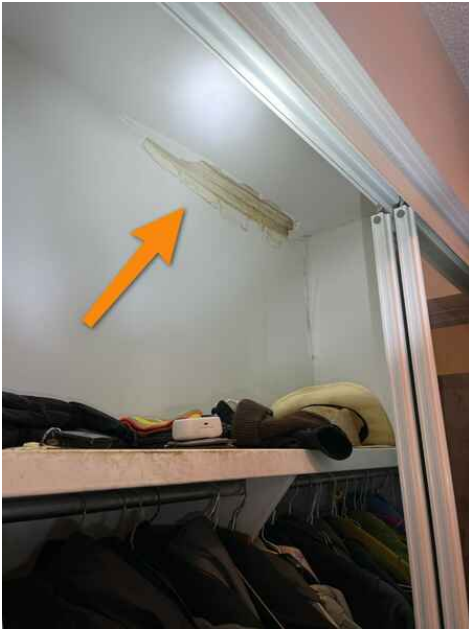
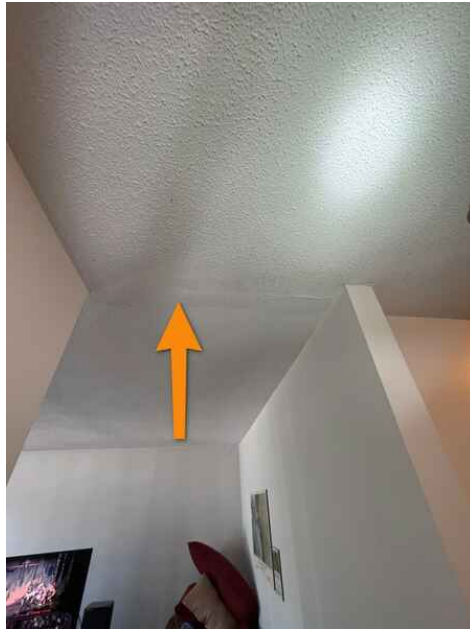
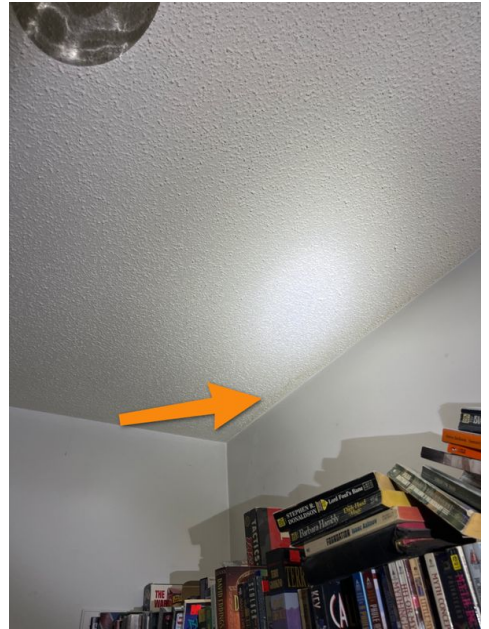
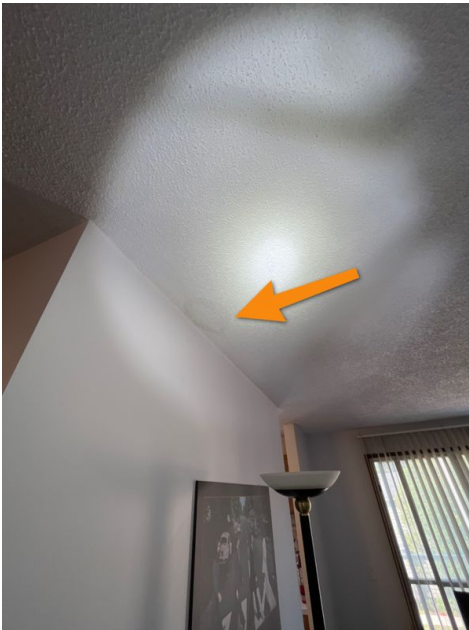
9.15.1 Water Marks / Damage

WATER MARKS / DAMAGE

Water marks and damage were noted in the following area(s). While no active leaks or moisture was present at the time of the inspection, it is recommended to inquire with the current occupants as to the history of the event and to monitor the area.

Contact a qualified professional.

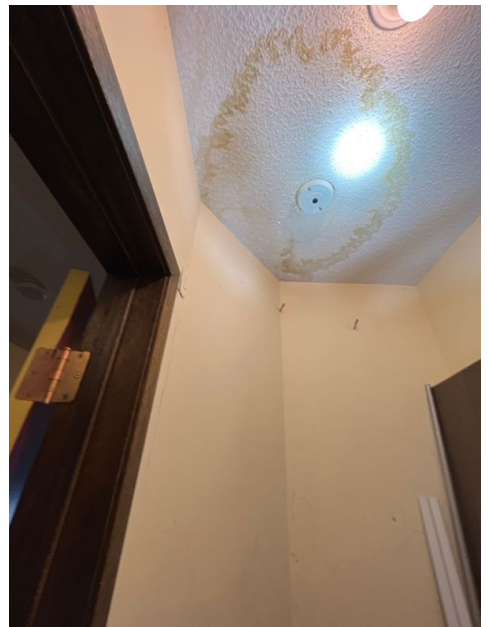
9.15.2 Water Marks / Damage

WATER MARKS / DAMAGE

Water marks and damage were noted in the following area(s). While no active leaks or moisture was present at the time of the inspection, it is recommended to inquire with the current occupants as to the history of the event and to monitor the area.

Contact a qualified professional.

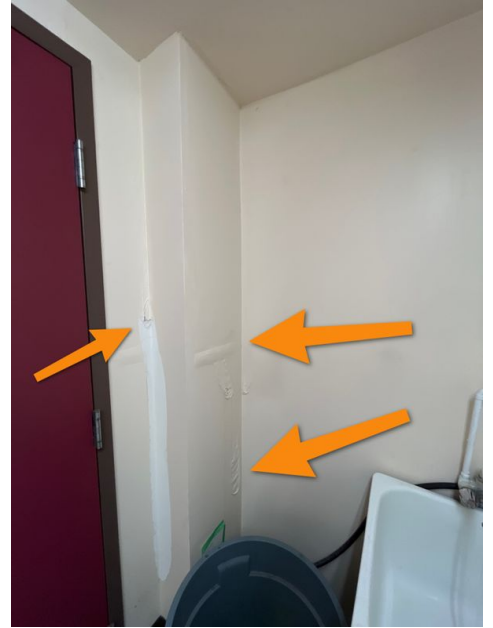
9.15.3 Water Marks / Damage

WATER MARKS / DAMAGE

Water marks and damage were noted in the following area(s). While no active leaks or moisture was present at the time of the inspection, it is recommended to inquire with the current occupants as to the history of the event and to monitor the area.

Contact a qualified professional.

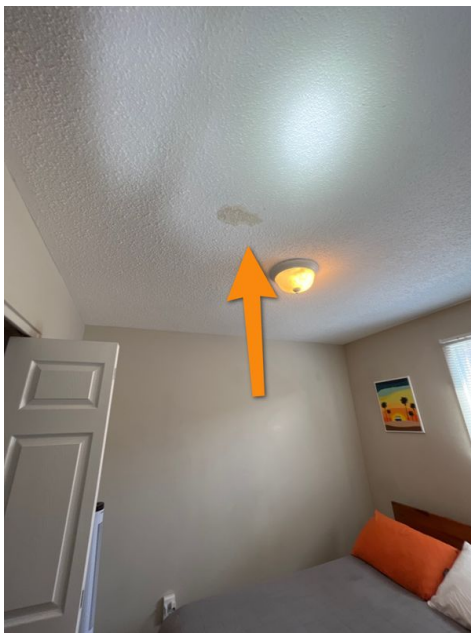
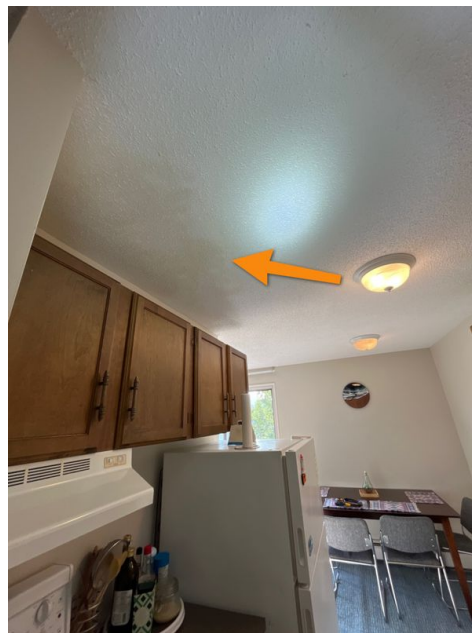
9.15.4 Water Marks / Damage

Water marks were noted in one or more areas. It is recommended to inquire on the history of the event(s).

Contact a qualified professional.

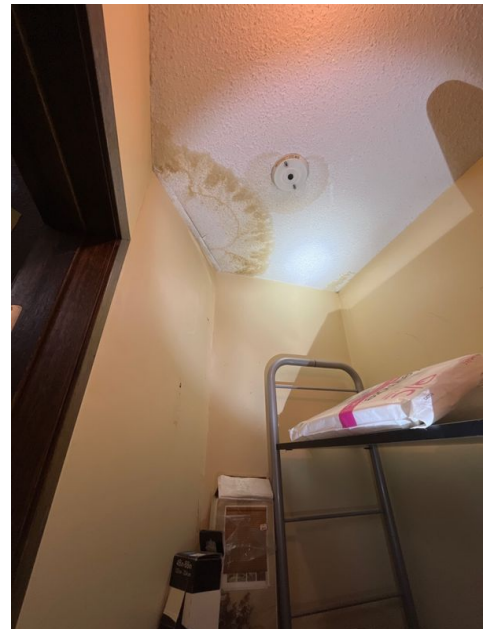
9.15.5 Water Marks / Damage

WATER MARKS

Water marks were noted in one or more areas. It is recommended to inquire on the history of the event(s).

Contact a qualified professional.

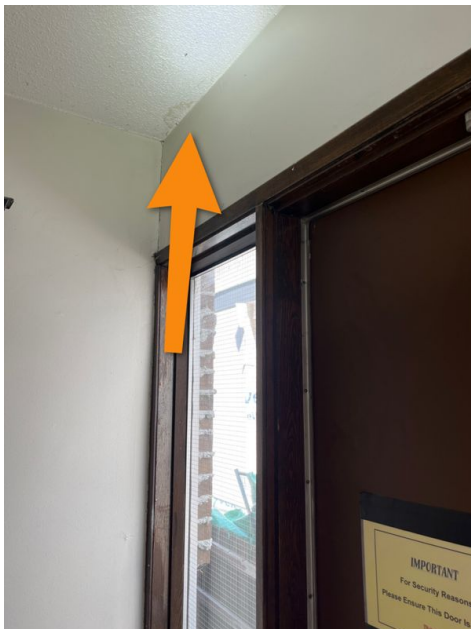
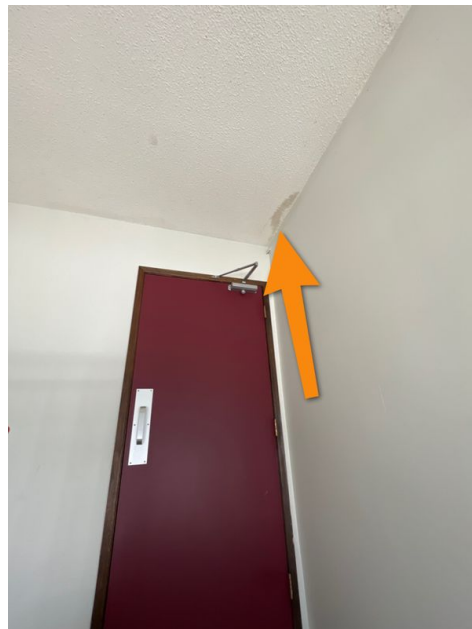
9.15.6 Water Marks / Damage

WATER MARKS

Water marks were noted in one or more areas. It is recommended to inquire on the history of the event(s).

Contact a qualified professional.

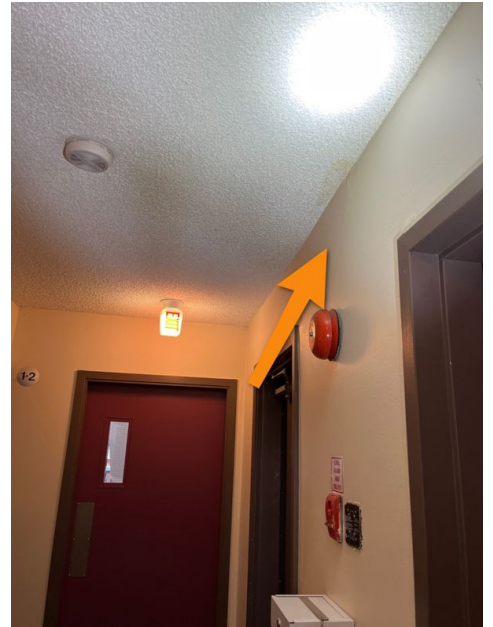
9.15.7 Water Marks / Damage

WATER MARKS

Water marks were noted in one or more areas. It is recommended to inquire on the history of the event(s).

Contact a qualified professional.

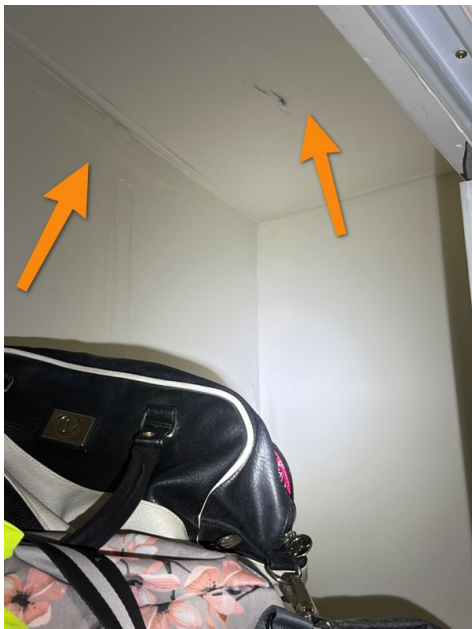
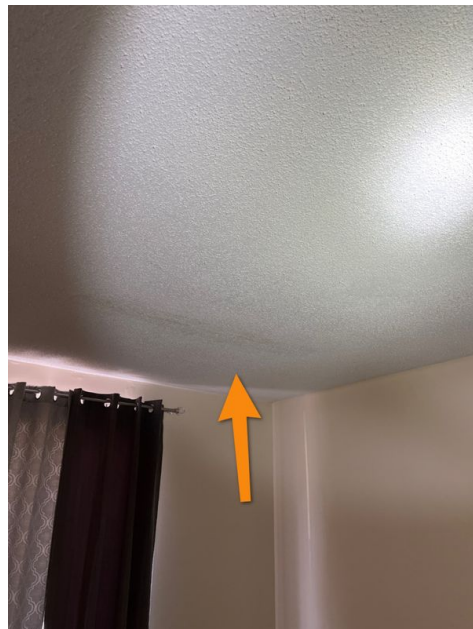
9.15.8 Water Marks / Damage

WATER MARKS

Water marks were noted in one or more areas. It is recommended to inquire on the history of the event(s).

Contact a qualified professional.

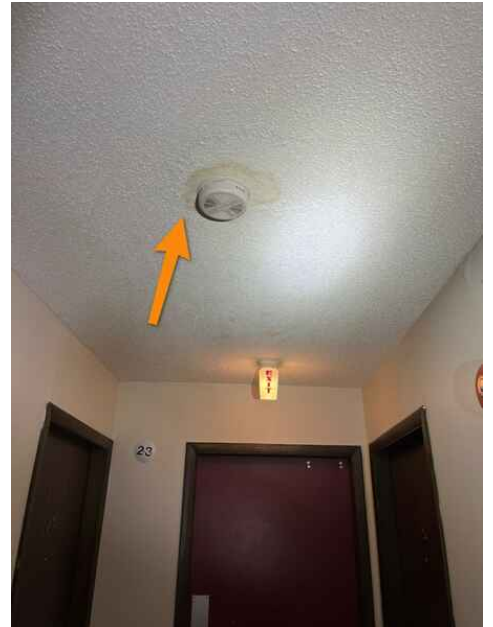
9.15.9 Water Marks / Damage

WATER MARKS

Water marks were noted in one or more areas. It is recommended to inquire on the history of the event(s).

Contact a qualified professional.

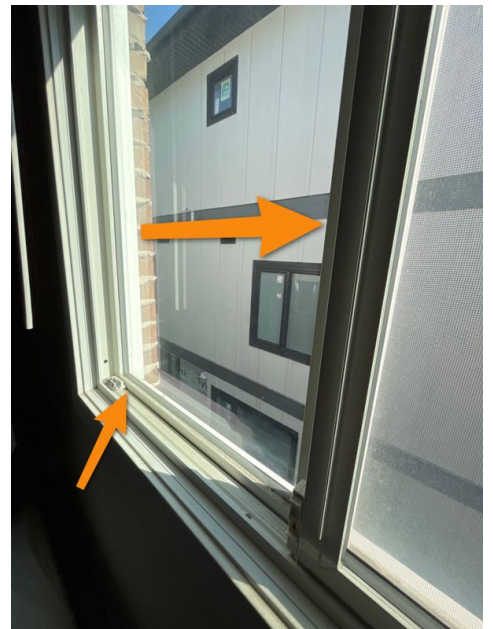
9.16.1 Windows

DAMAGED COMPONENTS

One or more windows were noted to have damaged components.

Contact a qualified window repair/installation contractor.

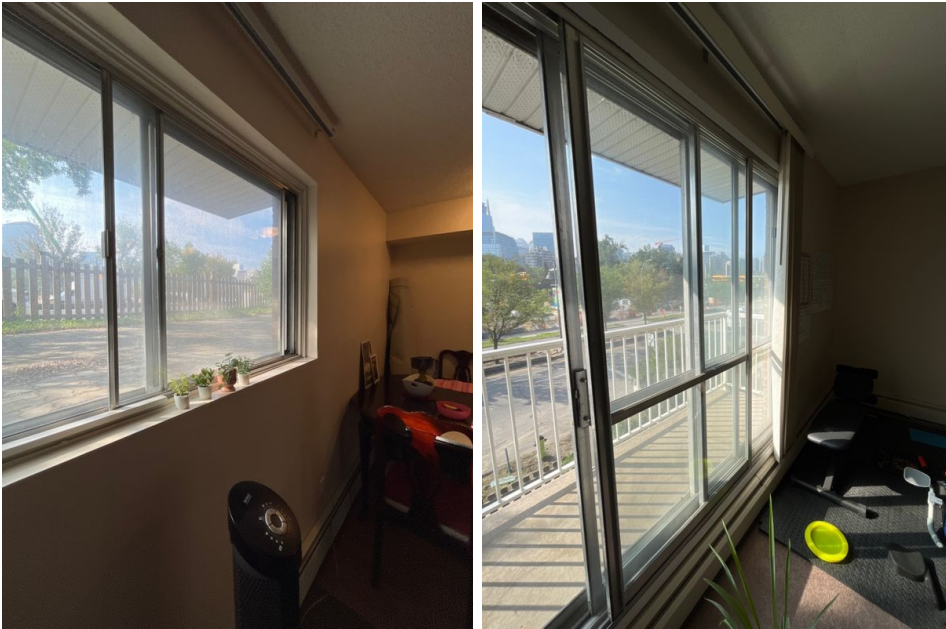
9.16.2 Windows

OLDER UNITS

Because some of the windows in the structure are old, and low quality, the potential buyer should budget to replace them over the next few years.

Contact a qualified window repair/installation contractor.

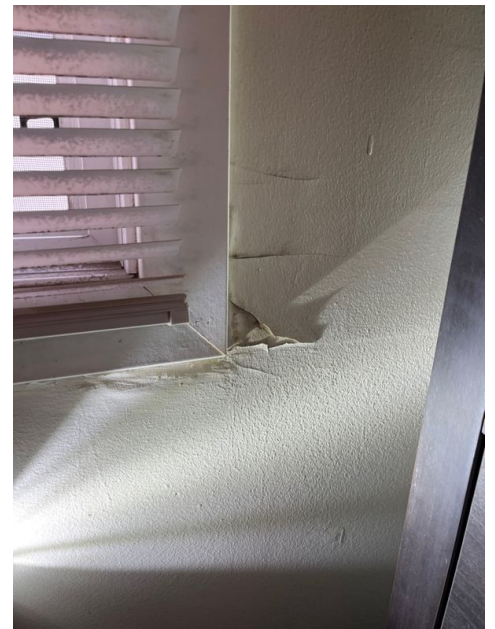
9.16.3 Windows

WATER DAMAGE

Water damage was noted at one or more windows. It was undetermined if this is a past issue or an ongoing one. With any renovations, rot, mold, and water marks may be found.

Contact a qualified professional.

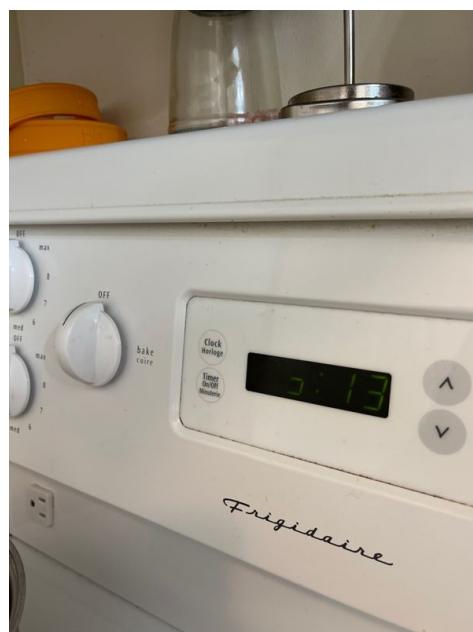
10.6.1 Range/Oven/Cooktop

DAMAGED COMPONENTS

Some of the components were noted to be damaged.

Contact a qualified appliance repair professional.

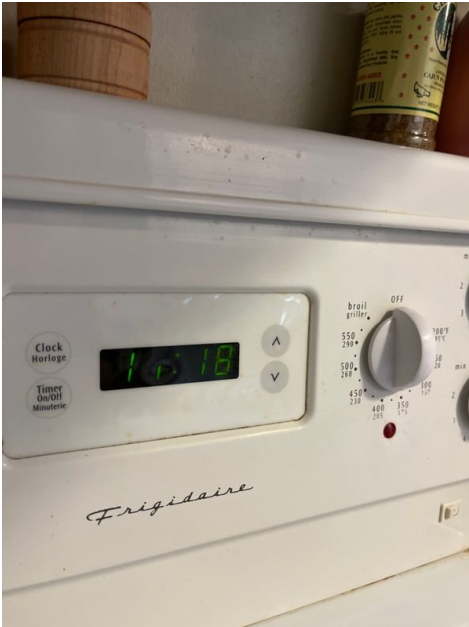
10.6.2 Range/Oven/Cooktop

DAMAGED COMPONENTS

Some of the components were noted to be damaged.

Contact a qualified appliance repair professional.

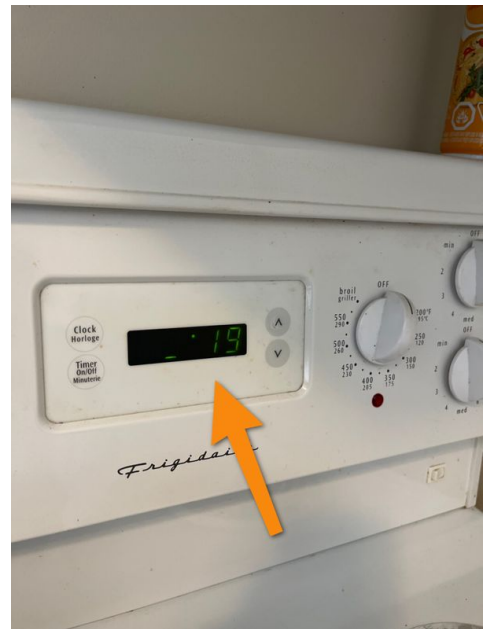
10.6.3 Range/Oven/Cooktop

DAMAGED COMPONENTS

Some of the components were noted to be damaged.

Contact a qualified appliance repair professional.

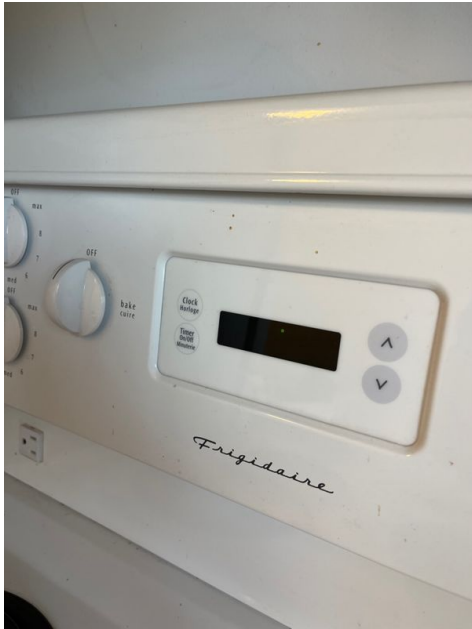
10.6.4 Range/Oven/Cooktop

DAMAGED COMPONENTS

Some of the components were noted to be damaged.

Contact a qualified appliance repair professional.
