# CERTA PROPERTY INSPECTIONS

## PROPERTY REPORT

234 Demo Street  
Calgary, AB T4B 1L1

SEPTEMBER 12, 2023

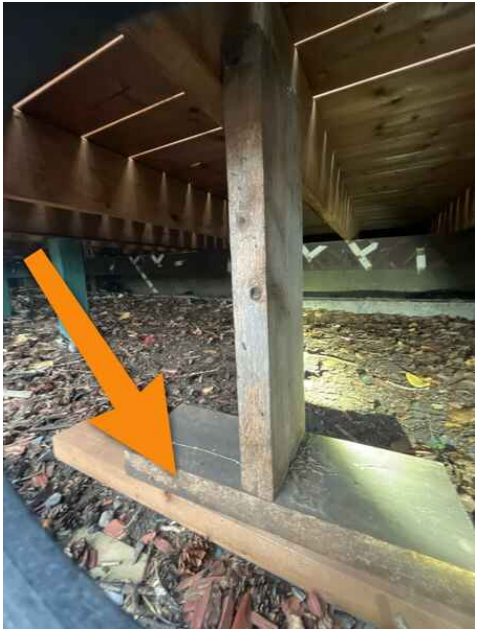
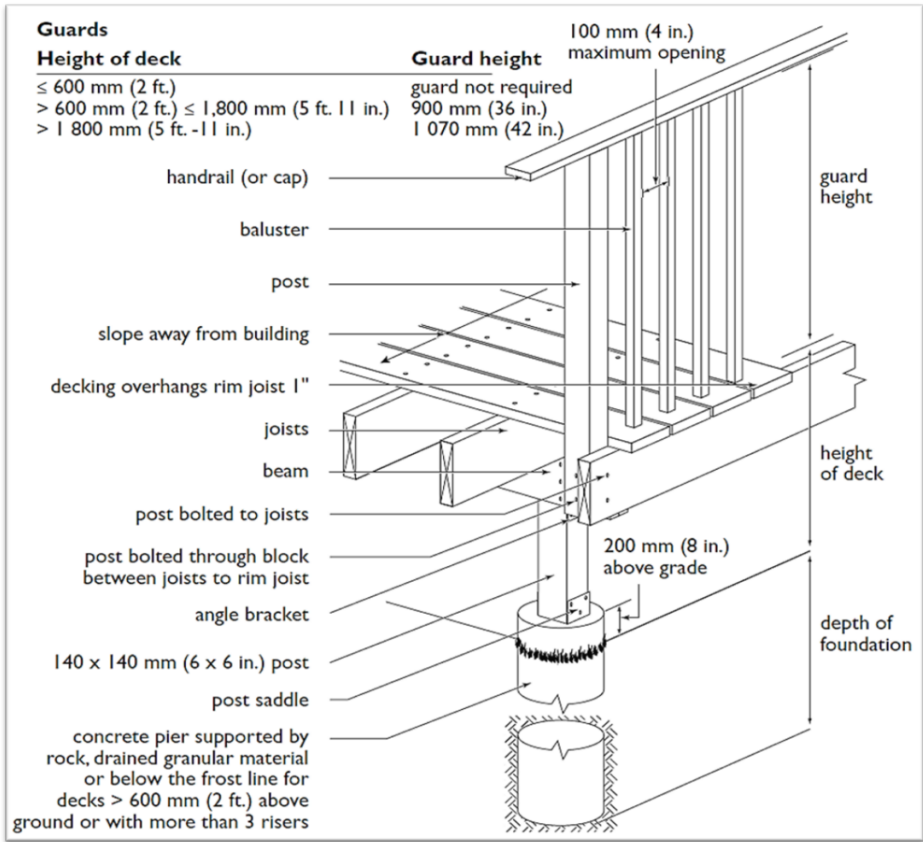
Deck(s)  
**UNKNOWN FOOTINGS**

Structures over 24" in height should have 10" (diameter) concrete pilings that extend below the frost line. At the time of the inspection, it was undetermined if these pilings existed with the structure. This should be further inspected and corrected if needed.

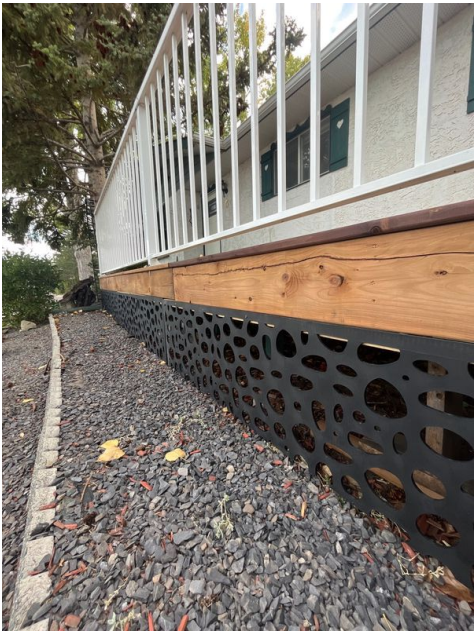
**LIMITED OR NO ACCESS**

Due to the limited access, the inspector was unable to inspect below the structure.

Structures over 24" in height should have 10" (diameter) concrete pilings that extend below the frost line. At the time of the inspection, it was undetermined if these pilings existed with the structure. This should be further inspected and corrected if needed.

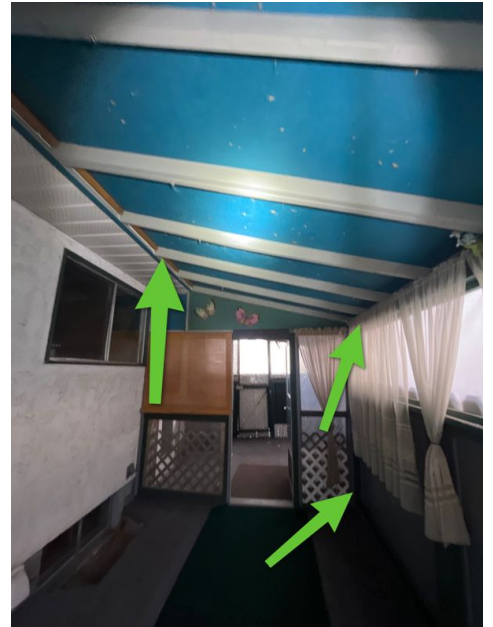
**UNKNOWN SECUREMENT**

Due to the building products, it was undetermined how the structure is secured. This should be further investigated.

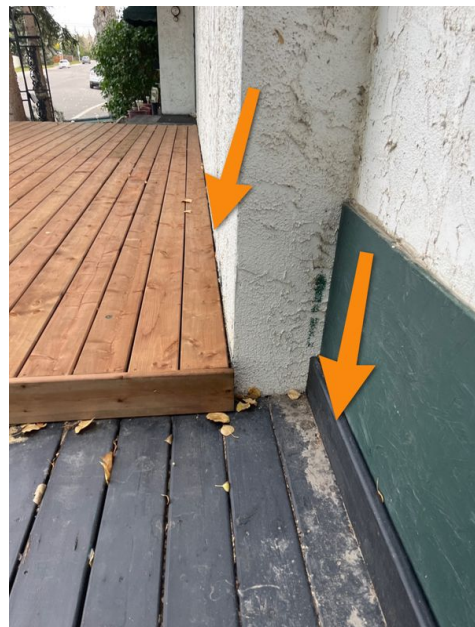
#### **DRIP EDGE NOT FOUND AT LEDGER BOARD**

No drip edge was found between the deck and the dwelling. This should be added, if missing, as it helps to keep moisture from entering the building envelope.

Contact a qualified carpenter.

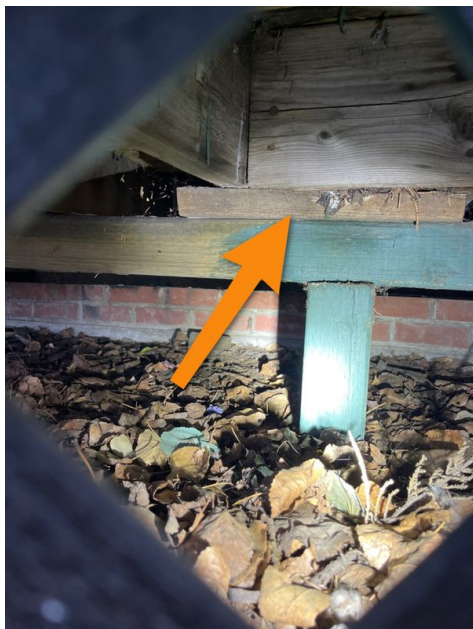
Poor shimming methods were noted for the structure. It is recommended to use steel shims.

Contact a qualified carpenter.

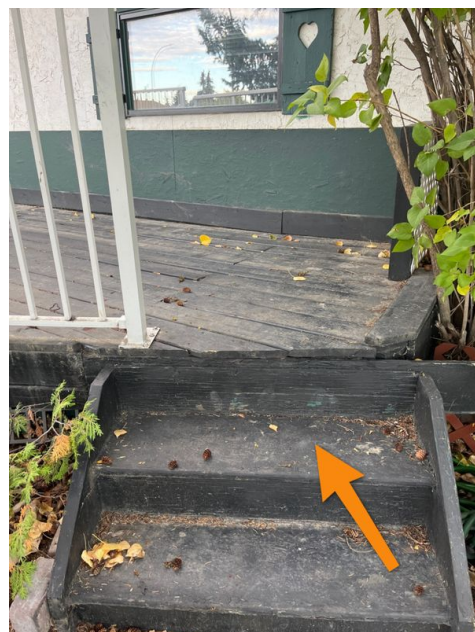
#### 2.7.6 Deck(s)

##### **RISER HEIGHT TOO TALL**

The maximum allowable riser height for stairs is 8".

Contact a qualified carpenter.

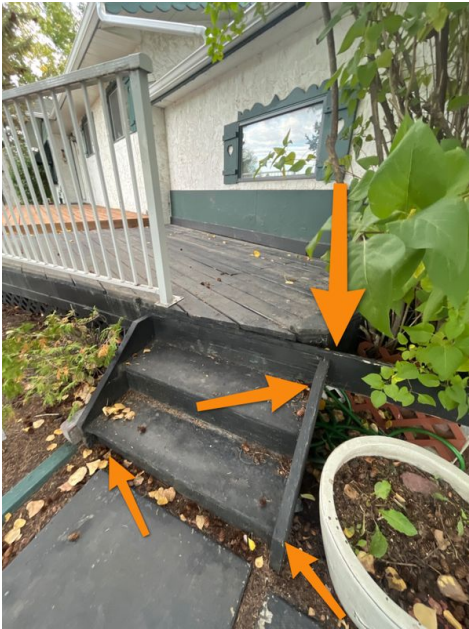
#### 2.7.7 Deck(s)

##### **ROT**

Some rot was noted at the structure. It is recommended to replace the affected materials with rot resistant components.

Contact a qualified carpenter.

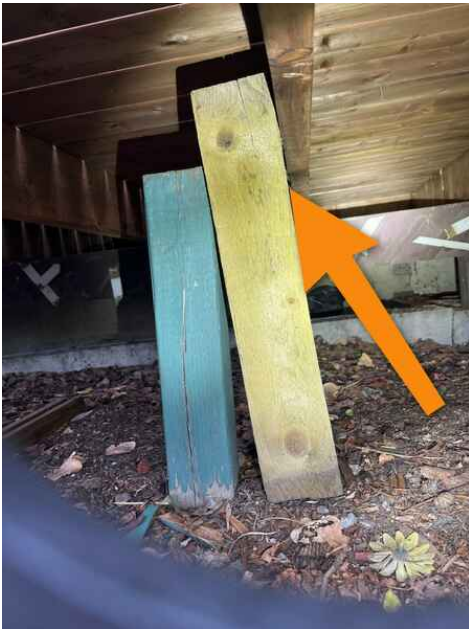
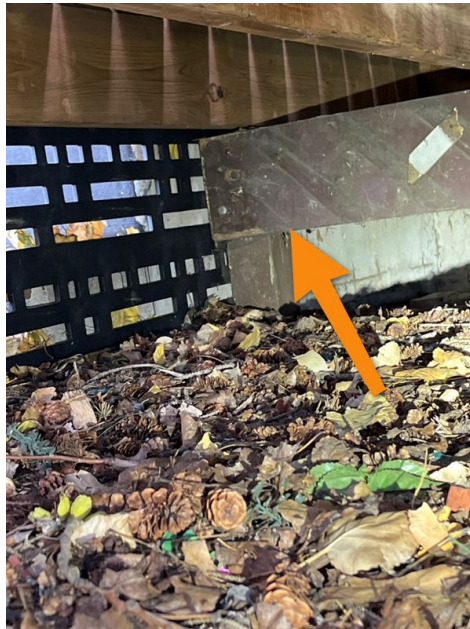
### 2.7.8 Deck(s)

#### UNCONVENTIONAL FRAMING METHODS

Unconventional framing methods were noted with the structure. Typically the size of the joists match the size of the ledger board.

Contact a qualified carpenter.

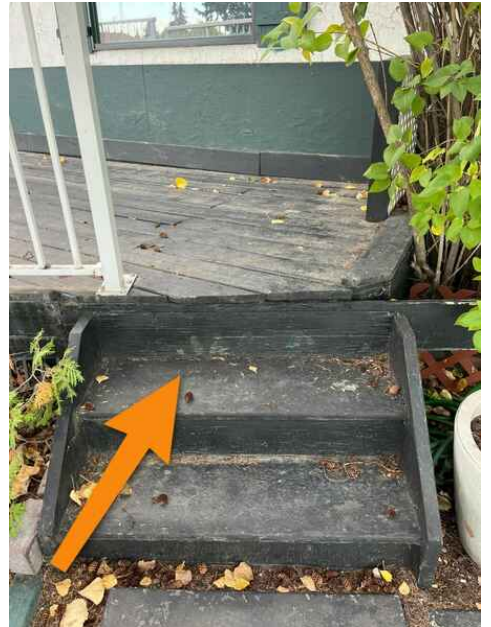
### 2.7.9 Deck(s)

#### UNEQUAL RISER HEIGHT

Contact a qualified carpenter.

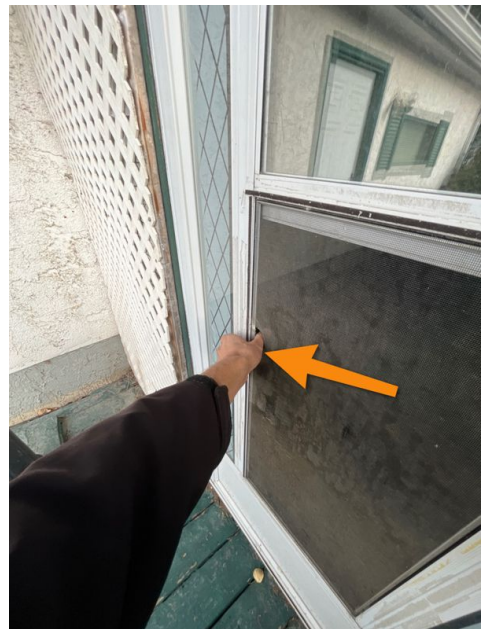
## 2.8.1 Door(s)

**ADJUSTMENT / SERVICING NEEDED**

Contact a qualified professional.

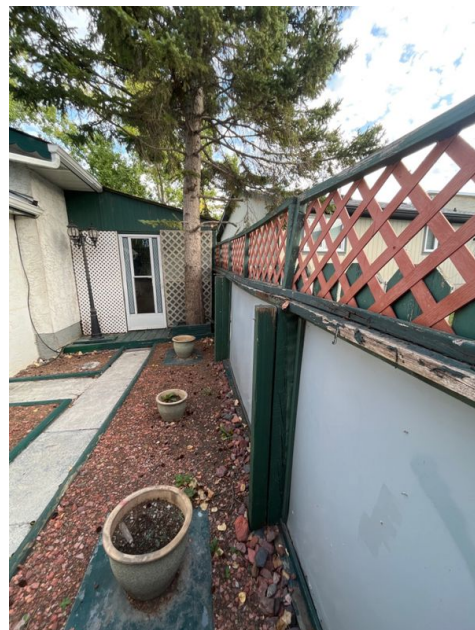
#### 2.14.1 Fence

##### **LEANING**

One or more areas of the fence line were noted to be leaning. It is recommended that a qualified contractor repairs this.

Contact a qualified carpenter.

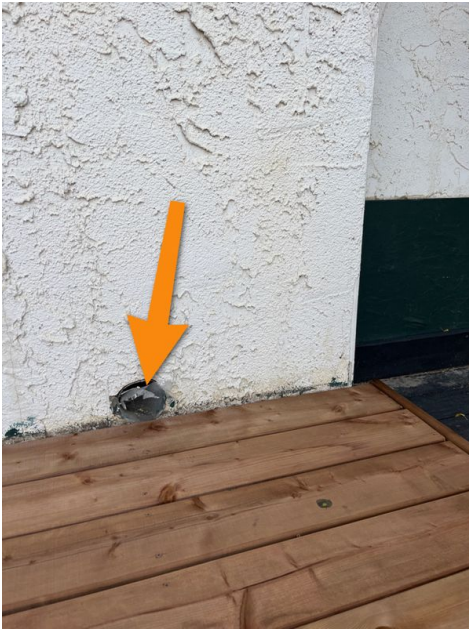
#### 2.17.2 Fresh Air Intakes

##### **UNSEALED OPENING(S)**

Contact a qualified professional.

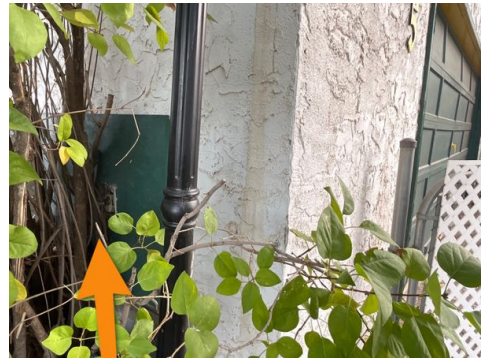
#### 2.20.1 GFCI

### **COVER PLATE(S) MISSING OR DAMAGED**

It is recommended to have functioning cover plates for junction boxes and switches. Extra Duty in use types of covers are recommended.

Contact a handyman or DIY project

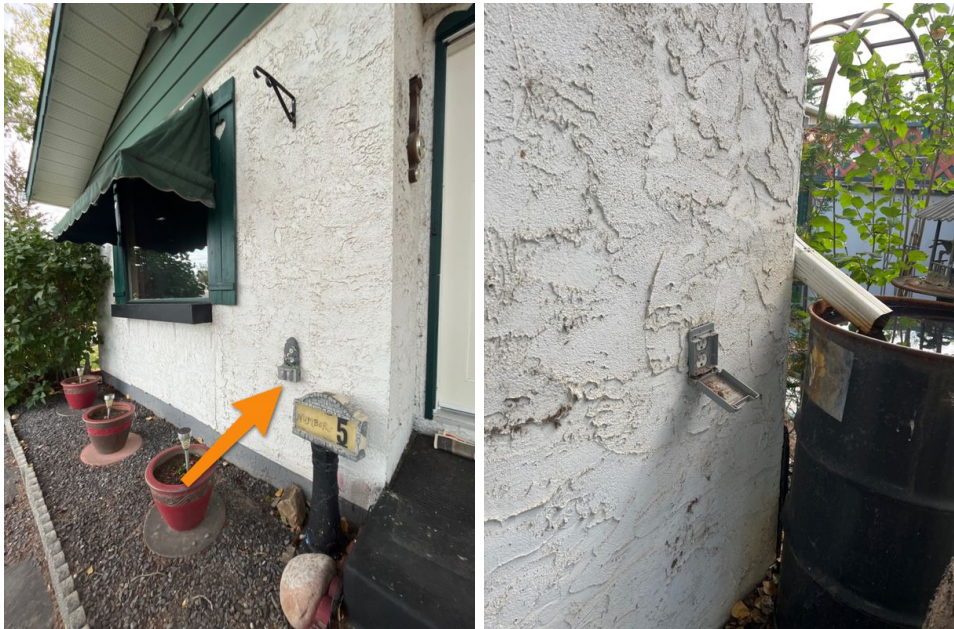
#### 2.20.2 GFCI

### **NO GFCI**

It is recommended that GFI protected receptacles be installed within 6 feet of any water sources as well as receptacles found outside below 2.5 meters. It is recommended to have a qualified electrician install these.

Recommendation  
Contact a qualified electrical contractor.

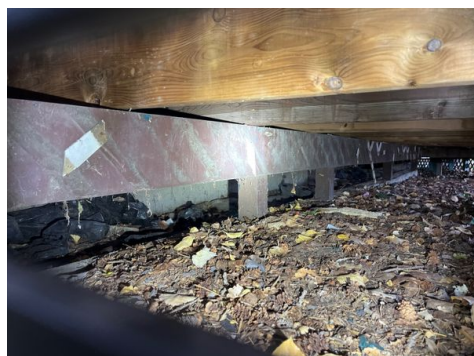
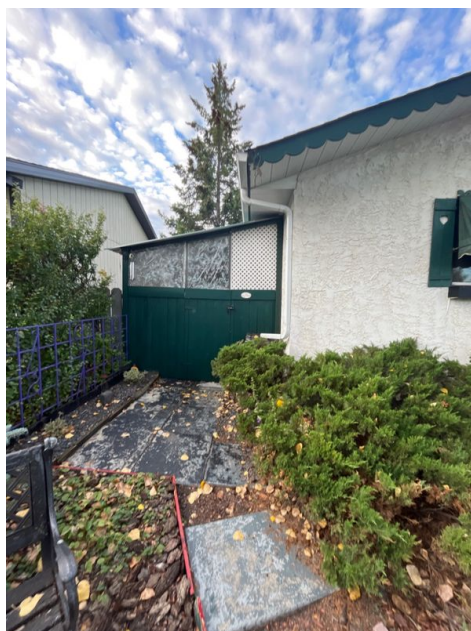
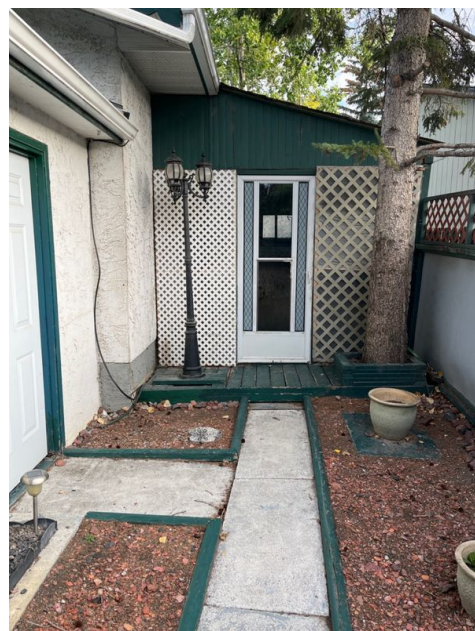
2.21.1 Grading  
**POOR GRADING**  
FRONT OF HOME

It is recommended that the grading around the structure be positive; meaning that it should slope away. This helps prevent water penetration into the structure. Fill areas that have settled next to the structure with clay—not topsoil— with a positive slope away from the structure (10 per cent is recommended). It should be noted that rock, gravel, mulch, etc. drains water down the exterior wall and not away. It is unknown what the grading is below these materials.

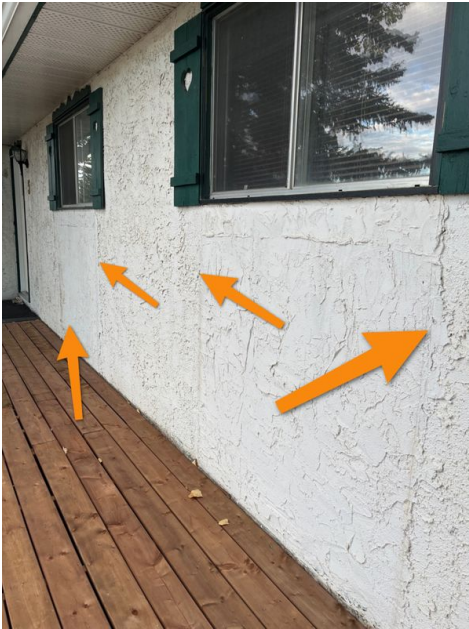
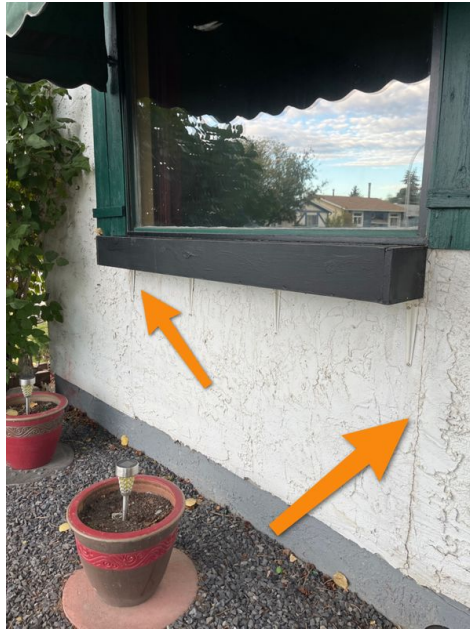
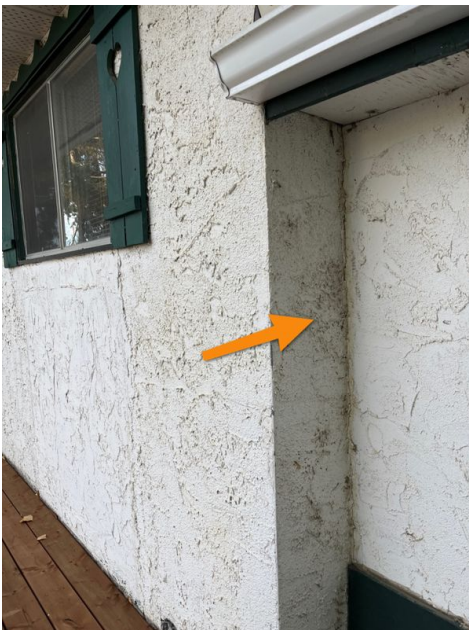
### 2.31.1 Siding

#### **CRACKS IN STUCCO**

Contact a qualified siding specialist.

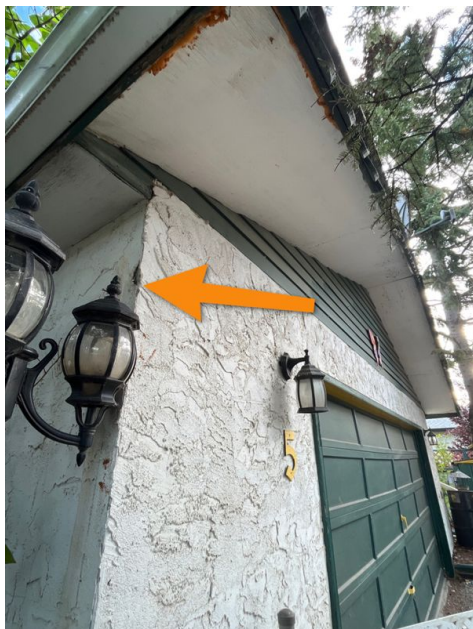
#### **GROUND CLEARANCE**

Contact a qualified siding specialist.

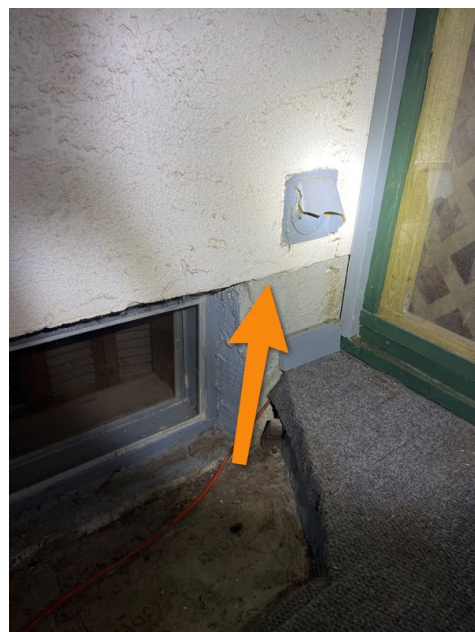
#### 2.37.1 Termination Vent

##### **DAMAGE / NOT SEALED**

Contact a qualified professional.

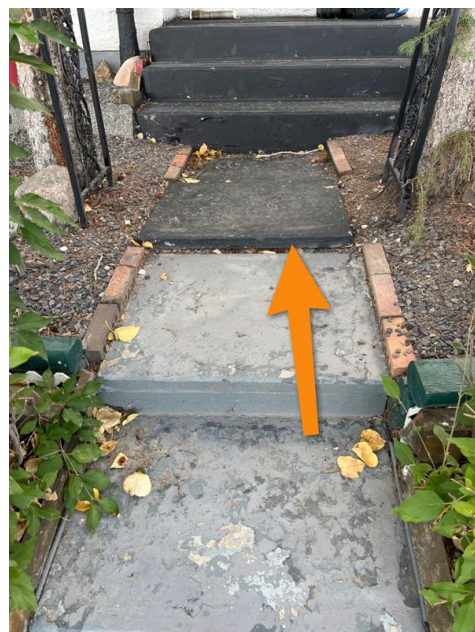
#### 2.40.1 Walkway(s)

### UNEVEN WALKWAY

It is recommended to have level walkways to prevent tripping hazards.

Contact a qualified landscaping contractor

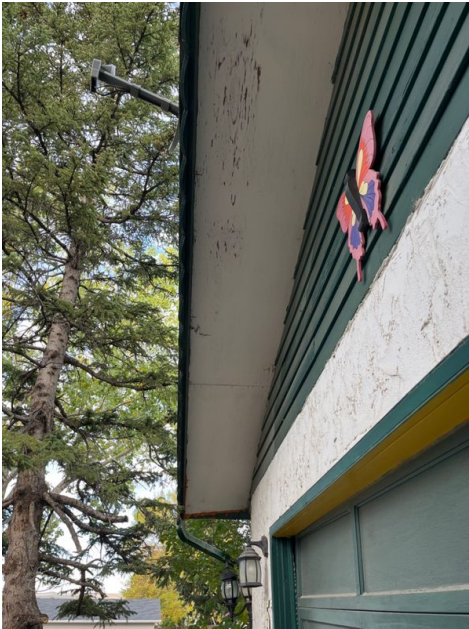
#### 2.42.1 Wood Products

### MAINTAIN WOOD PRODUCTS

It is recommended to maintain exterior wood products on a regular basis; this consists of removing old and damaged paint / stain, priming and reapplying new products. This will prolong the lifespan of the wood product.

Contact a qualified handyman.

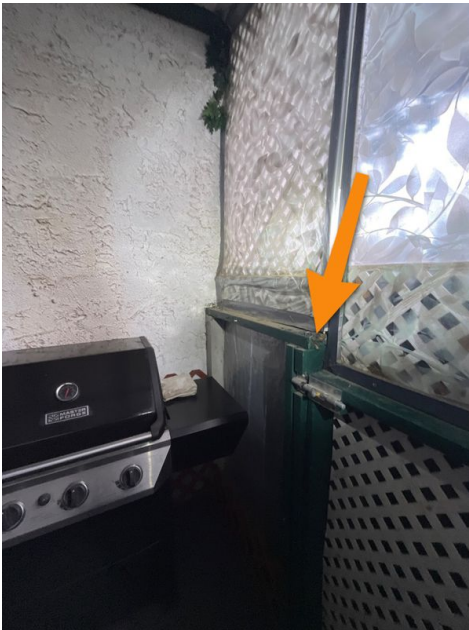
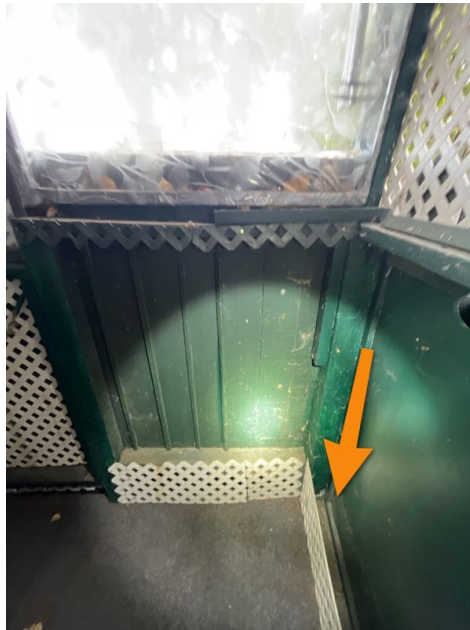
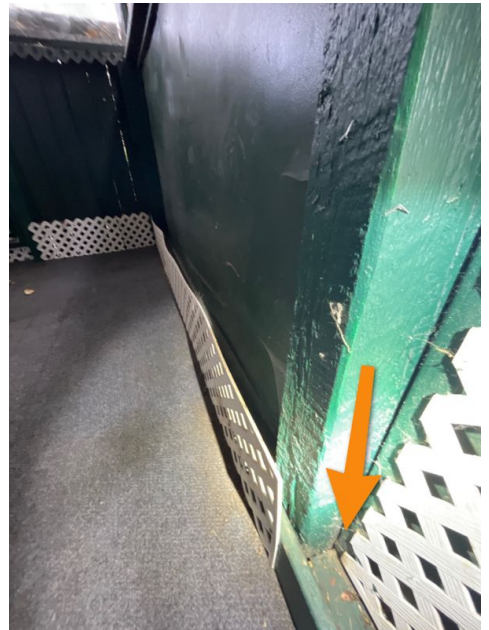
#### 2.42.2 Wood Products

##### **ROT**

Rot was noted with some of the components. It is recommended to budget for replacements.

Contact a qualified carpenter.

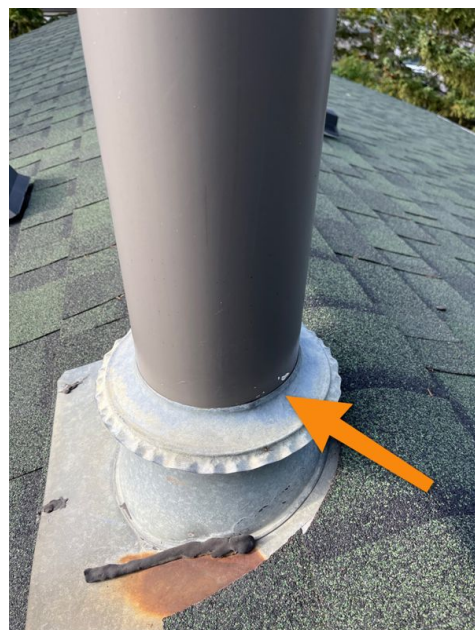
### 3.1.1 Chimneys

#### SEALANT MISSING / DETERIORATED

It is recommended to seal openings to keep the weather out.

Contact a qualified professional.

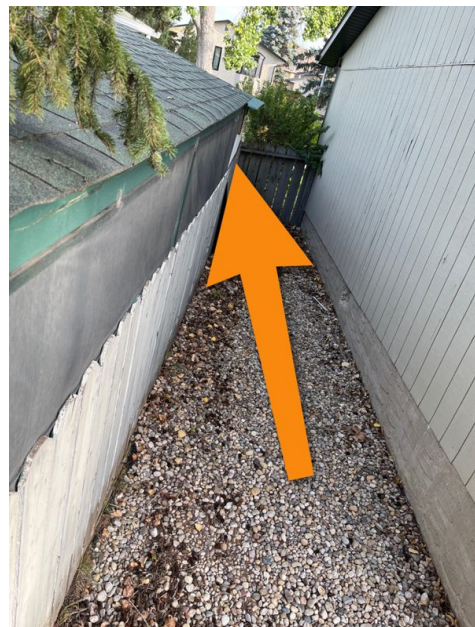
## 3.3.1 Downspouts / Gutters

**GUTTERS MISSING**

One or more areas were noted to be missing gutters on the structure. Gutters are recommended because they collect rain water from the roof and direct it away from the building.

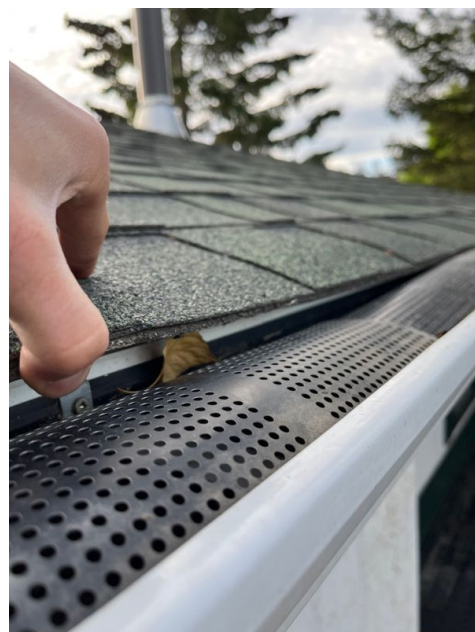
## 3.4.1 Flashings

**DRIP EDGE NOT INSTALLED**

Drip edges were missing on the roof line. This should be added as it helps to prevent water migrating up and underneath the roof covering material and rotting out the sheathing below.

Contact a qualified roofing professional.

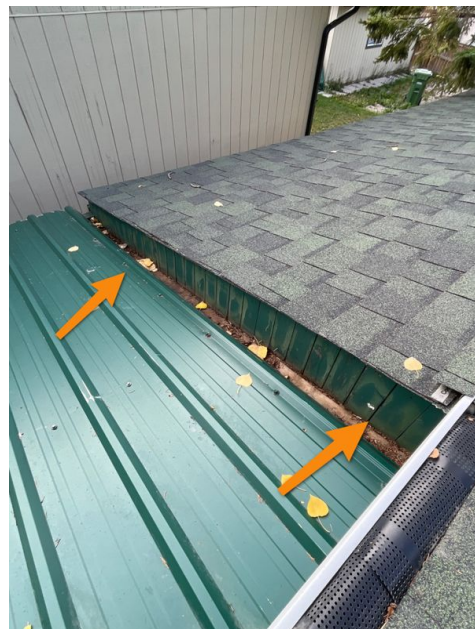
**WALL FLASHING MISSING**

No step flashing was noted. This should be added to prevent water intrusion into the structure.

Contact a qualified roofing professional.

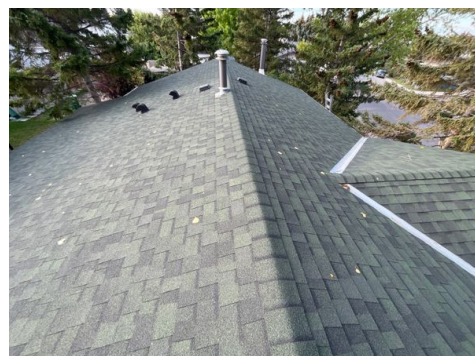
#### 3.7.1 Roof Vents

### ADDITIONAL ROOF VENTILATION RECOMMENDED

It is recommended that when future roof upgrades / replacements are completed; to add additional roof vents. Proper venting helps to prolong the lifespan of roof covering material; high temperatures deteriorate the life span of most roof covering materials.

Contact a qualified roofing professional.

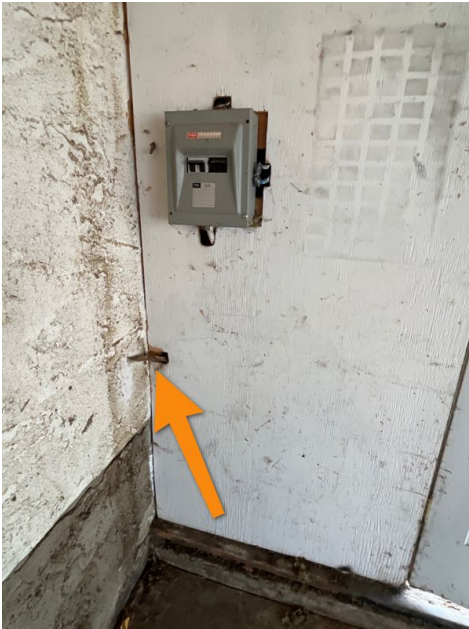
### 4.3.1 Conductors

#### EXPOSED TO DAMAGE

Conductors should be protected from damage.

Contact a qualified electrical contractor.

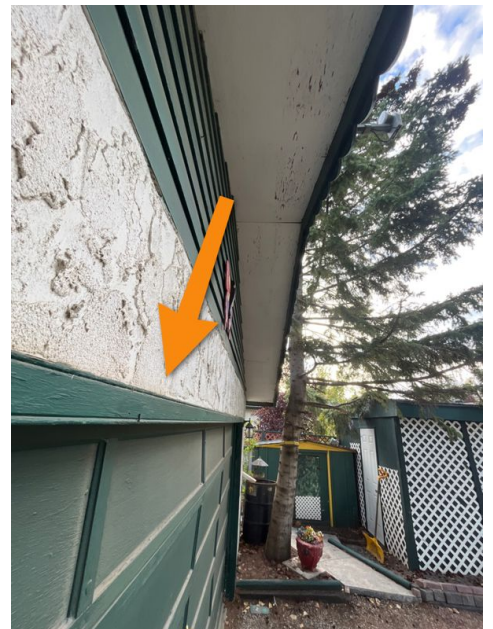
#### 4.7.1 Exterior Doors

##### **DRIP EDGE MISSING**

It is recommended to have drip edges above all doors and windows to prevent water migration behind the component. Caulking is an alternative however will need to be replaced every few years.

Contact a qualified door repair/installation contractor.

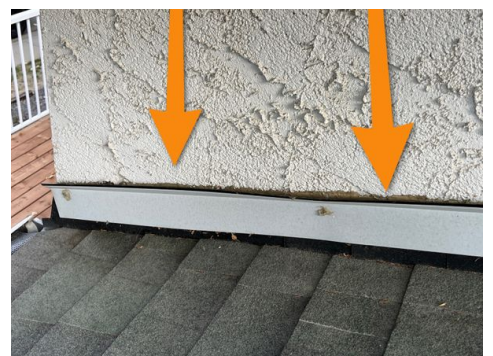
#### 4.8.1 Flashings

##### **POOR INSTALLATION**

Flashing should be let into side walls to prevent water intrusion. Multiple gaps were noted at the roof flashing for the structure.

Contact a qualified roofing professional.

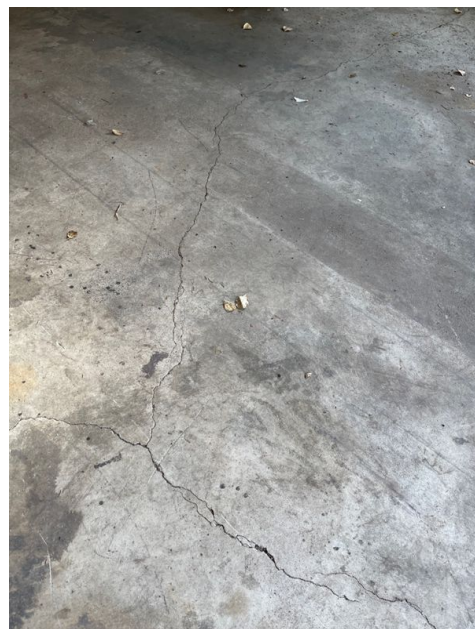
#### 4.9.1 Floor

### TYPICAL CRACKS

Typical cracks and spalling were noted on the garage concrete slab. It is recommended to seal these areas to prevent further deterioration.

Contact a qualified driveway contractor.

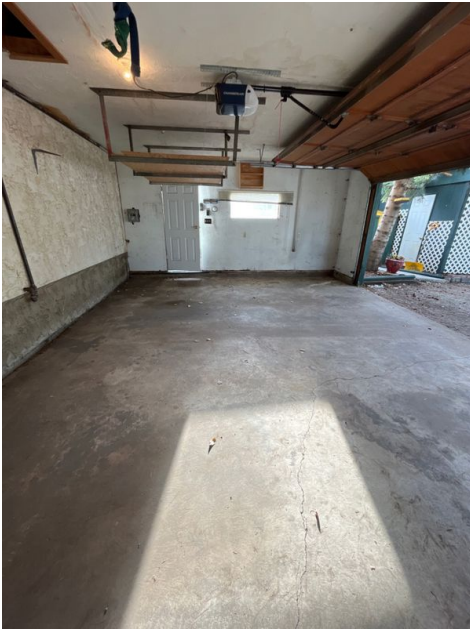
#### 4.9.2 Floor

### SLOPED

The slab was noted to slope towards the dwelling. It is recommended to have this levelled to prevent water intrusion into the dwelling.

Contact a qualified professional.

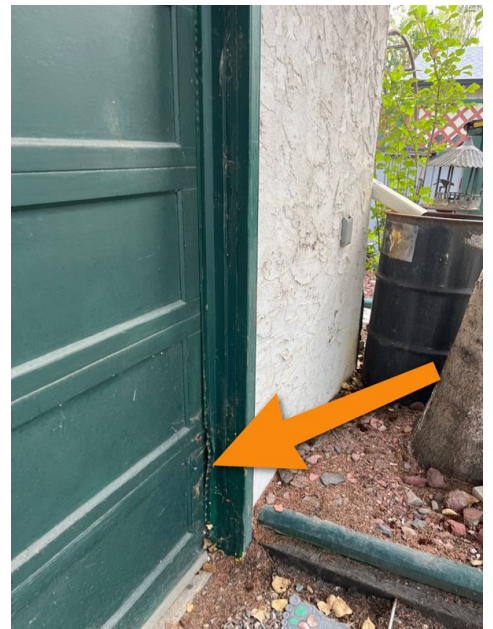
#### 4.11.1 Garage Door

##### **WEATHER STRIPPING**

Some of the weather stripping is deteriorating or missing and should be serviced.

Contact a qualified professional.

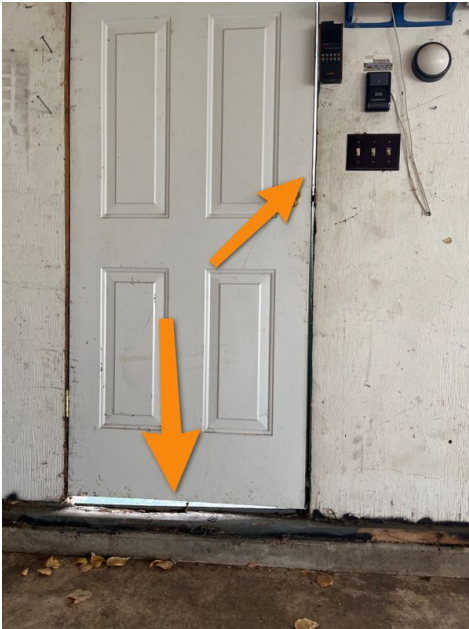
#### 4.17.1 Man Door

##### **OPENINGS**

It is recommended to seal the openings at exterior doors to keep the weather out.

Contact a qualified professional.

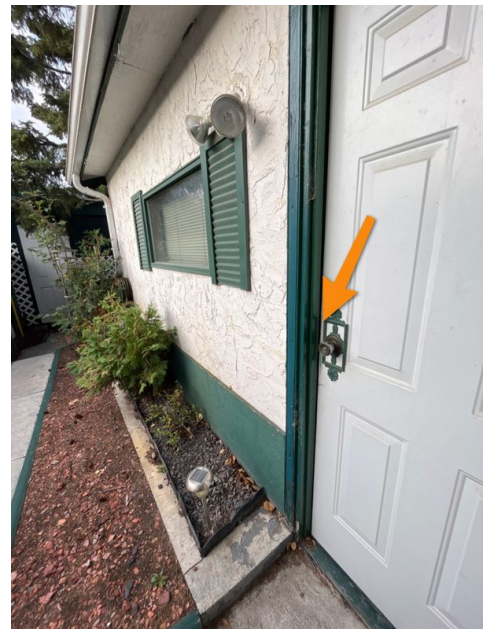
#### 4.17.2 Man Door

### **HARDWARE MISSING**

It is recommended to install a deadbolt for the door.

Contact a qualified professional.

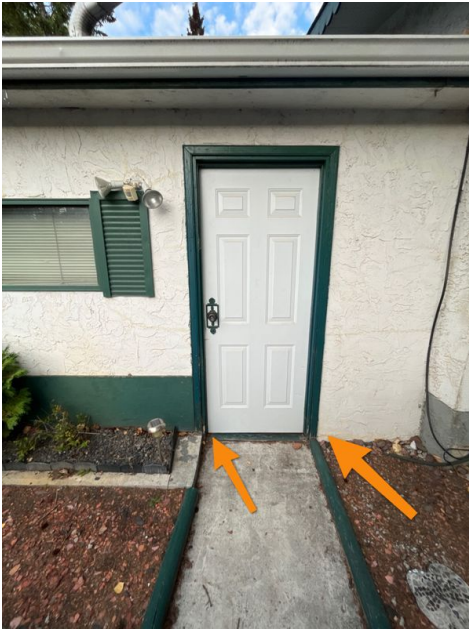
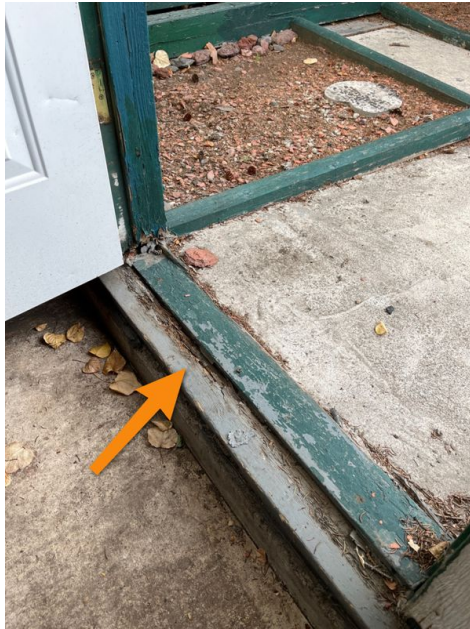
#### 4.17.3 Man Door

### **ROT**

Rot was noted in one or more areas. It is recommended to budget to replace the affected components with rot resistant materials. With any renovations, additional water damage may be found.

Contact a qualified professional.

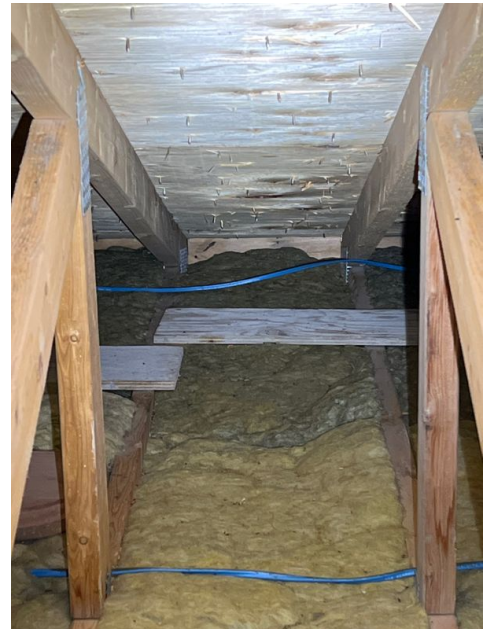
#### 4.23.1 Roof Vents

##### **BLOCKED**

Contact a qualified professional.

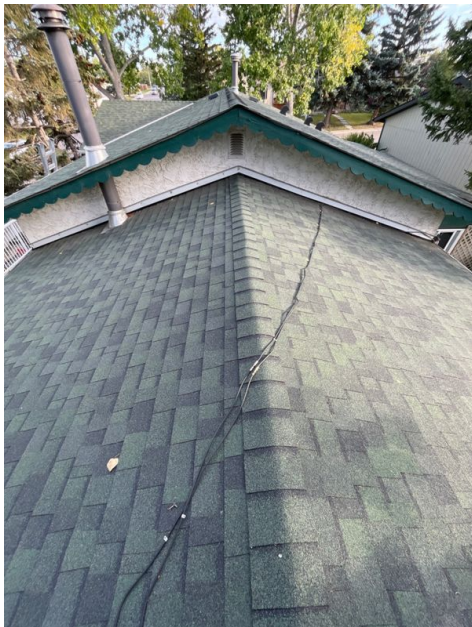
#### 4.23.2 Roof Vents

##### **MISSING**

It is recommended to install roof vents.

Contact a qualified roofing professional.

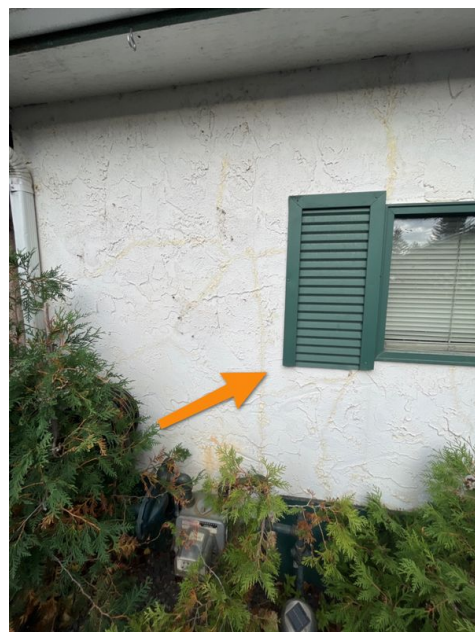
#### 4.24.1 Siding

##### **CRACKS IN STUCCO**

Some cracks in the stucco were found at the exterior walls of the structure. All cracks and openings should be sealed and monitored for further expansion as they may indicate an ongoing issue.

Contact a qualified siding specialist.

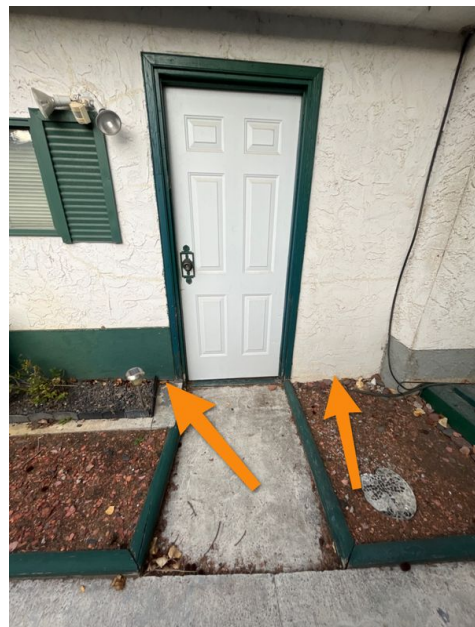
#### 4.24.2 Siding

##### **GROUND CLEARANCE**

It is recommended to have a minimum 6" clearance between siding and the grading of the structure to allow the air to wick away any water on the exterior wall. Siding that is adversely affected by moisture requires 8" clearance from grade. In addition, this helps mitigate damaging the siding from freezing water.

**Too close to grade**

Contact a qualified siding specialist.

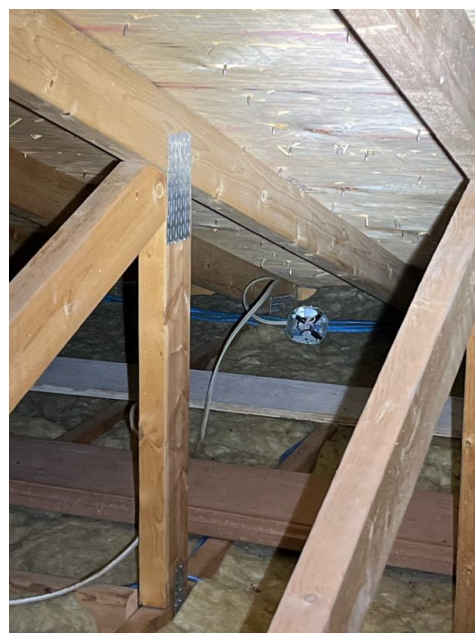
## 4.25.1 Junction Box

**POOR SECUREMENT**

Contact a qualified professional.

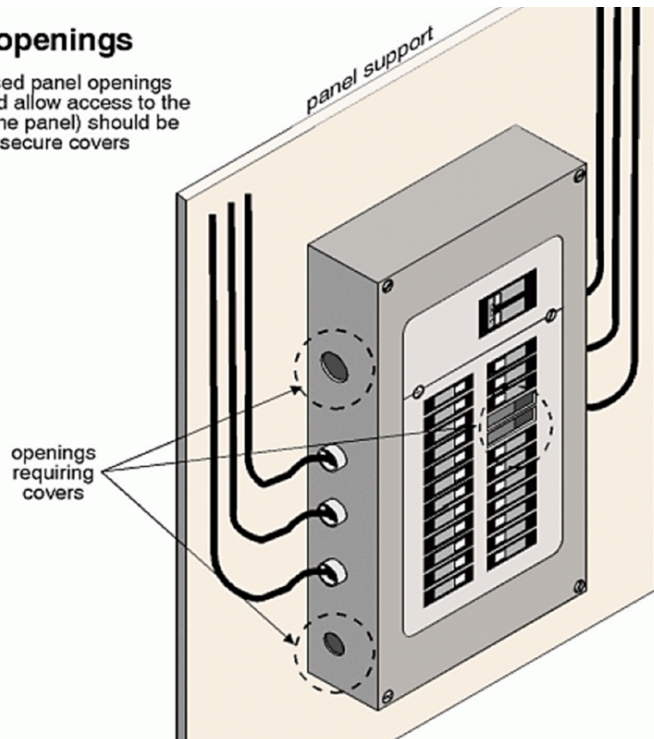
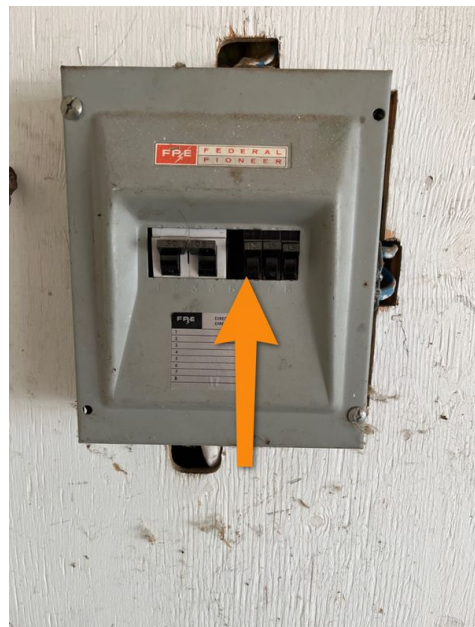
## Panel openings

any exposed panel openings (that would allow access to the inside of the panel) should be fitted with secure covers

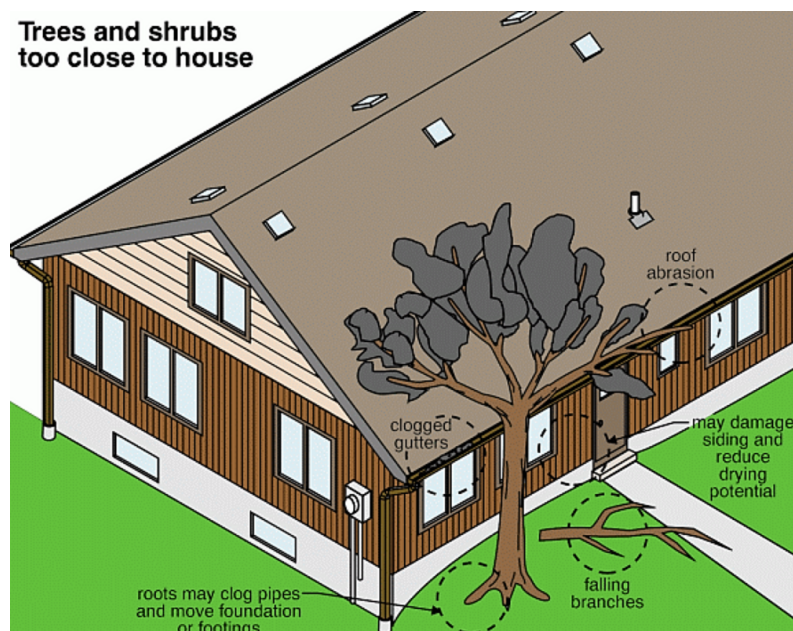
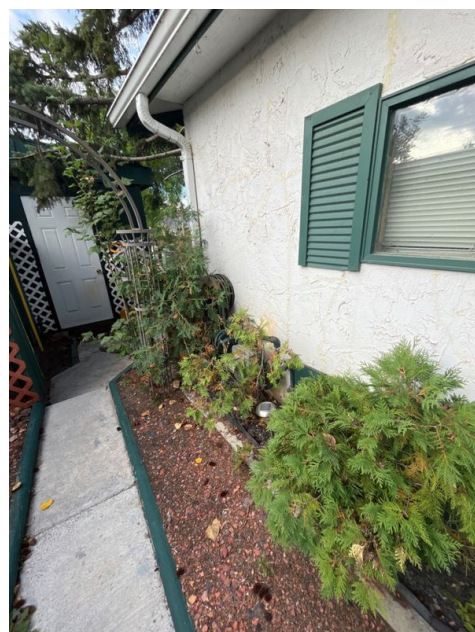
### 4.31.1 Vegetation

## VEGETATION TOO CLOSE

Trees and shrubs should be kept away from structures as they can damage them. In addition, vegetation gives off lots of moisture and often harbours critters.

### Trees and shrubs too close to house

Contact a handyman or DIY project

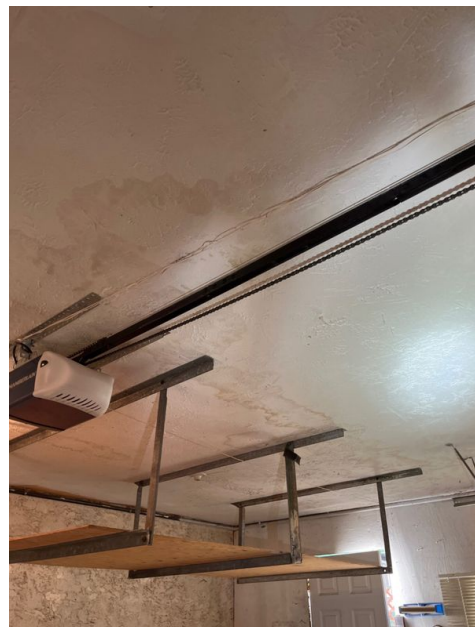
Water marks were noted in one or more areas of the structure. It is recommended to inquire on the history of the event(s).

Contact a qualified professional.

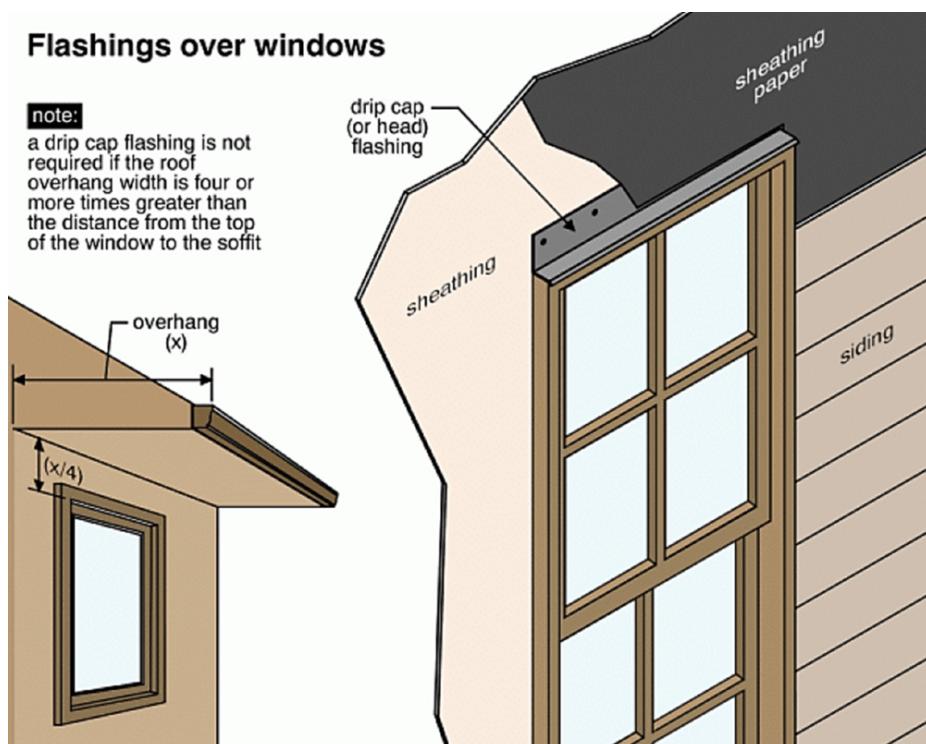
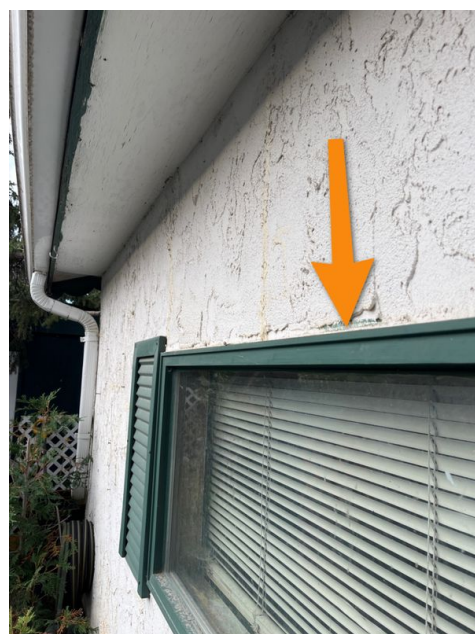
#### 4.34.1 Windows

### MISSING DRIP EDGE FLASHING - WINDOWS

It is recommended to have drip edges above and below all doors and windows to prevent water migration behind the components.

Contact a qualified siding specialist.

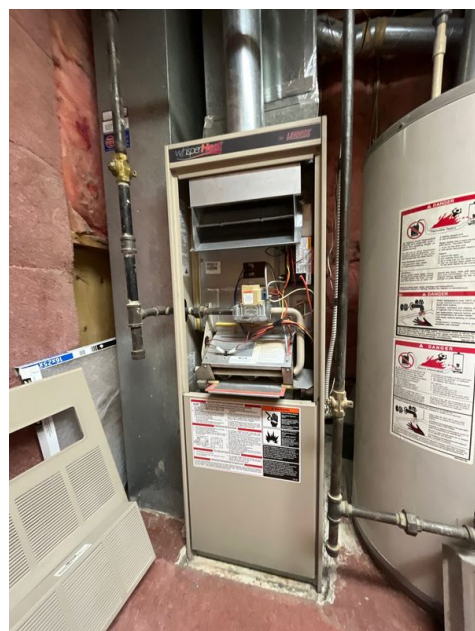
### DID NOT ENGAGE

The following heat source did not engage when tested. When there was a call for heat (thermostat was increased), the electronic spark igniter turned on and a pilot flame was lit. However, beyond this, the main burners did not engage. The furnace did not engage to produce heat for the purpose of heating the dwelling. This should be further investigated.

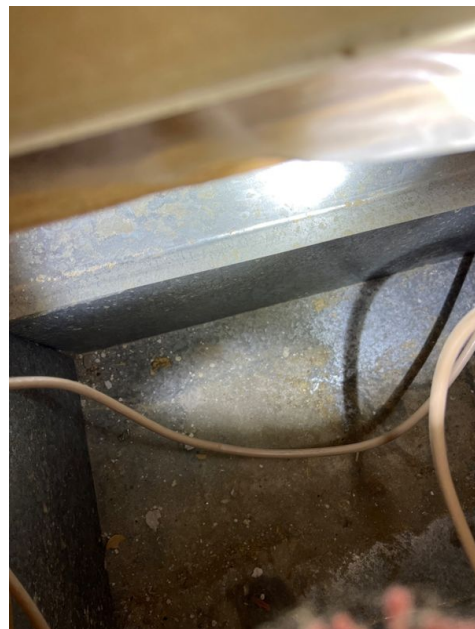
5.5.1 Distribution Systems

Debris was found in the duct work. These should be cleaned every 3-5 years depending on use. Dirty duct work can affect the quality of air in the structure resulting in allergy like symptoms.

Contact a qualified HVAC professional.

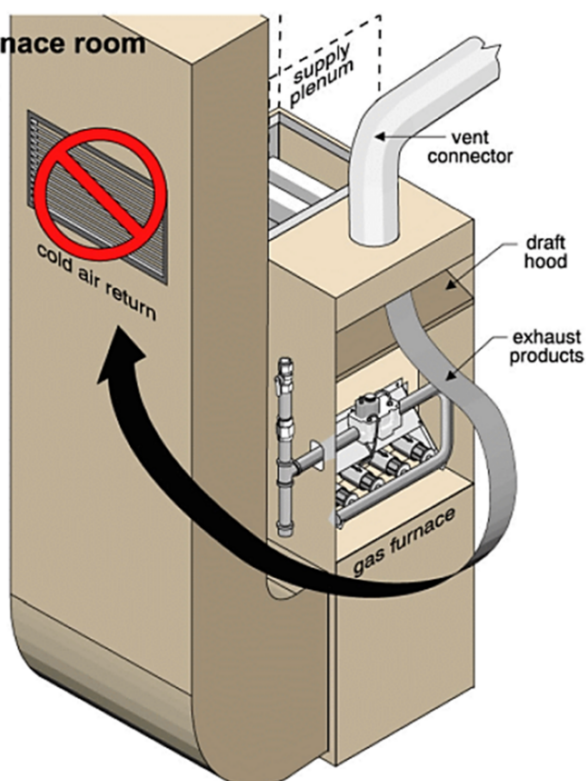
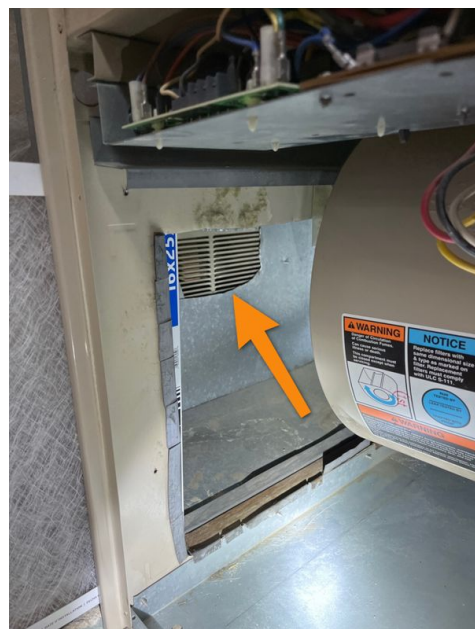
### 5.5.2 Distribution Systems

#### RETURN AIR DUCT IN MECHANICAL ROOM

a return grille in the furnace room can allow the furnace blower to pull exhaust products out of the draft hood into the house air stream  
this can be a life safety issue

Contact a qualified HVAC professional.

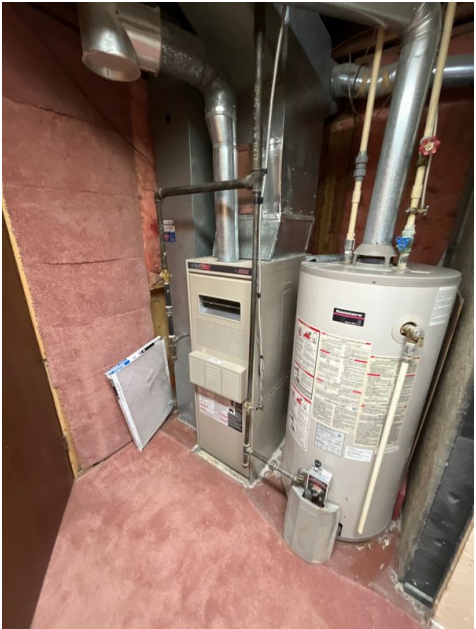
5.12.1 Venting  
**MISSING FRESH AIR**

No combustion air pod was found in the mechanical room. This is likely due because it was not required when the dwelling was constructed. It is recommended to install one to prevent back drafting. If the furnace is to be replaced, a direct vented unit will be installed thus not requiring dedicated combustion air.

Recommendation  
Contact a qualified HVAC professional.

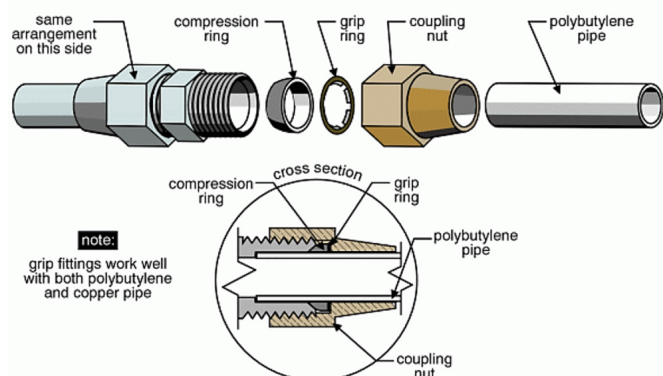
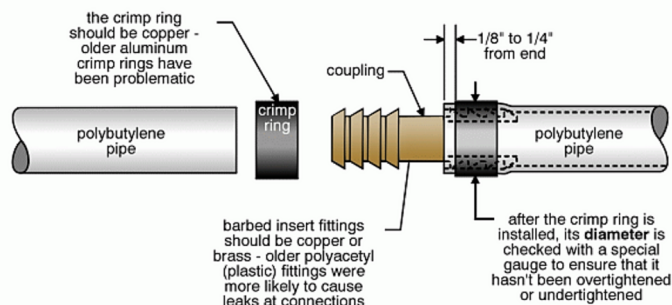
Polybutylene piping was found in the structure. This type of piping was prone to leak at the connection joints. It is recommended that this pipe be monitored for leaks. It is recommended that the potential buyer(s) inquire with the insurance provider to see if this material poses a concern for insuring the structure. This material was typically used between 1985 - 1995.
