# CERTA PROPERTY INSPECTIONS

## PROPERTY REPORT

234 Demo Street  
Calgary, AB T4B 1L1

SEPTEMBER 12, 2023

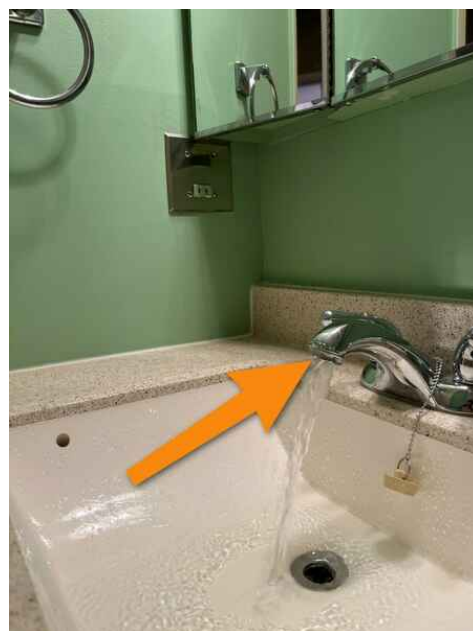
### 6.4.1 Fixtures

It is recommended to service the following aerator.

Contact a qualified plumbing contractor.

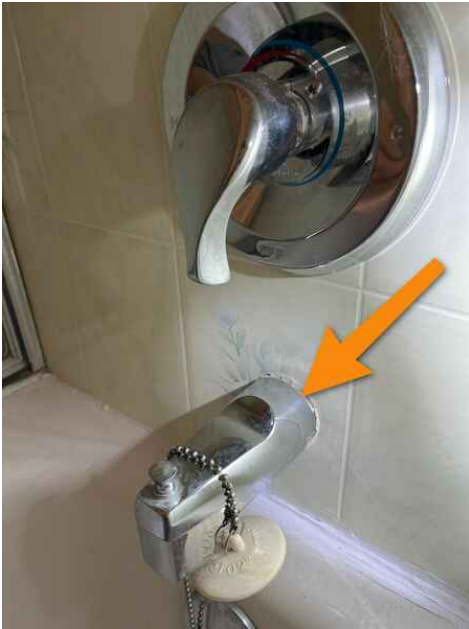
### 6.4.2 Fixtures

#### DETERIORATED OR MISSING CAULKING

One or more locations at the structure exhibited missing or caulking past its life expectancy. Caulking helps prevent water migration into areas not designed to contain water. It is recommended to rectify this.

Contact a qualified professional.

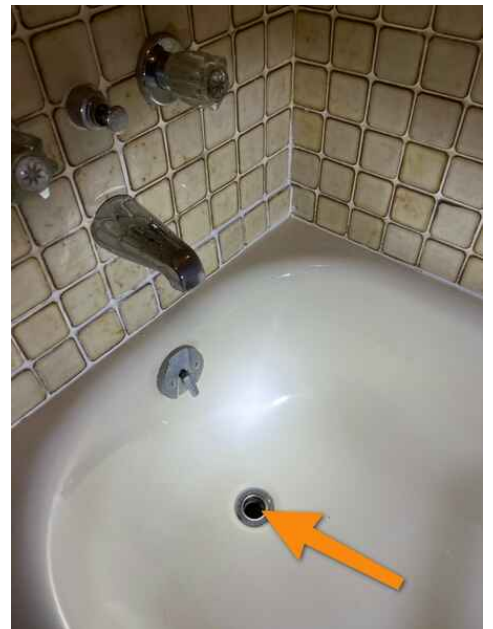
#### 6.4.3 Fixtures

##### **DRAIN STOP DEFICIENCY**

One or more drain stops were deficient. Replacement units can be purchased from the local hardware store inexpensively.

Contact a handyman or DIY project

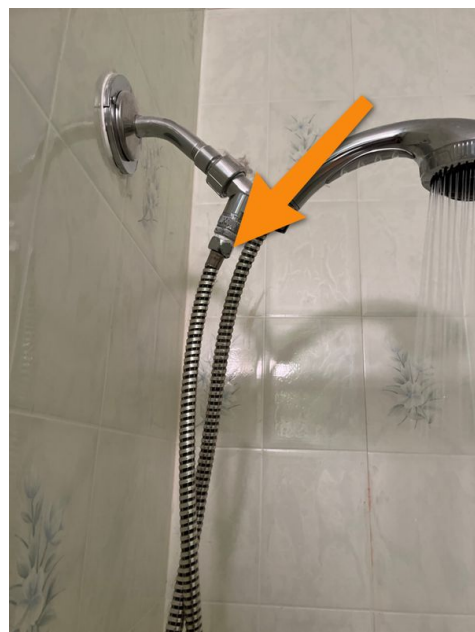
One or more fixtures were noted to have nuisance drips.

Contact a qualified plumbing contractor.

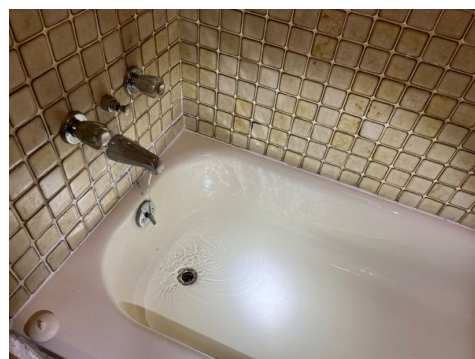
#### 6.4.6 Fixtures

##### **SLOW DRAIN(S)**

One or more fixtures were noted to have a slow drain; this should be serviced to provide adequate drainage. Pouring baking soda followed by vinegar may help break up obstructions down hole if debris is the culprit.

Contact a qualified plumbing contractor.

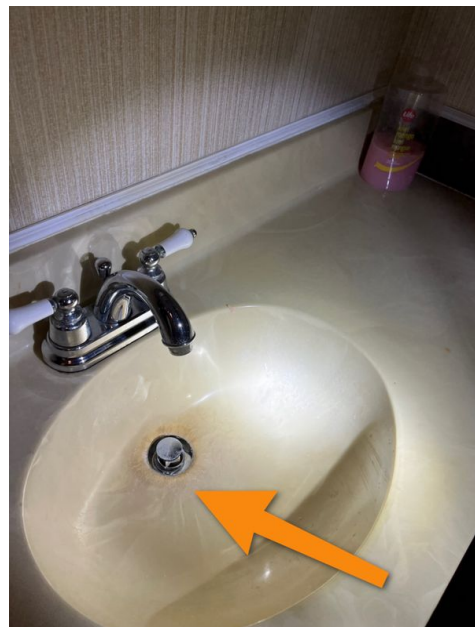
## 6.4.7 Fixtures

**SURFACE DEFECTS**

One or more fixtures were noted to have surface defects. While no leaks were noted during the inspection, it is recommended that these be repaired or budgeted to be replaced.

Contact a qualified professional.

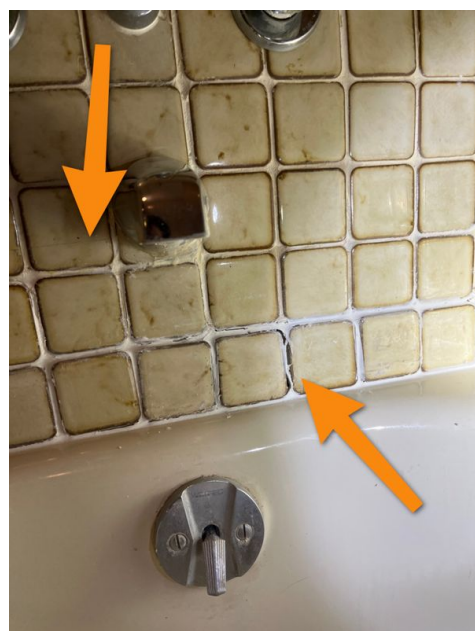
## 6.4.8 Fixtures

**TILE DAMAGE**

Some of the tile or grout was noted to be damaged and should be repaired to mitigate water damage.

Contact a qualified plumbing contractor.

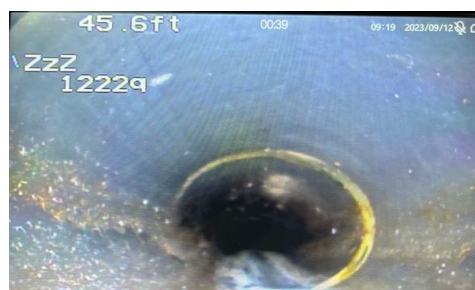
## 6.11.1 Sewer Camera Inspection

**OVALITY**

Ovality was noted in the sewer waste line. While this may have occurred at the time of installation, it is recommended to monitor the line with a camera inspect every 2 years to confirm the ovality is not continuing to increase.

Contact a qualified professional.

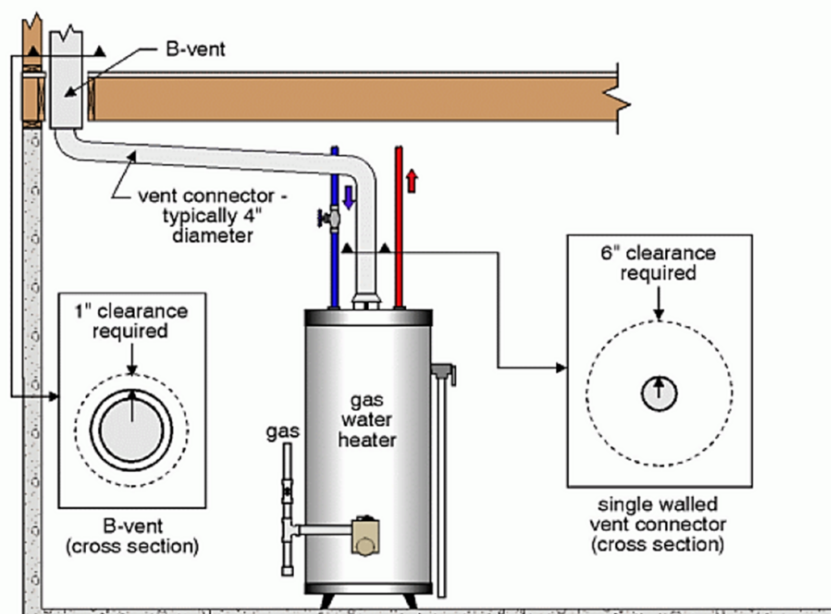
## 6.14.1 Venting

**COMBUSTIBLE CLEARANCE**

B vent clearance is a minimum of 1" from combustibles while C vents require 6". The clearance was not met in the following area(s). It is recommended that a qualified professional rectify this.

Contact a qualified HVAC professional.

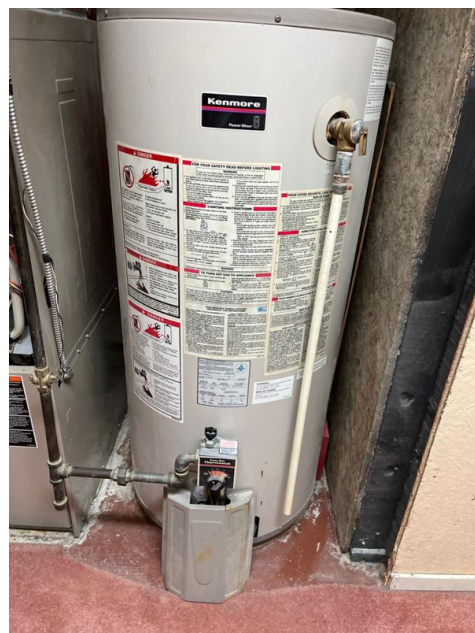
### 6.15.1 Water Heater

Due to the age of the water heater, it is recommended that the client(s) begin budgeting for a replacement unit. Proper maintenance of the unit, such as annual drainage along with bi-annual rod replacement have shown to increase the life span of these systems. If the structure has been vacant for more than 4 weeks, it is recommended to flush the water from water heater to mitigate any exposure of waterborne pathogens.

Contact a qualified plumbing contractor.

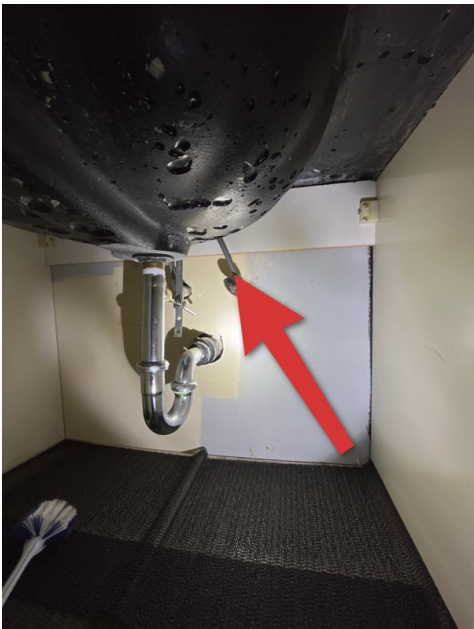
### 6.16.1 Water Supply, Distribution Systems

Polybutylene piping was found in the structure. This type of piping was prone to leak at the connection joints. It is recommended that this pipe be monitored for leaks. It is recommended that the potential buyer(s) inquire with the insurance provider to see if this material poses a concern for insuring the structure. This material was typically used between 1985 - 1995.

Contact a qualified plumbing contractor.

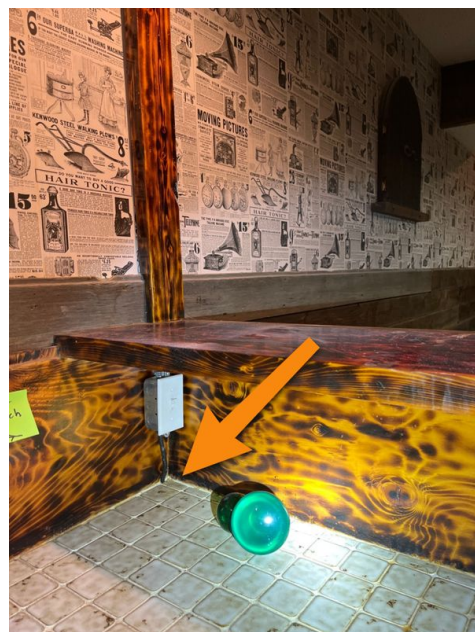
### 7.1.2 Branch Wiring

Exposed non-metallic dry sheathing (NMS) circuit wiring was found. All exposed NMS wiring below 1.5 meters should be protected by armoured sheathing.

Contact a qualified electrical contractor.

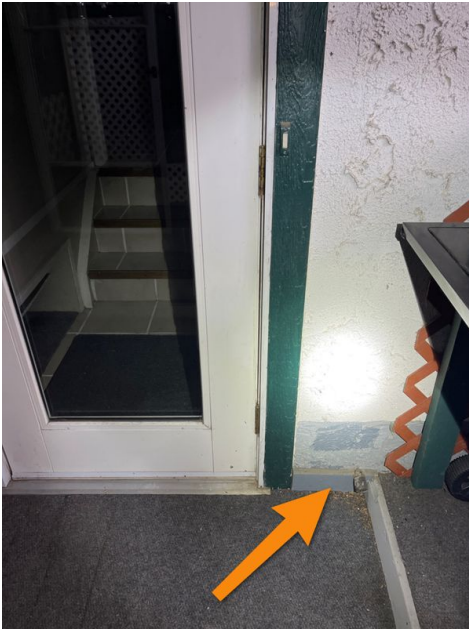
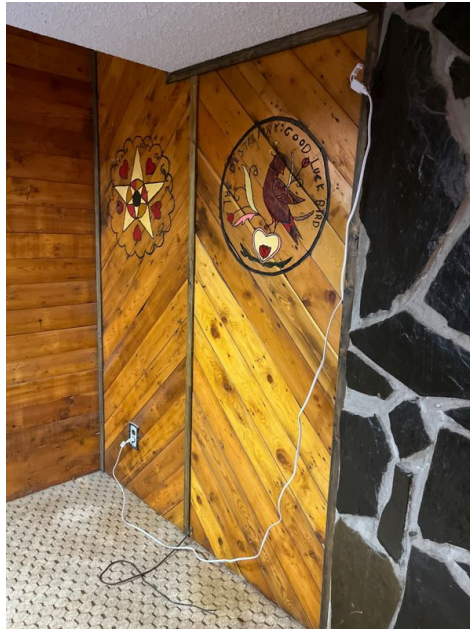
### 7.3.1 Extension Cord Use

#### **EXTENSION CORD USE**

Contact a qualified electrical contractor.

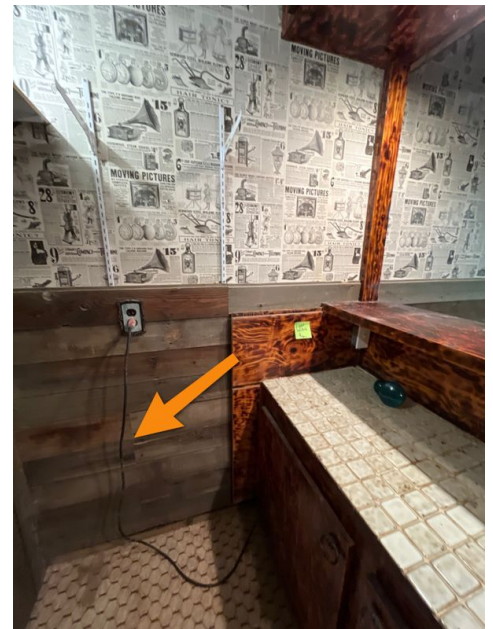
#### 7.4.1 Exterior Use

### **IMPROPER USE**

Contact a qualified electrical contractor.

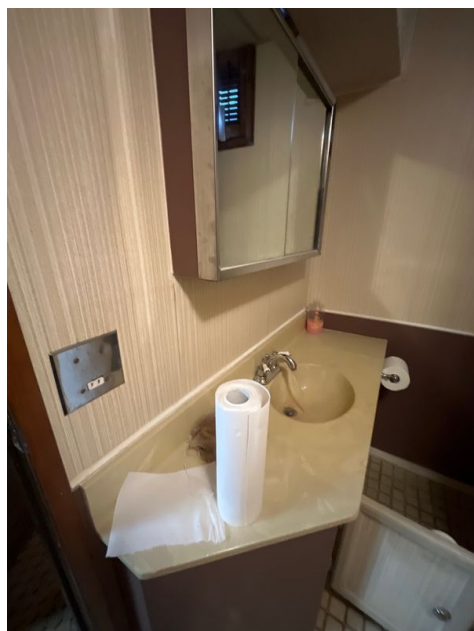
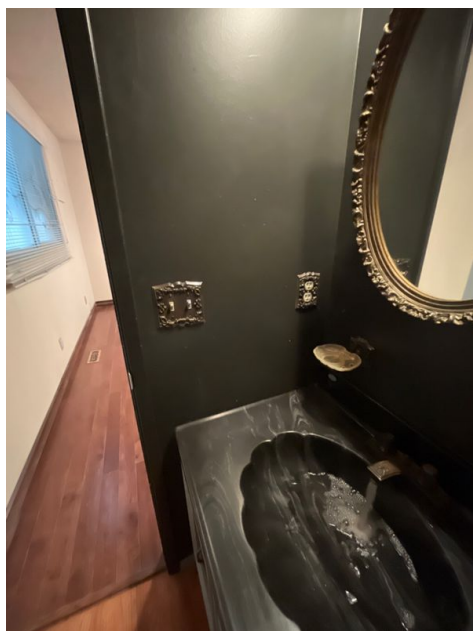
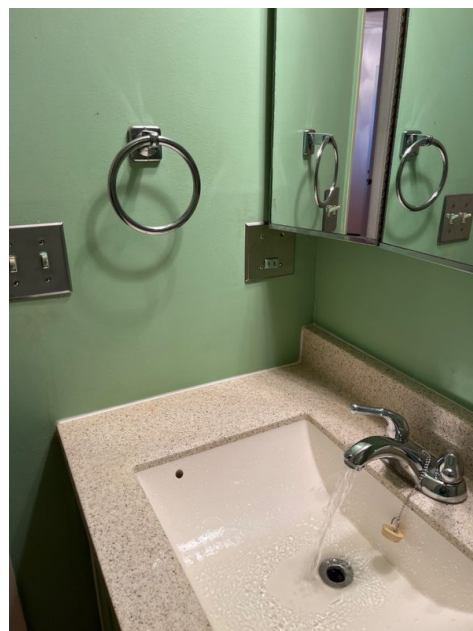
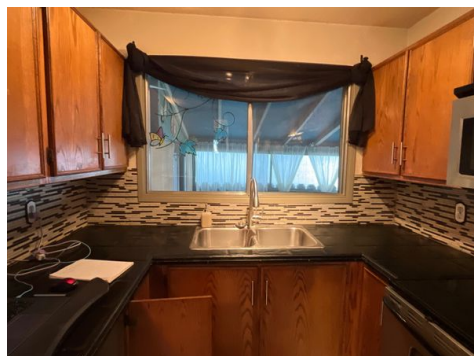
#### 7.5.1 GFCI & AFCI

### **NO GFCI PROTECTION INSTALLED**

It is recommended that GFI protected receptacles be installed within 1.5 meters of any water sources as well as receptacles found outside below 2.5 meters. It is recommended to have a qualified electrician install these.

Contact a qualified electrical contractor.

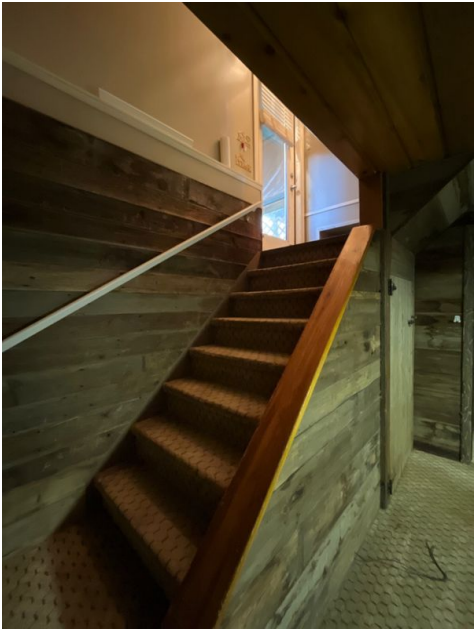
7.7.1 Lighting Fixtures

**NO 3 WAY SWITCH**

It is recommended to have three way switches for stairways.

Recommendation  
Contact a qualified electrical contractor.

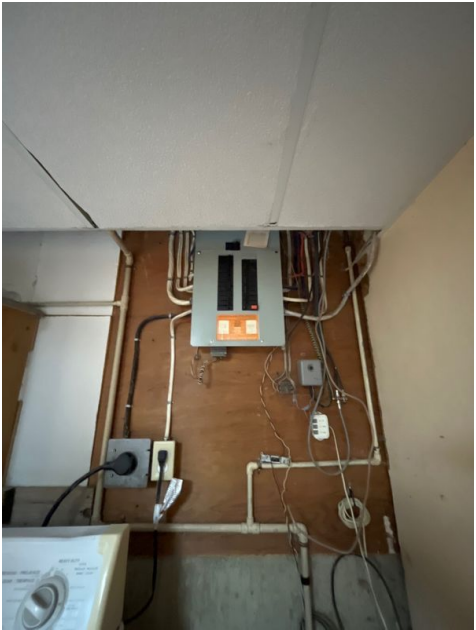
### 7.8.1 Main Panelboard

## INADEQUATE ACCESS

Electrical panels should have access 1 meter in front for servicing.

Recommendation  
Contact a qualified electrical contractor.

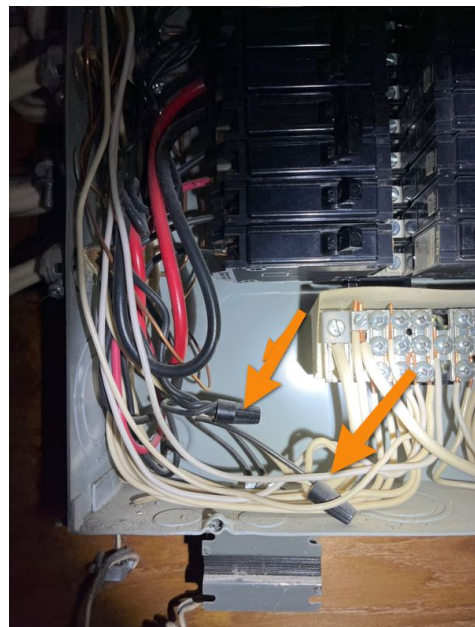
## 7.8.2 Main Panelboard

**SPLICES**

Contact a qualified electrical contractor.

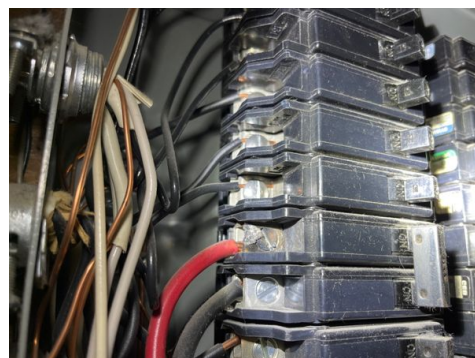
## 7.11.1 Overcurrent Protection Devices (Breakers / Fuses)

**DAMAGE - BREAKER**

Damage was noted at one or more breakers and should be replaced by a qualified electrician.

Contact a qualified electrical contractor.

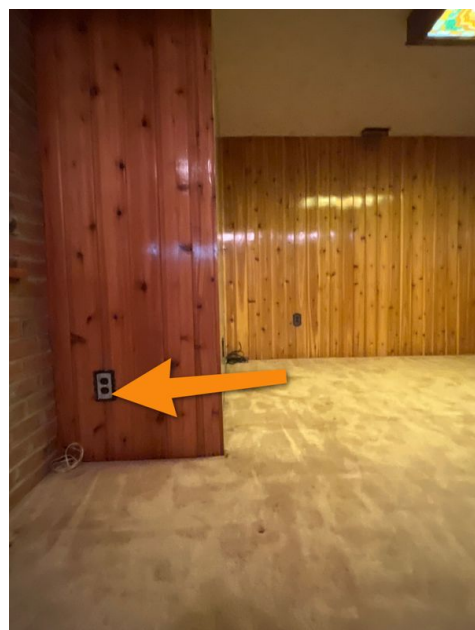
## 7.12.1 Outlets

**NOT TESTED**

Contact a qualified electrical contractor.

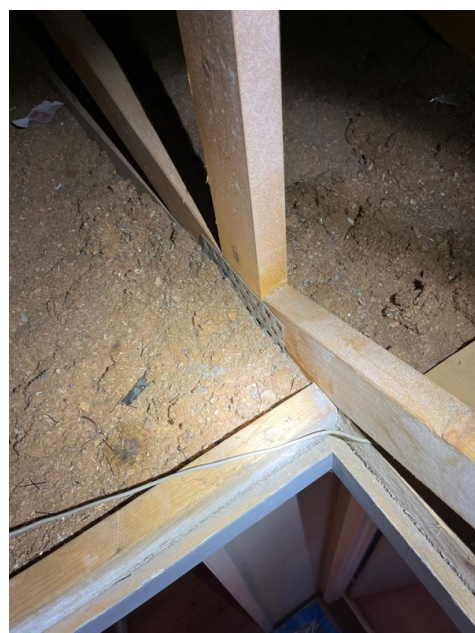
### 8.1.1 Attic & Foundation

It is recommended to install weather stripping at the attic hatch. Weather stripping prevents warm and cold air contacting one another causing condensation (water) which is a precursor to mold development.

Contact a handyman or DIY project

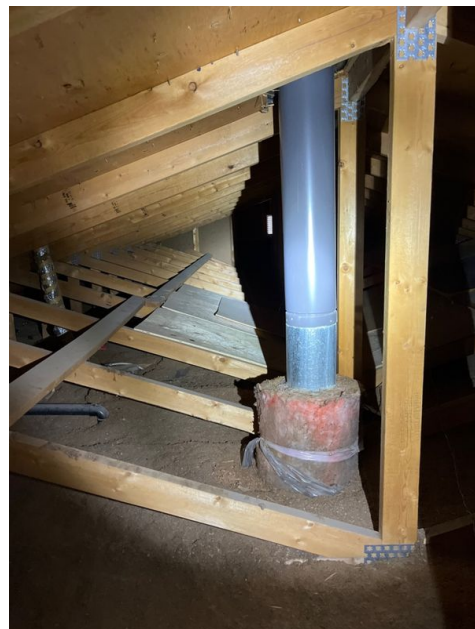
## 8.1.2 Attic &amp; Foundation

**COMBUSTIBLE CLEARANCE**

B vent clearance is a minimum of 1" from combustibles while C vents require 6". The clearance was not met in the following area(s). It is recommended that a qualified professional rectify this.

Contact a qualified HVAC professional.

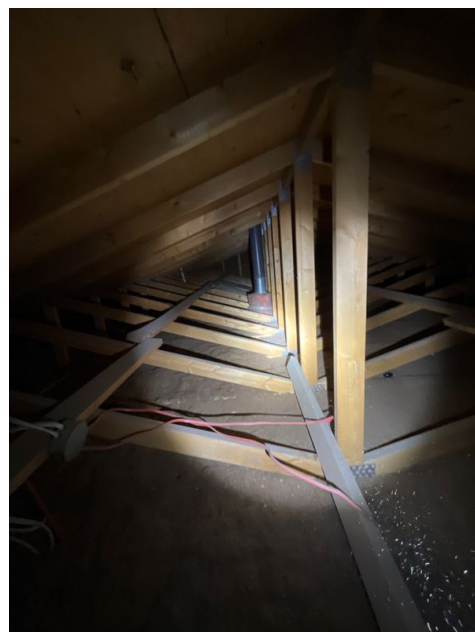
## 8.1.3 Attic &amp; Foundation

**UNPROTECTED WIRING - ATTIC**

Exposed non-metallic dry sheathing (NMS) circuit wiring was found. All exposed NMS wiring with headroom of at least 1 meter should be protected by armoured sheathing.

Contact a qualified electrical contractor.

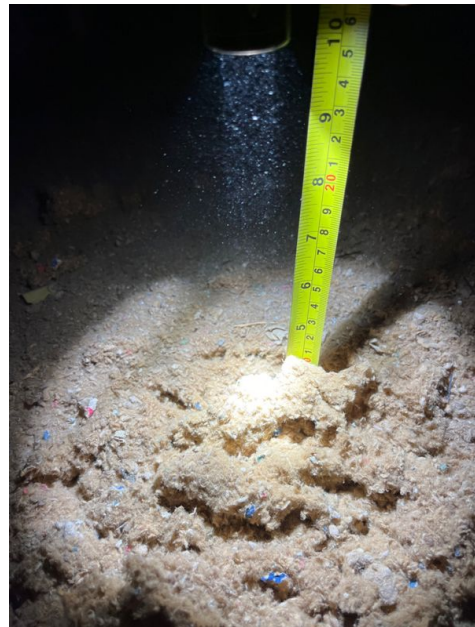
## 8.2.1 Attic Insulation

**AMOUNT LESS THAN CURRENT STANDARDS**

The attic was found to have less than today's standard in one or more areas. Today's standards is R 50 - 60. It is recommended to top up the insulation for better energy efficiency.

Contact a qualified insulation contractor.

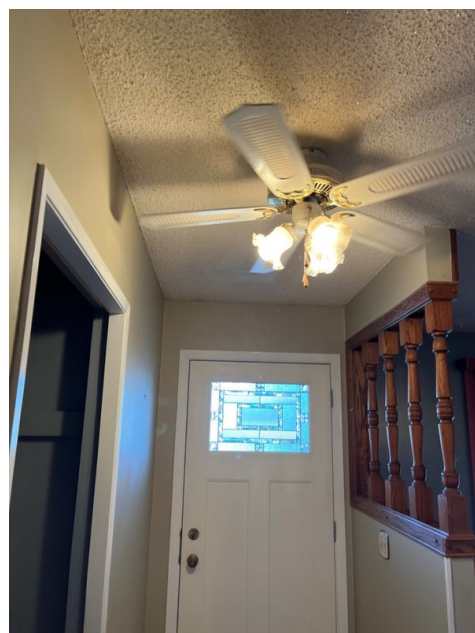
### 10.1.1 Ceiling Fan

One or more ceiling fans were noted to wobble. These should be serviced.

Contact a qualified professional.

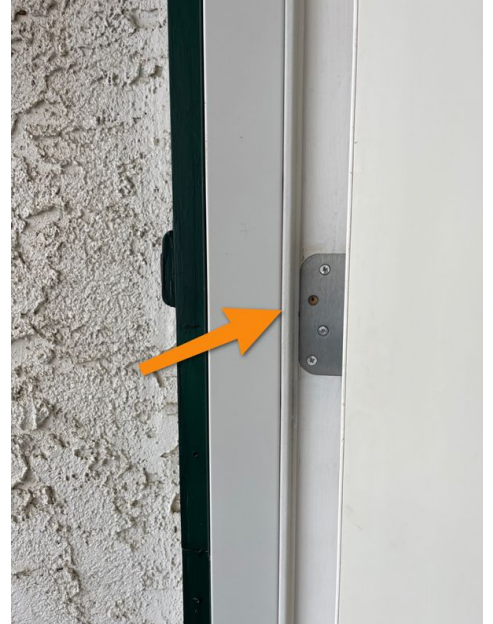
## 10.4.2 Doors

**FASTENERS MISSING**

It is recommended to install fasteners for the hinges.

Contact a qualified door repair/installation contractor.

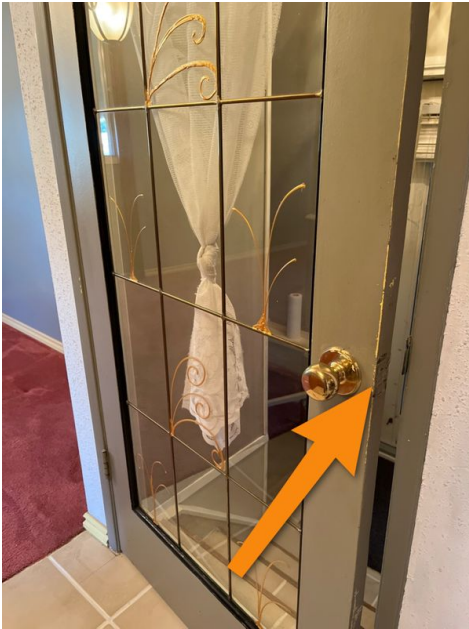
## 10.4.3 Doors

**SERVICING RECOMMENDED**

Contact a qualified door repair/installation contractor.

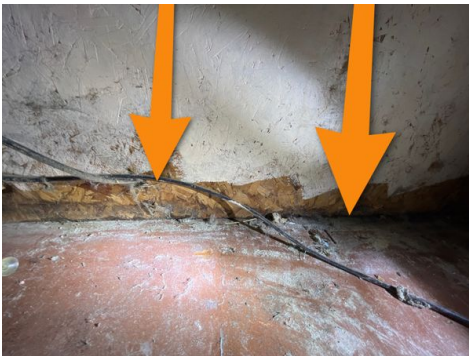
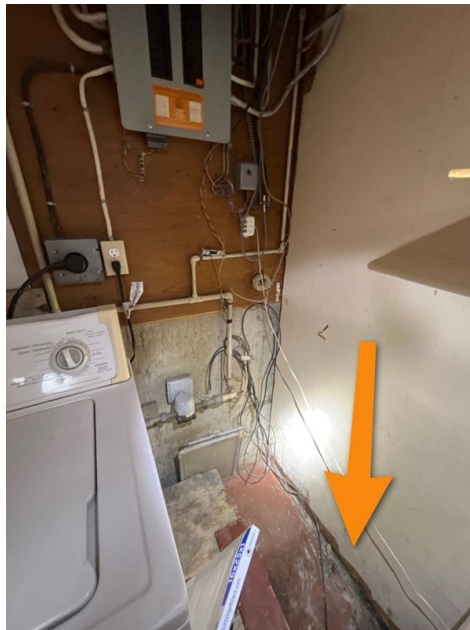
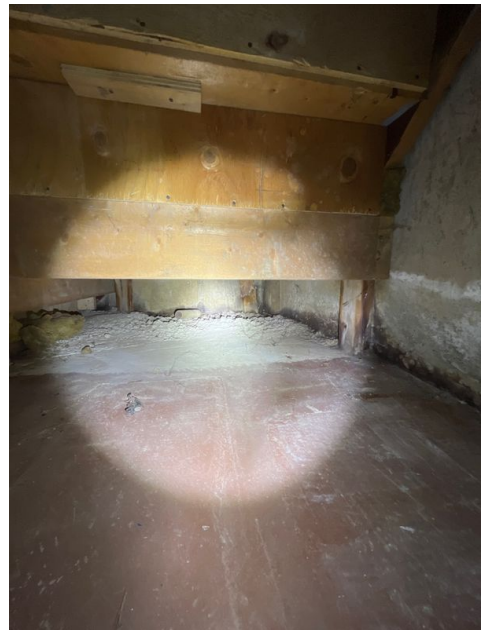
#### 10.7.1 Hazardous Materials

### POSSIBLE ORGANIC GROWTH

One or more areas were found to have, what appears to be organic growth. It is recommended to remove this by either using a mold killing agent or replacing the building material. With any renovations, additional signs of water damage may be found.

Contact a qualified mold remediation contractor

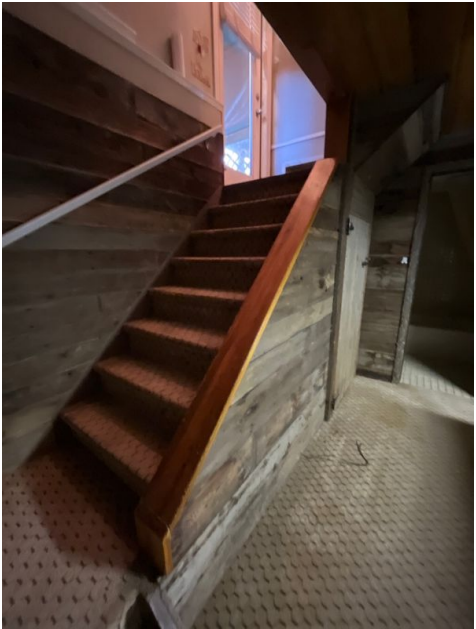
#### 10.13.1 Steps, Stairways & Railings

### BALUSTERS MISSING

The baluster space is not up to modern safety standards. The space between balusters should not allow passage of a 4 3/8-inch sphere for child safety. Recommend a qualified handyman or original installer repair and bring up to code.

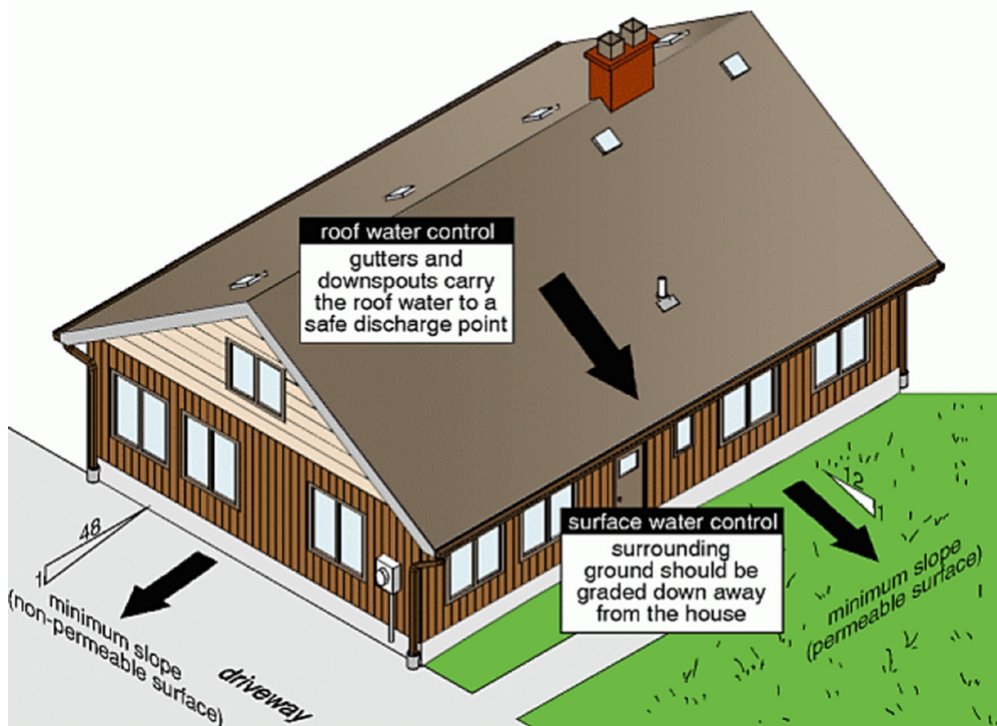
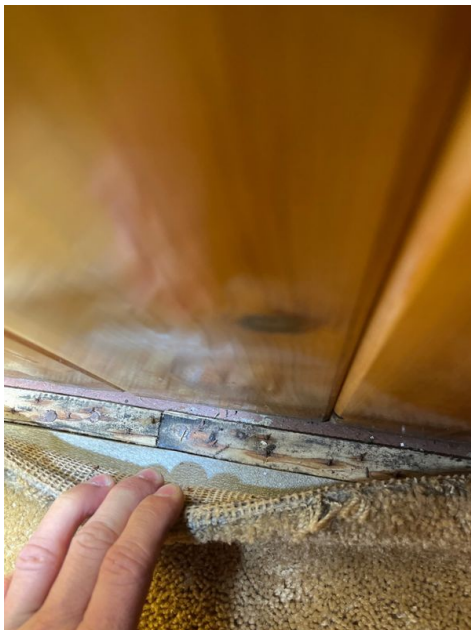
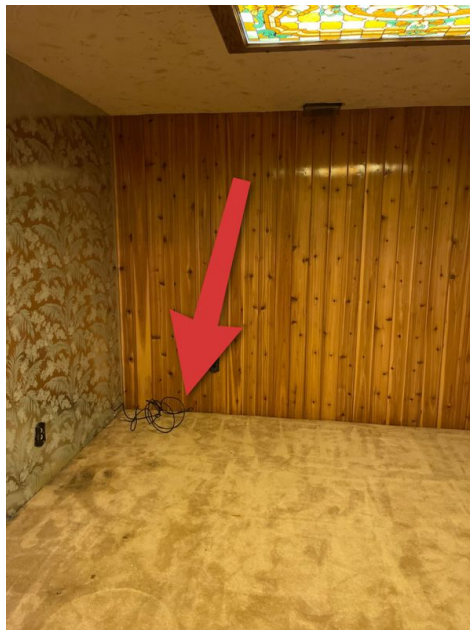
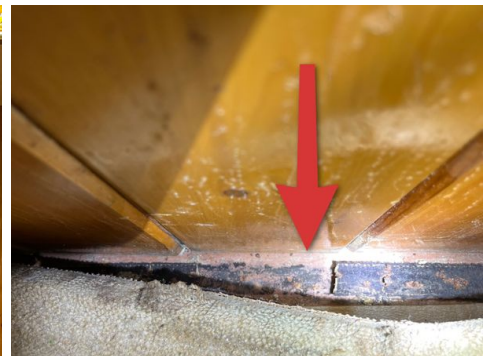
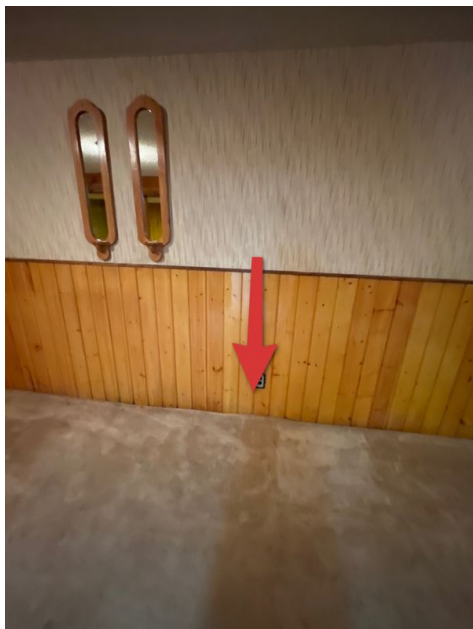
10.15.1 Water Marks / Damage

**WATER DAMAGE - EXTERIOR WALLS**

It appears that water damage was noted in the following area(s). While no active leaks or moisture was present at the time of the inspection, it is recommended to inquire with the current occupants as to the history of the event and to monitor the area.

Recommendation  
Contact a qualified professional.

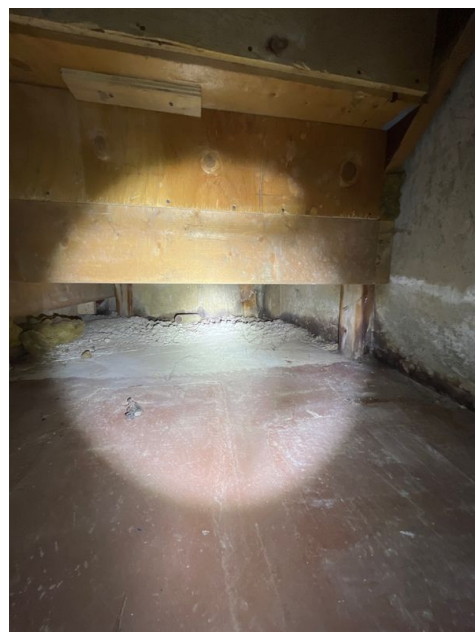
#### 10.15.2 Water Marks / Damage

### **WATER MARKS**

Water marks were noted in one or more areas. It is recommended to inquire on the history of the event(s).

Contact a qualified professional.

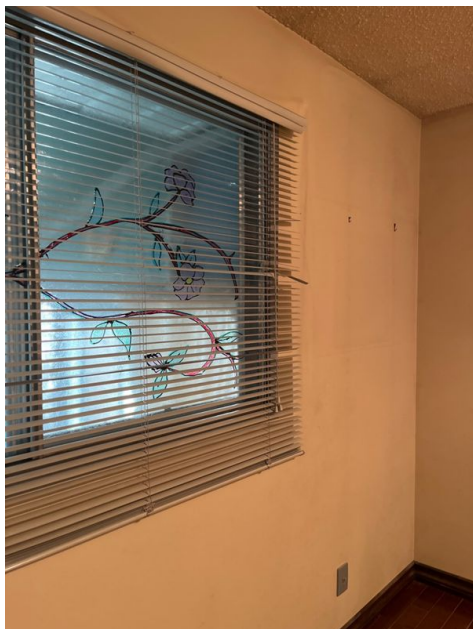
#### 10.16.1 Windows

### **BLINDS DAMAGE**

Some of the blinds were noted to be damaged.

Contact a qualified professional.

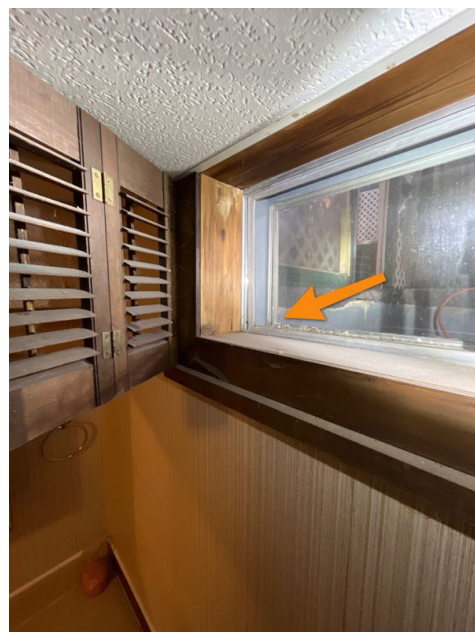
#### 10.16.2 Windows

##### **DAMAGE**

One or more windows were noted to be damaged.

Contact a qualified window repair/installation contractor.

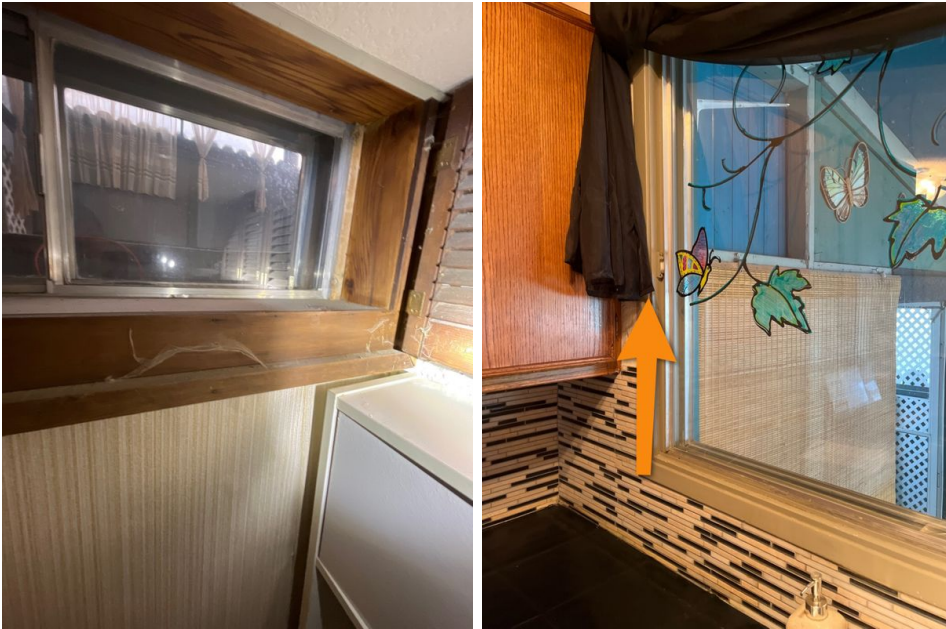
#### 10.16.3 Windows

##### **HARDWARE MISSING**

One or more windows had missing hardware and should be repaired by a qualified individual.

Contact a qualified window repair/installation contractor.

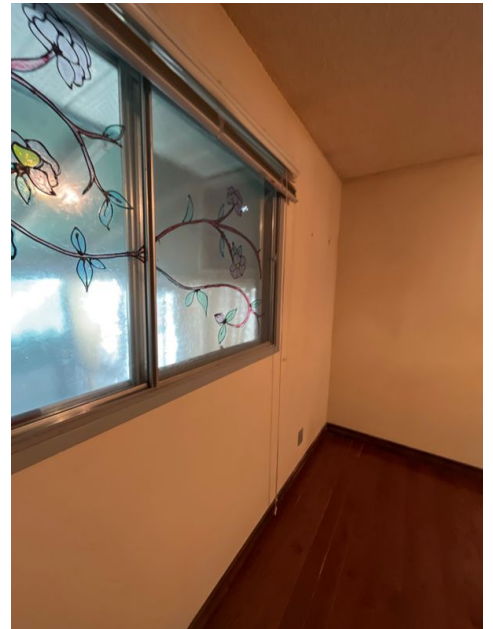
#### 10.16.4 Windows

##### **OLDER UNITS**

Because some of the windows in the structure are old, and low quality, the potential buyer should budget to replace them over the next few years.

Contact a qualified window repair/installation contractor.

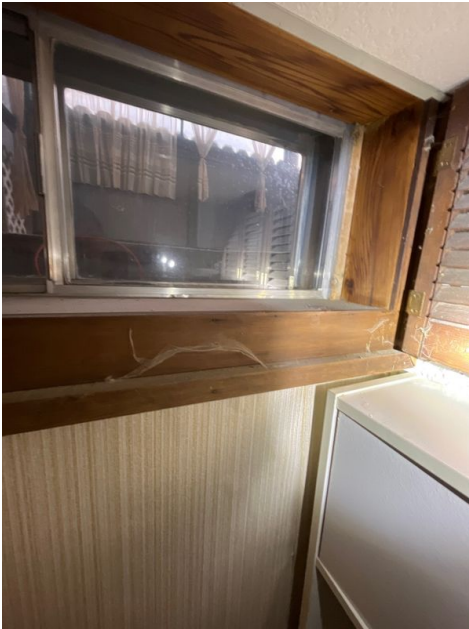
#### 10.16.5 Windows

##### **SCREEN MISSING**

One or more window(s) were missing screens.

Contact a qualified window repair/installation contractor.

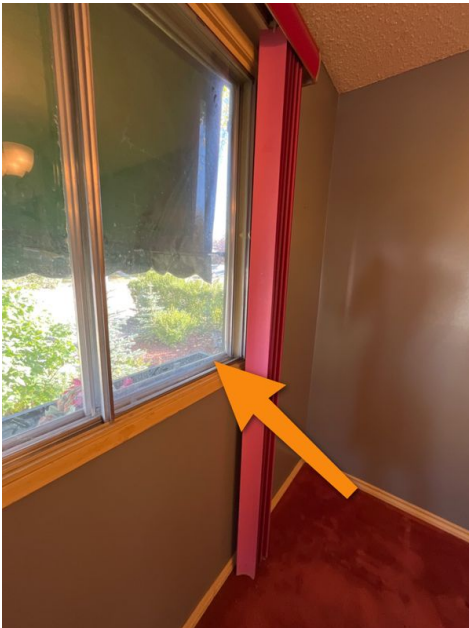
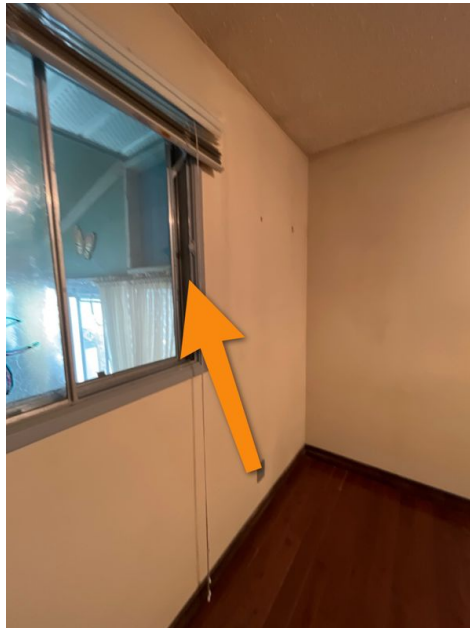
#### 10.16.6 Windows

### **SERVICE RECOMMENDED**

Contact a qualified window repair/installation contractor.

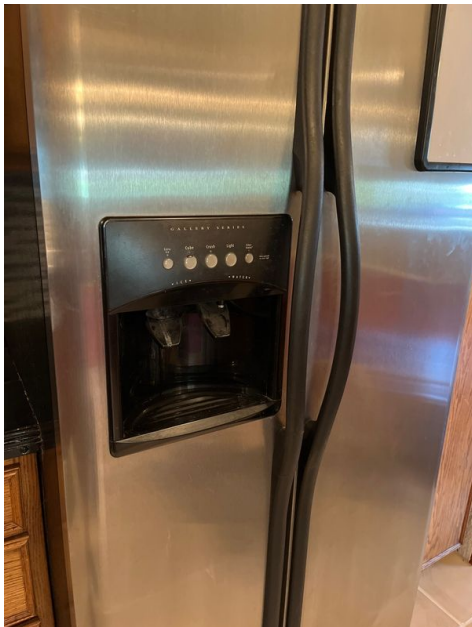
Refrigerator

**WATER LINE NOT CONNECTED**

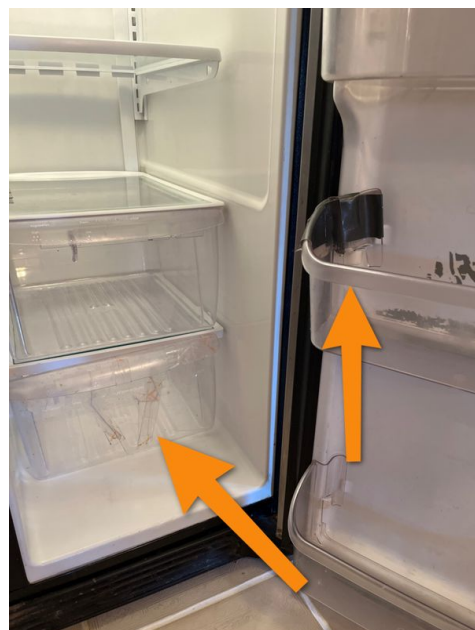
### 11.9.1 Refrigerator

#### **DAMAGED COMPONENTS**

One or more damaged components were noted in the appliance.

Contact a qualified appliance repair professional.

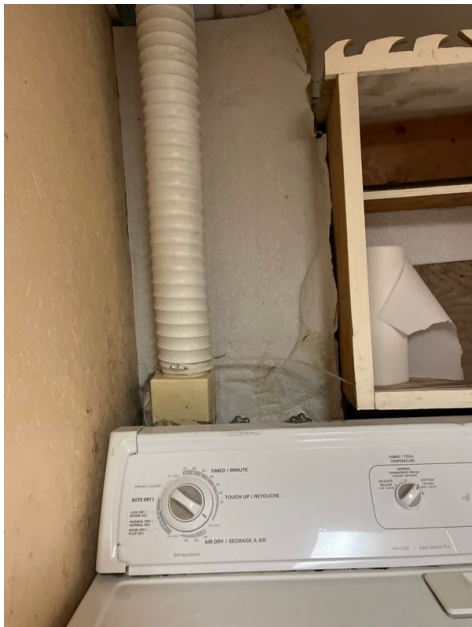
### 11.10.1 Washer / Dryer

#### **DRYER - PLASTIC VENT**

It is recommended to have smooth metal duct for dryer vent lines.

Contact a qualified professional.

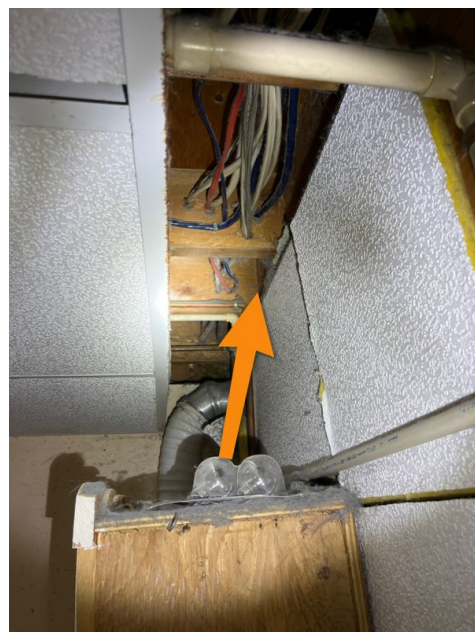
#### 11.10.2 Washer / Dryer

##### **EXCESSIVE LINT**

Lots of lint was found behind the dryer. The unit should be moved and the space should be cleaned.

Contact a handyman or DIY project

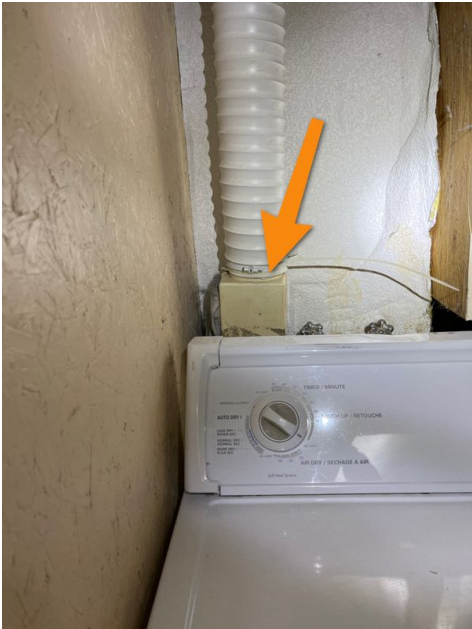
#### 11.10.3 Washer / Dryer

##### **DRYER HEAT RECOVERY BOX**

It is recommended to remove heat recovery boxes as they can lead to mold growth.

Contact a qualified professional.

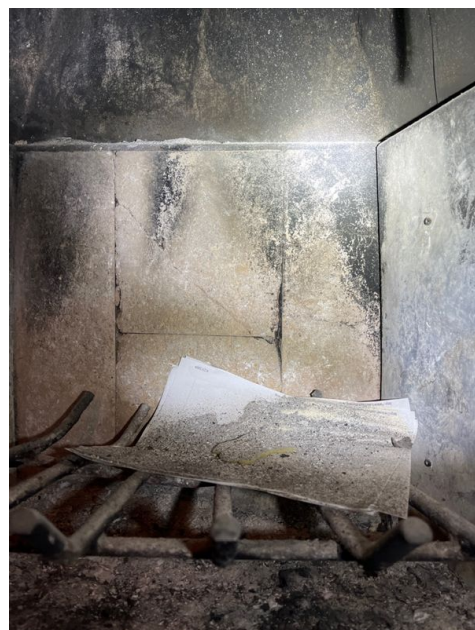
#### **FIREBRICK DAMAGED**

Some of the firebrick was noted to be damaged. This should be repaired or replaced.

Contact a qualified fireplace contractor.

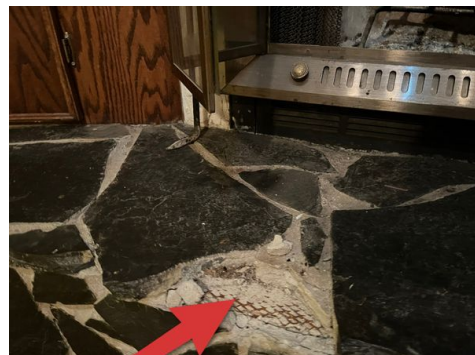
## 12.1.3 Factory-Built Fireplace

**FLOOR PROTECTION - DAMAGED**

The hearth pad was found to be cracked and missing mortar. These should be sealed / repaired for fire protection.

Contact a qualified fireplace contractor.

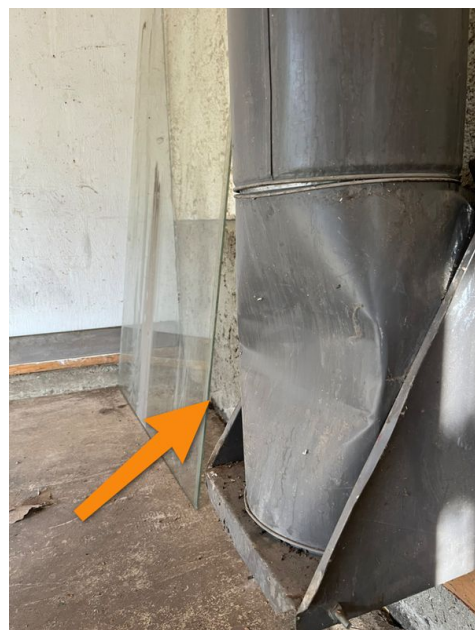
## 12.1.4 Factory-Built Fireplace

**CHIMNEY DAMAGE**

Some damage was noted to the chimney and should be repaired.

Contact a qualified professional.

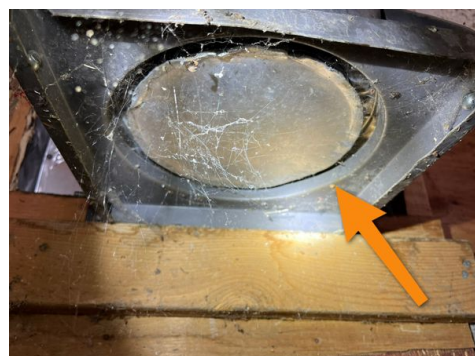
## 12.1.5 Factory-Built Fireplace

**CHIMNEY CLEANOUT**

A cleanout was not found with the chimney base T. One should be added.

Contact a qualified professional.
