PROPERTY REPORT

1234 Main Street
Calgary, AB T3K3V9

Buyer Name
09/17/2024 9:00AM

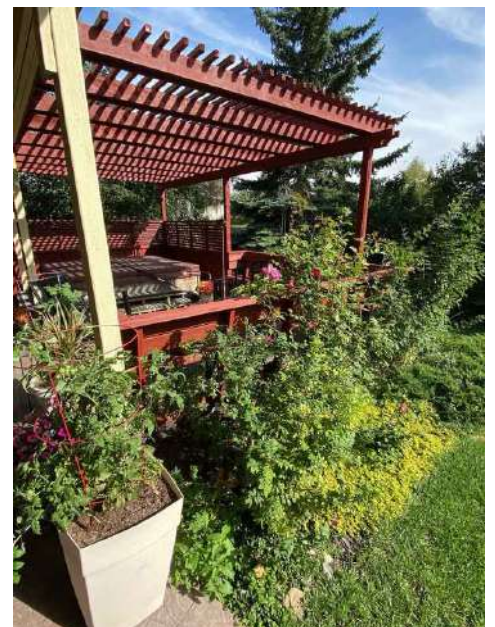
Due to the limited access, the inspector was unable to inspect below the structure.

Structures over 24" in height should have 10" (diameter) concrete pilings that extend below the frost line. At the time of the inspection, it was undetermined if these pilings existed with the structure. This should be further inspected and corrected if needed.

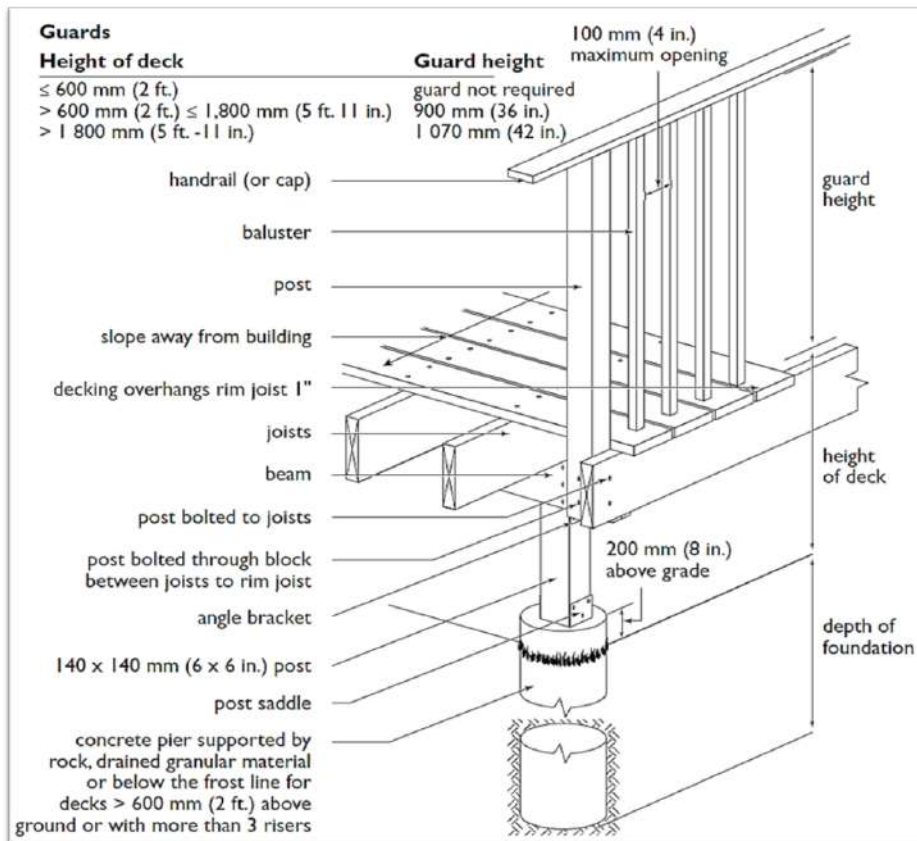
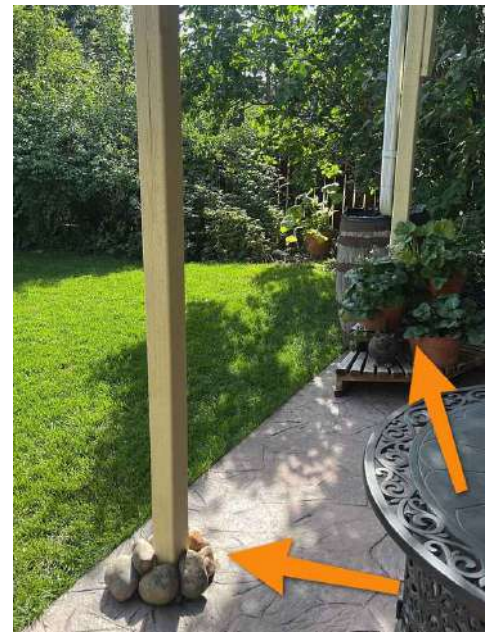
Deck(s)

UNKNOWN FOOTINGS

Structures over 24" in height should have 10" (diameter) concrete pilings that extend below the frost line. At the time of the inspection, it was undetermined if these pilings existed with the structure. This should be further inspected and corrected if needed.

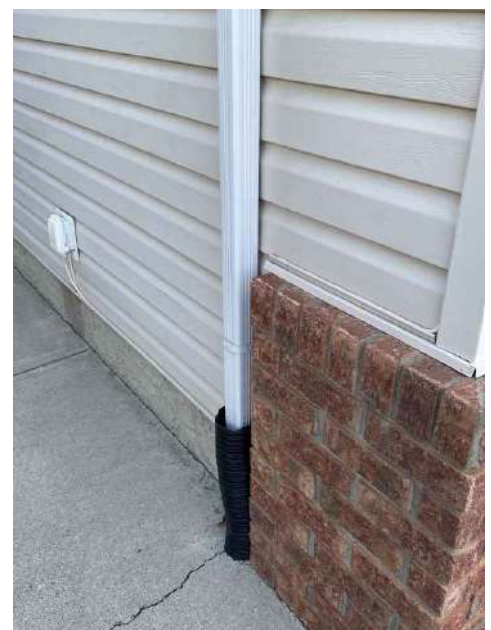
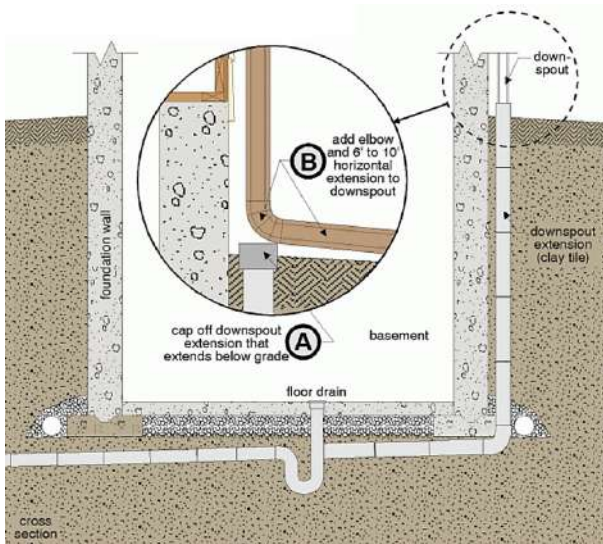
Downspouts / Gutters

BELOW GRADE DOWNSPOUTS

It is recommended that the integrity of these systems be tested. If there is damage to these underground drain systems, this may lead to water discharging near the foundation wall resulting in water penetration into the basement.

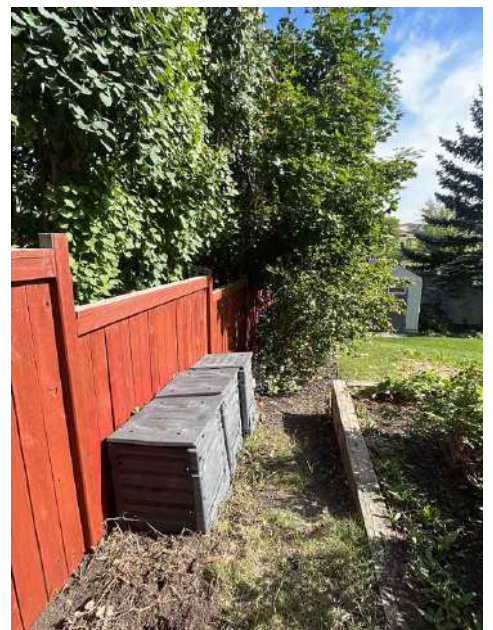
Fence

STORED ITEMS

Due to stored items, some components of the fence line could not be inspected.

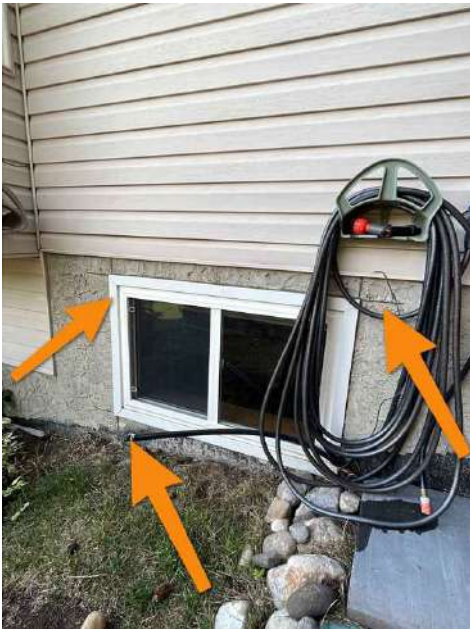
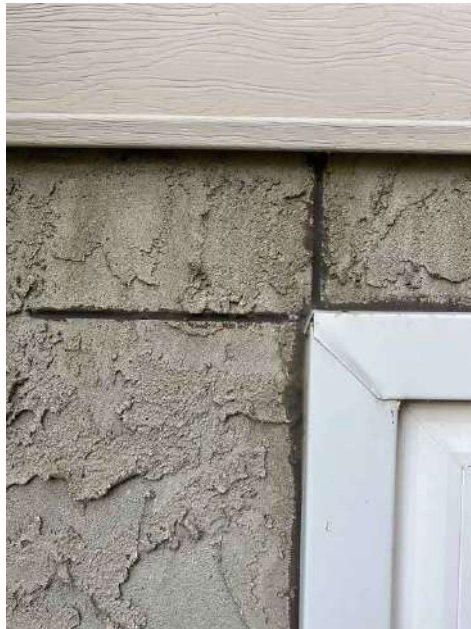
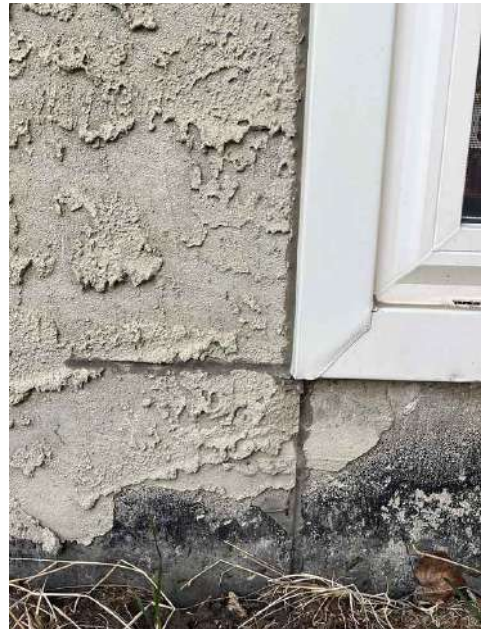
Foundation

UNKNOWN ALTERATIONS

It is recommended to confirm that the following alteration(s) do not affect the structural integrity of the building.

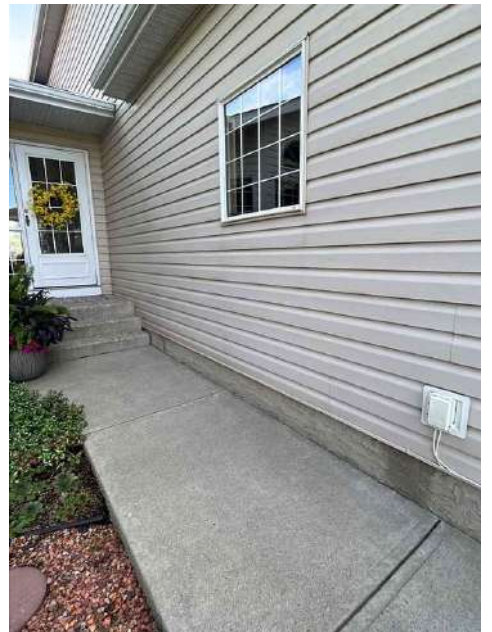
GFCI / Outlets

NOT TESTED

One or more of the exterior receptacles were not tested.

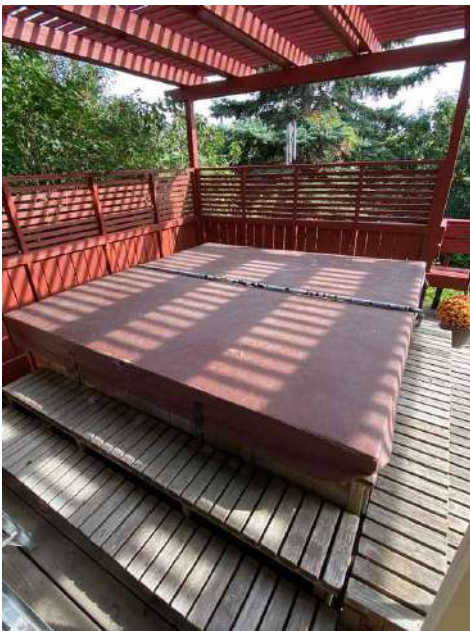
Spa / Hot Tub

NOT TESTED / INSPECTED

The following hot tub was not tested. It is recommended to confirm the operation with the current owners.

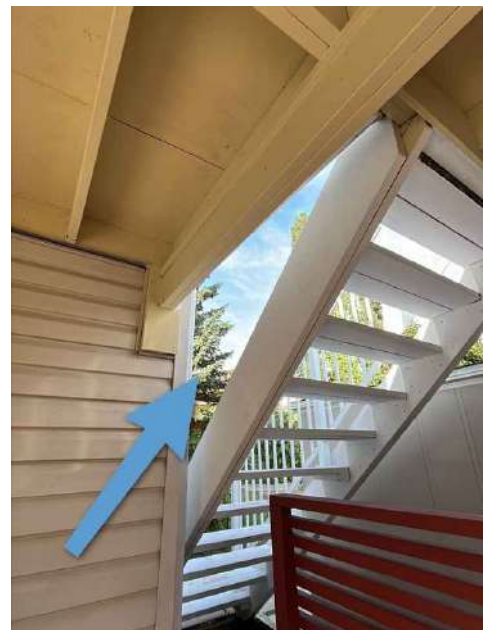
2.7.1 Deck(s)

BALUSTERS MISSING

Structures over 24" in height should have handrails and balusters to help prevent falling incidents.

Contact a qualified carpenter.

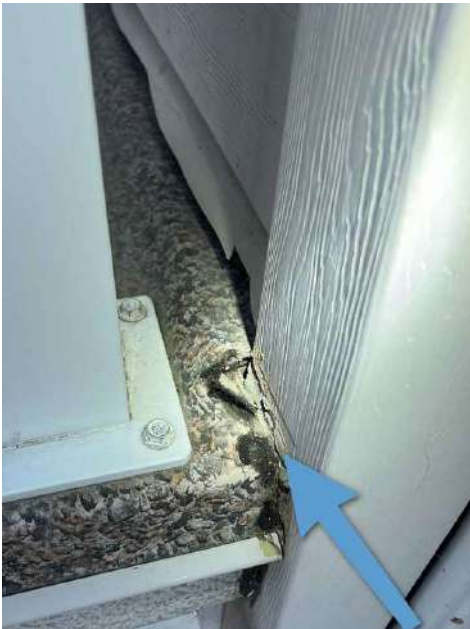
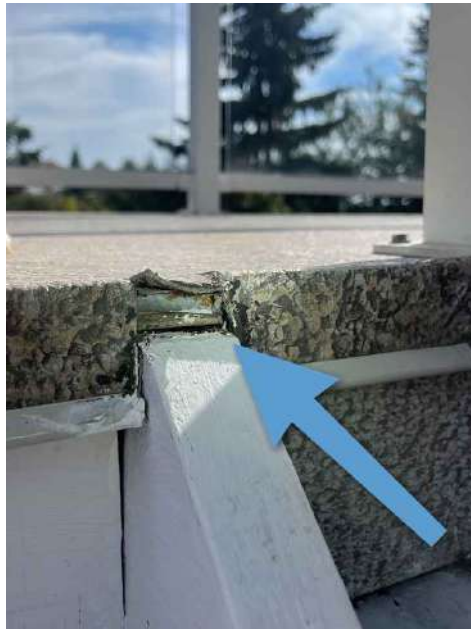
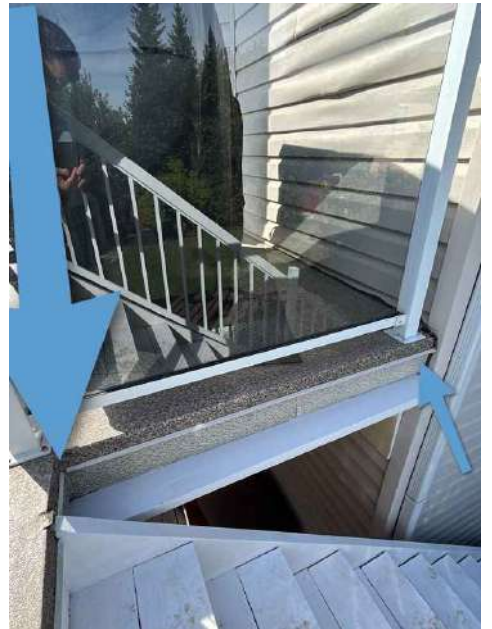
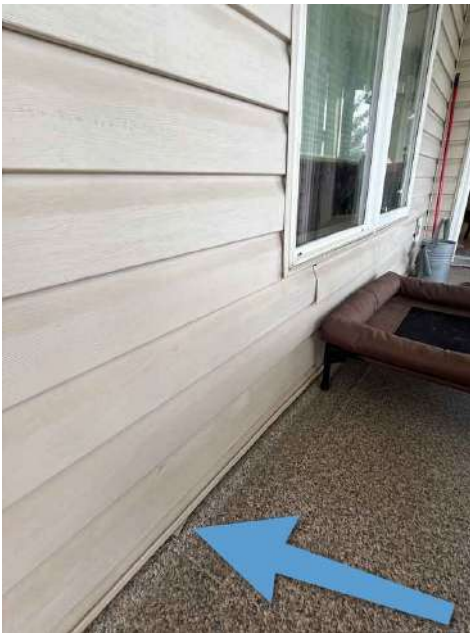
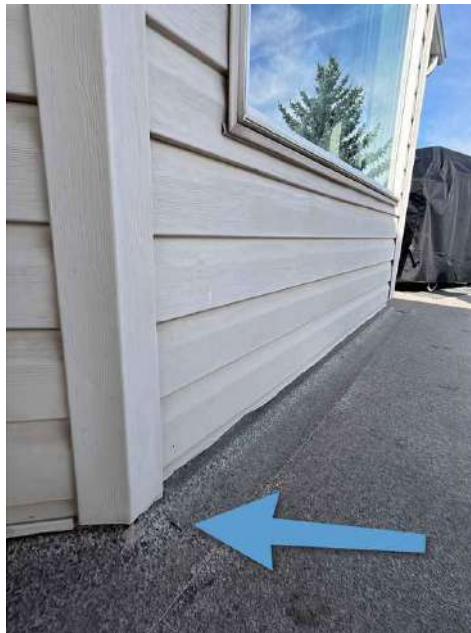
Some damage was noted to the deck covering material. It is recommended to seal this to prevent further deterioration.

Contact a qualified professional.

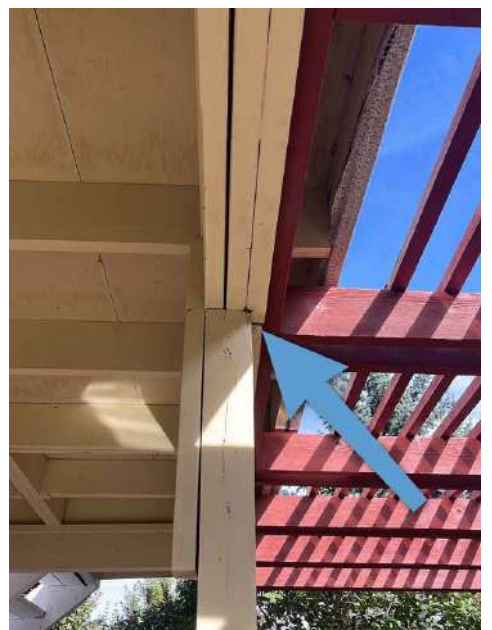
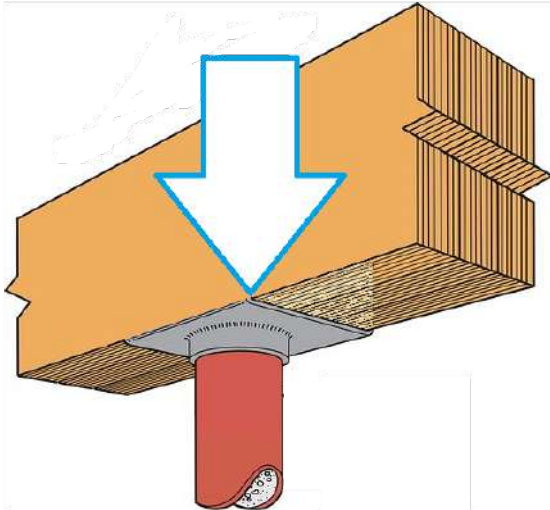
2.7.4 Deck(s)

POST - INADEQUATE SUPPORT SPAN

Contact a qualified carpenter.

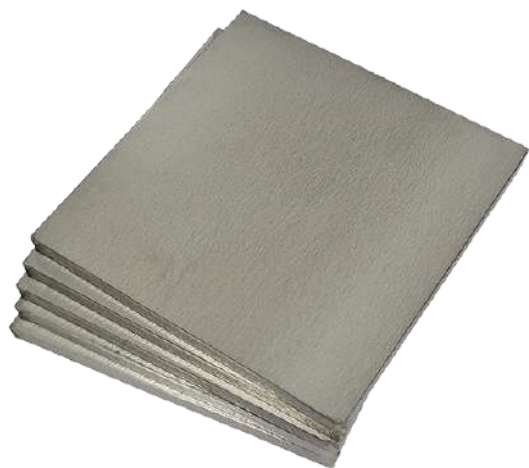
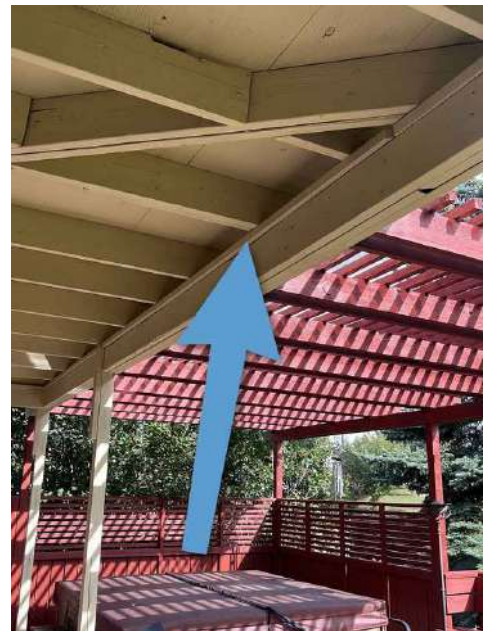
2.7.5 Deck(s)

POOR SHIMMING PRACTICE

Poor shimming methods were noted for the structure. It is recommended to use steel shims.

Recommendation
Contact a qualified carpenter.

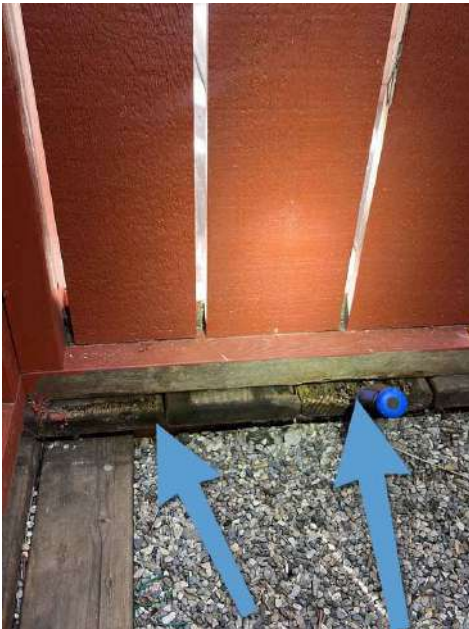
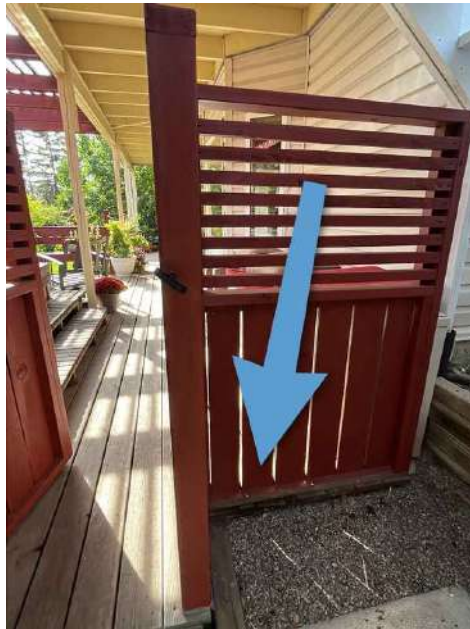
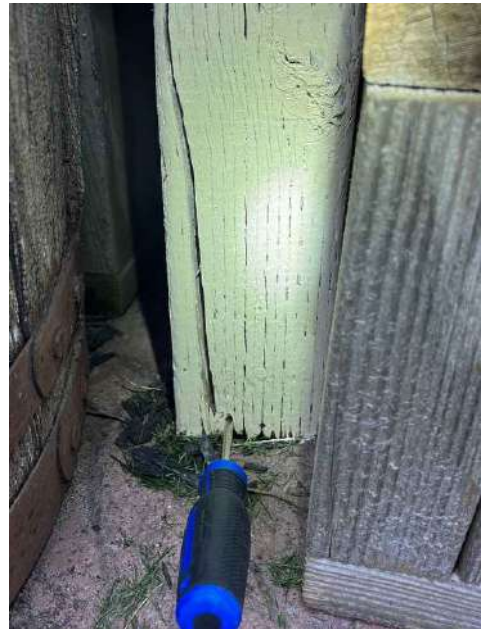
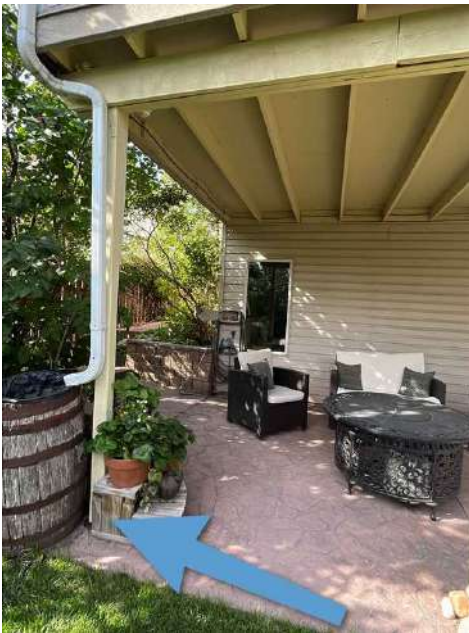
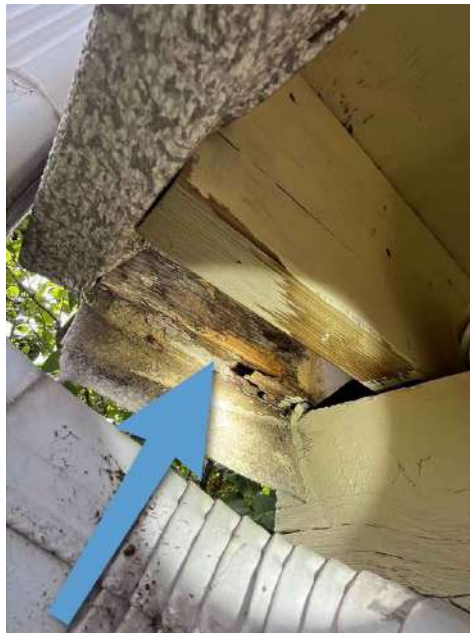
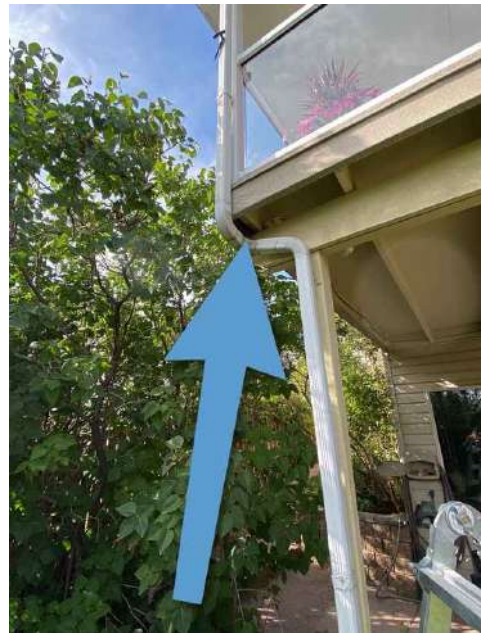
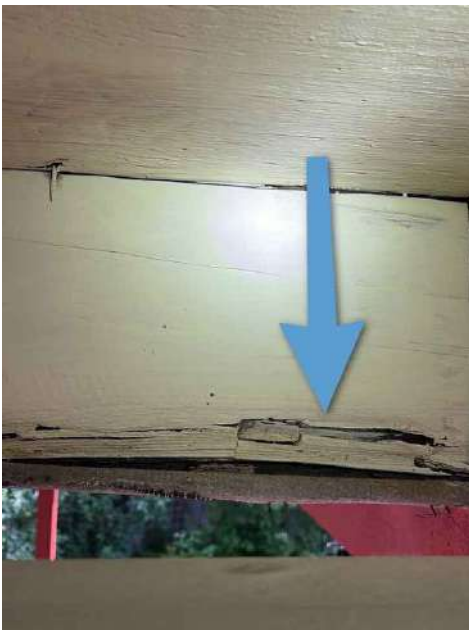
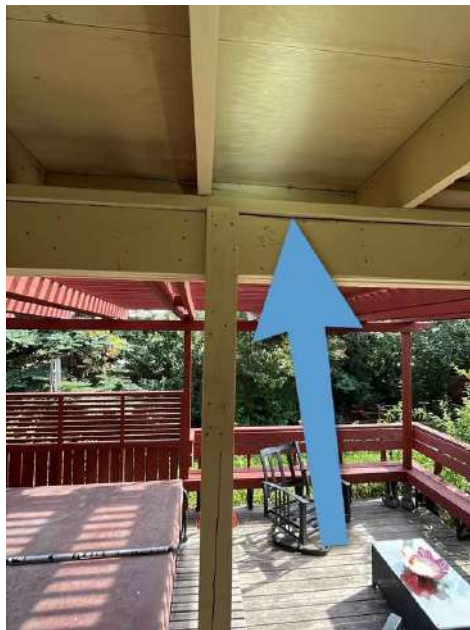
Some rot was noted at the structure. It is recommended to replace the affected materials with rot resistant components.

Recommendation
Contact a qualified carpenter.

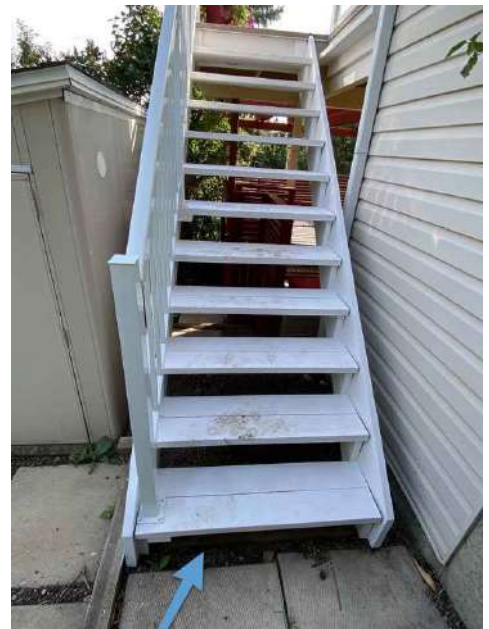
2.7.7 Deck(s)

STAIRS - RISER HEIGHT TOO TALL

Risers should not be more than 7 and 7/8 inches. A qualified carpenter should rectify this.

Recommendation
Contact a qualified carpenter.

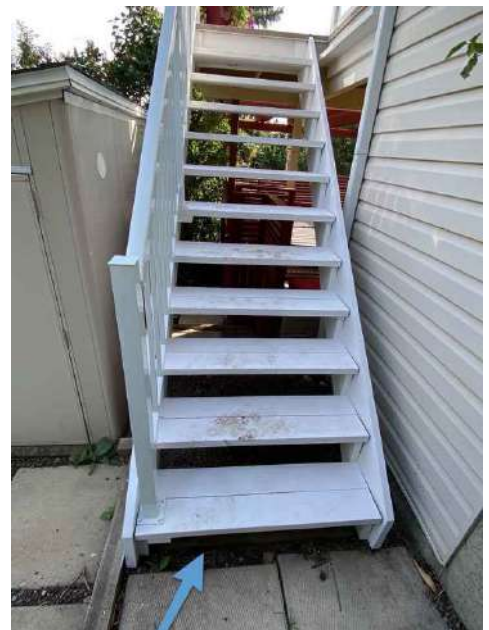
2.7.8 Deck(s)

STAIRS - RISER HEIGHT UNEQUAL

Riser height should be within 13/64 to 25/64 inches on steps to prevent tripping accidents.

Recommendation
Contact a qualified carpenter.

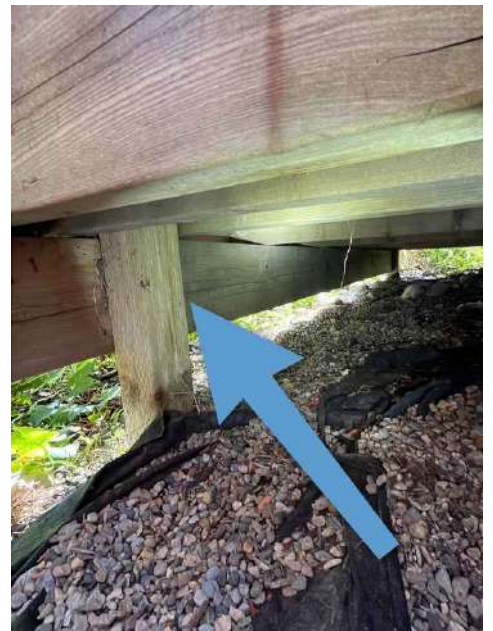
2.7.9 Deck(s)

Unconventional framing methods were noted with the structure. Typically the beam would rest on top of support posts.

Recommendation
Contact a qualified carpenter.

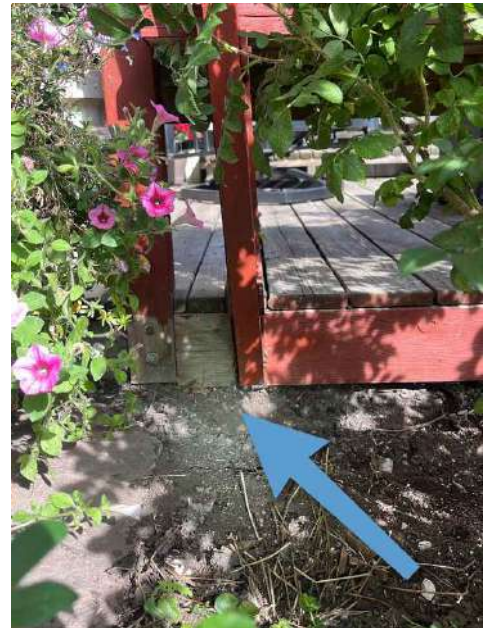
2.7.10 Deck(s)

WOOD SOIL CONTACT

It is recommended that wood not be in contact with soil to mitigate rot.

Contact a qualified professional.

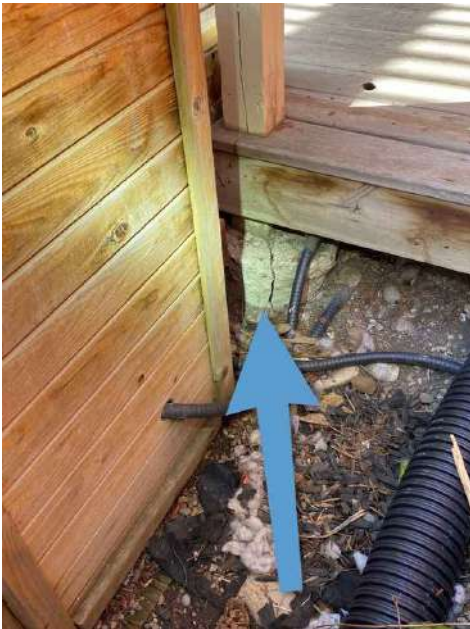
2.7.11 Deck(s)

CRACKED FOOTING

The following footing was found to be damaged. It is recommended to fix.

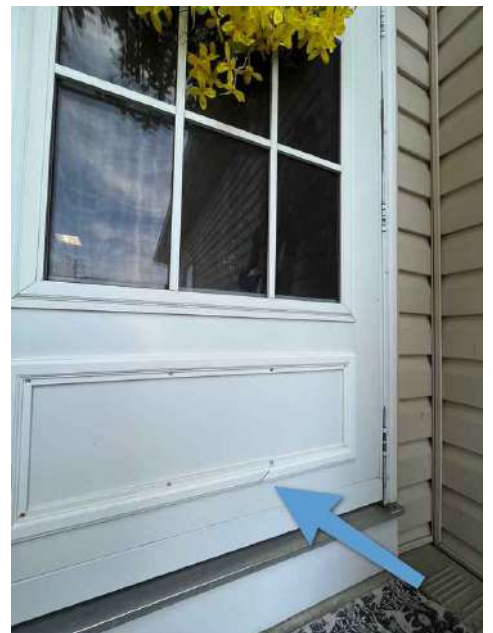
2.8.1 Doors

DAMAGE

One or more doors were noted to have damage.

Contact a qualified door repair/installation contractor.

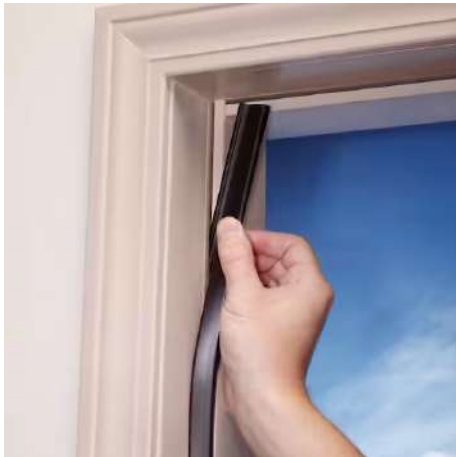
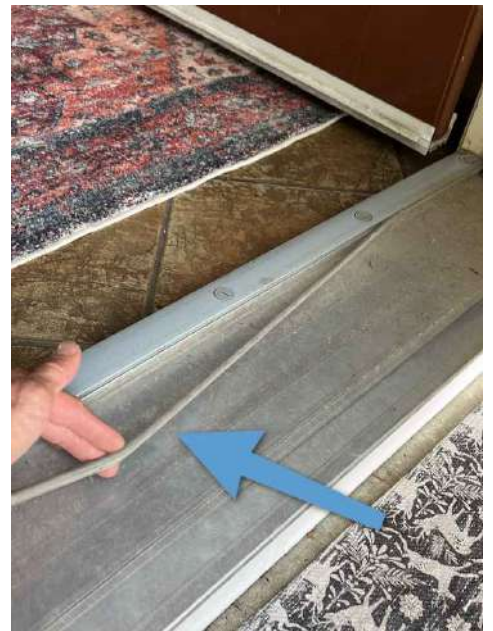
2.8.2 Doors

**WEATHERSTRIPPING
INADEQUATE**

It is recommended to install new weather stripping at the following exterior doors. Weather stripping helps to the seal against the weather.

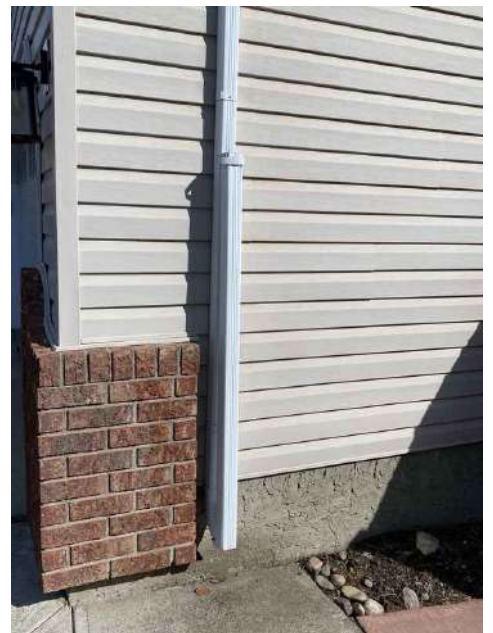
2.9.1 Downspouts / Gutters

DRAIN NEAR STRUCTURE

Downspouts should always be deployed to aid in water expulsion away 6 feet from the structure. Downspout extensions should be secured to downspouts and extended away from the building. This helps to prevent water migrating into the building. Downspouts should be checked for leaks and sealed or replaced if found.

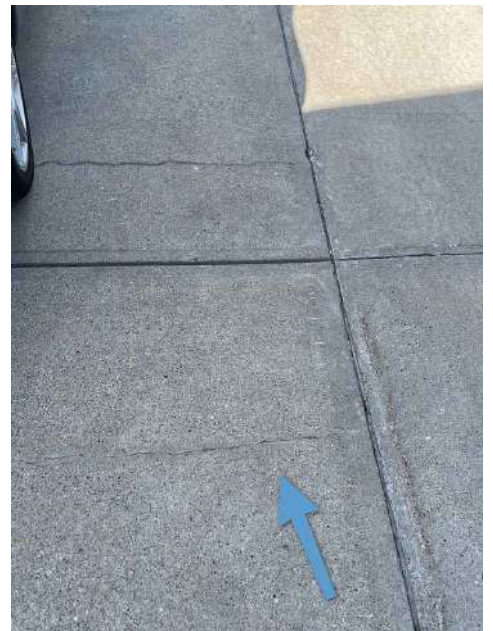
2.10.1 Driveway(s)

CRACKS - CONCRETE

Cracking and or spalling was found at the driveway. A masonry sealant for concrete driveways, such as Sikaflex, can be used which may help prevent further expansion of the cracks by preventing water penetration and further cracking when it freezes in colder temperatures. For asphalt driveways, it is recommended to seal openings with an approved sealant.

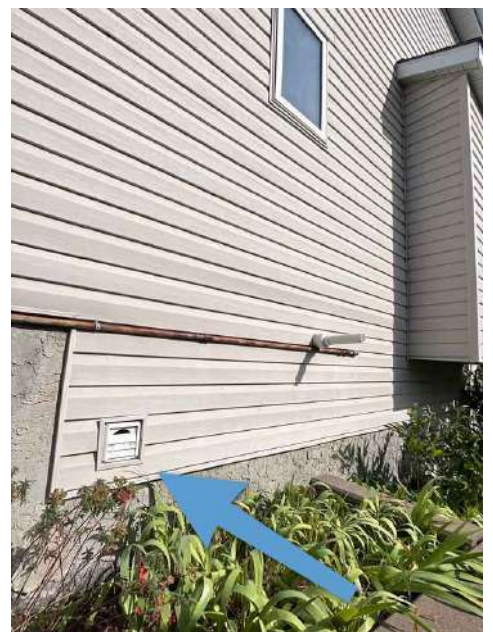
2.11.1 Dryer Vent

VENT DAMAGE

It is recommended to repair or replace the dryer vent.

Contact a qualified professional.

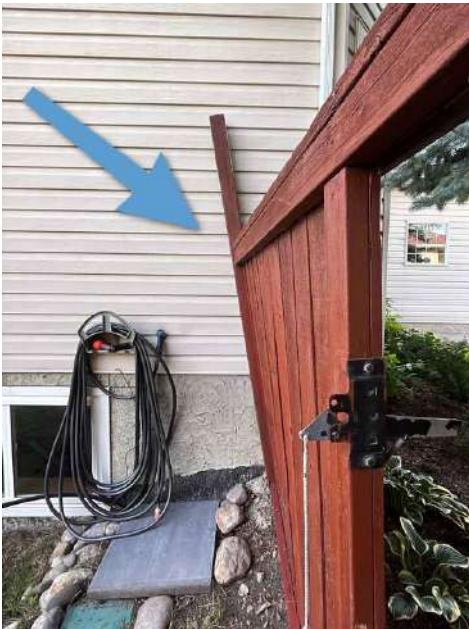
2.15.1 Fence

LEANING

One or more areas of the fence line were noted to be leaning. It is recommended that a qualified contractor repairs this.

Contact a qualified carpenter.

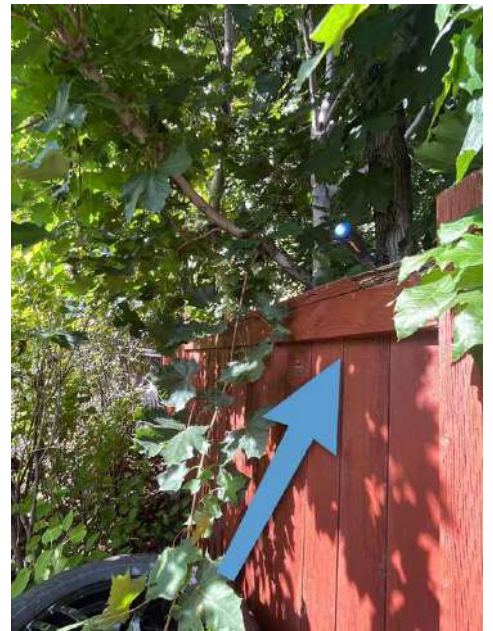
2.15.2 Fence

ROT

Rot was noted in several areas of the fence line. It is recommended to budget for replacement components.

Contact a qualified carpenter.

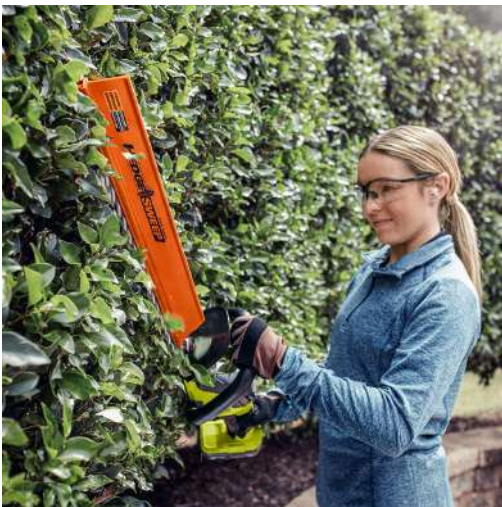
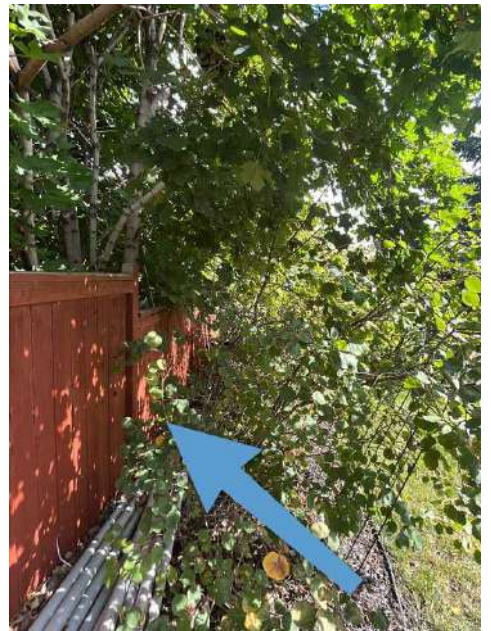
2.15.4 Fence

VEGETATION TOO CLOSE

It is recommended to keep vegetation away from the fenceline as it may push on the fence, harbours critters, and moisture.

Recommendation
Contact a qualified handyman.

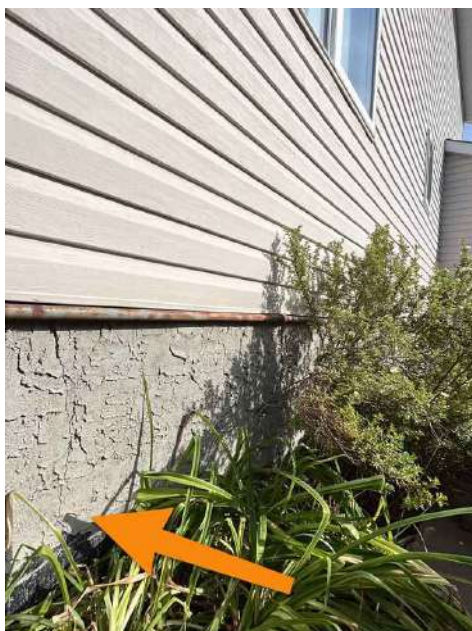
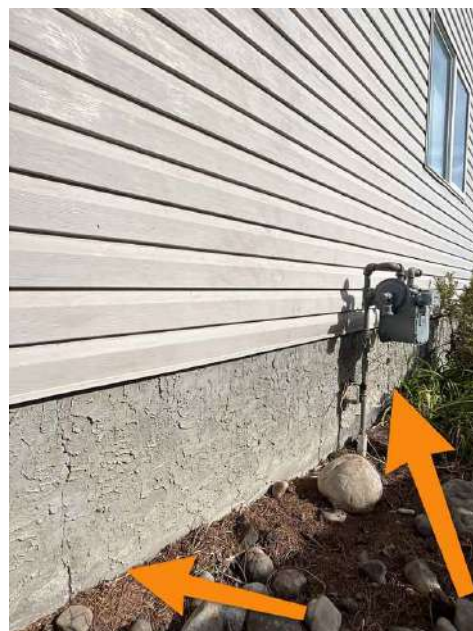
2.17.1 Foundation

CRACK(S) IN FOUNDATION - VERTICAL

One or more cracks in the foundation walls were found. Cracks should be monitored for water penetration and growth. It is recommended that all cracks and fissures be sealed to prevent water migration. An epoxy resin injection should be used on clean dry cracks while a polyurethane foam injection can be used in active and or dirty cracks. It should be noted that the epoxy injection provides structural bearing while the polyurethane foam does not.

Recommendation
Contact a foundation contractor.

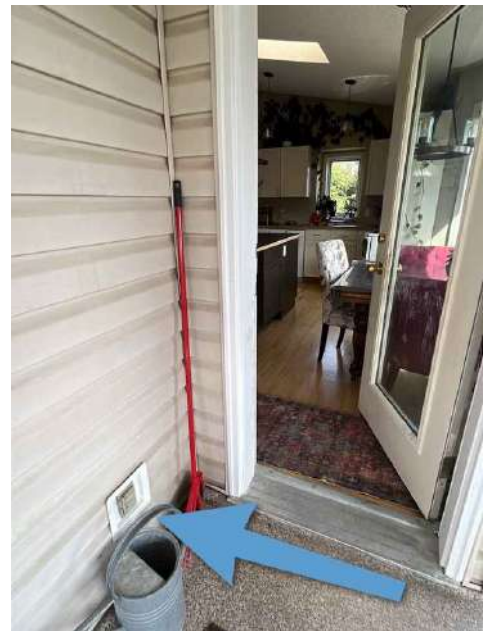
2.21.1 GFCI / Outlets

It is recommended that GFI-protected receptacles be installed when found outside below 2.5 meters. It is recommended to have a qualified electrician install these.

Contact a qualified electrical contractor.

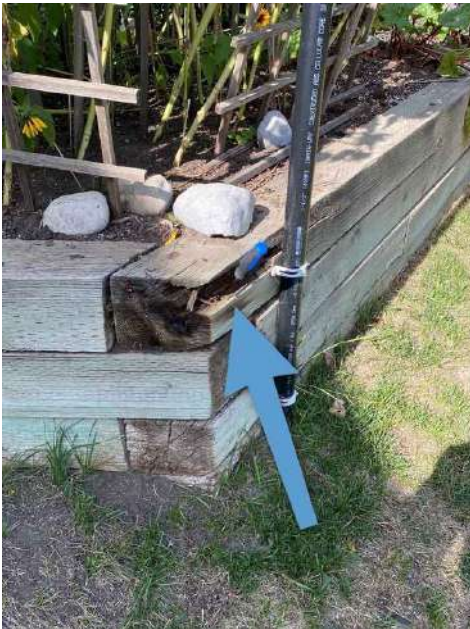
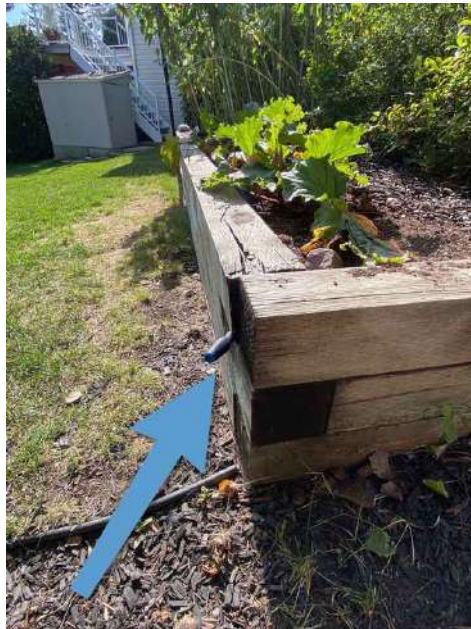
ROT

One or more areas were noted to have rot. It is recommended to budget to repair the affected components.

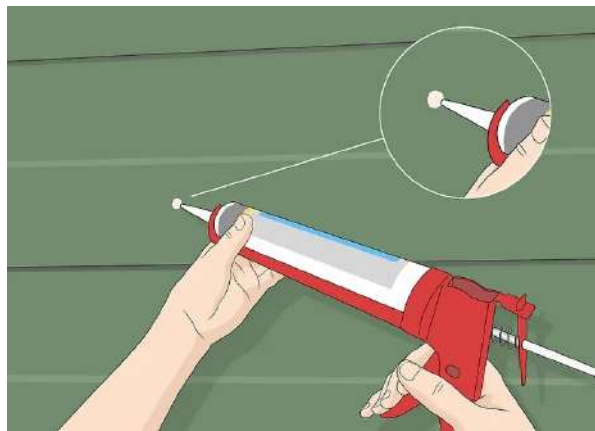
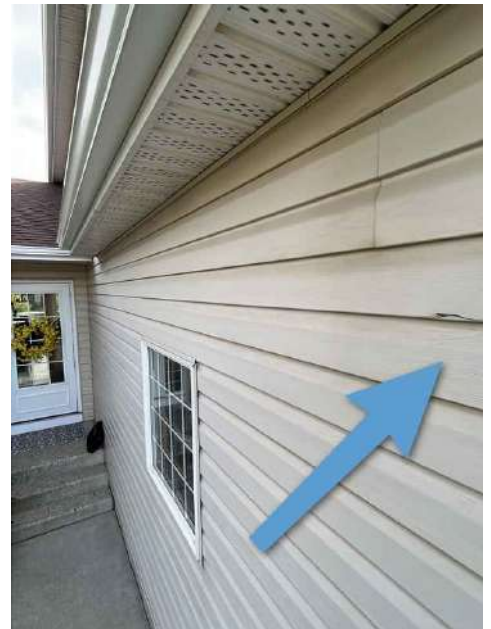
2.33.1 Siding

DAMAGE - VINYL

Damage was noted at the siding. It is always recommended to seal / caulk any gaps and penetrations around the building envelope. Doing so helps prevent weather and critters from entering and damaging the structure.

Recommendation
Contact a qualified siding specialist.

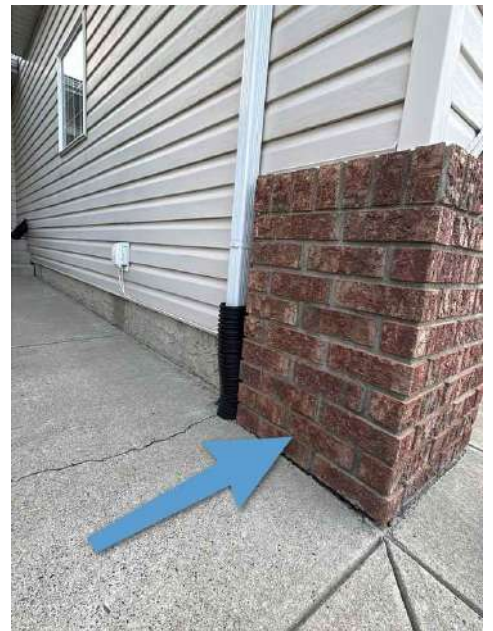
2.33.2 Siding

GROUND CLEARANCE

It is recommended to have a minimum 6" clearance between the siding and the grading of the structure to allow the air to wick away any water on the exterior wall. Siding that is adversely affected by moisture requires 8" clearance from grade. In addition, this helps mitigate damaging the siding from freezing water.

Too close to grade

Recommendation
Contact a qualified siding specialist.

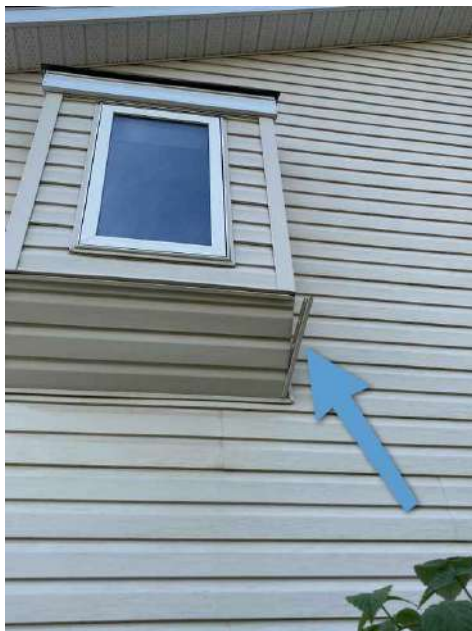
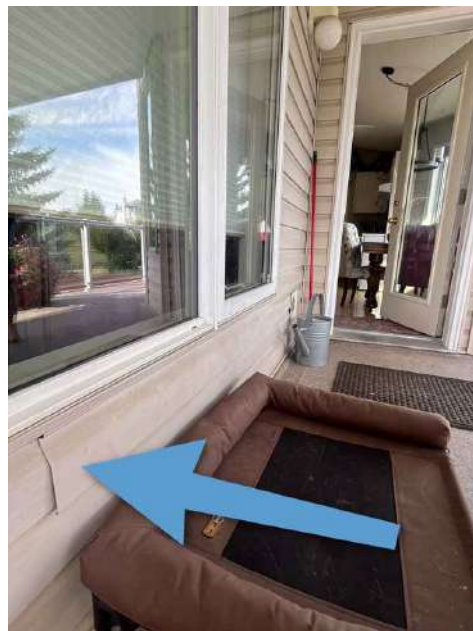
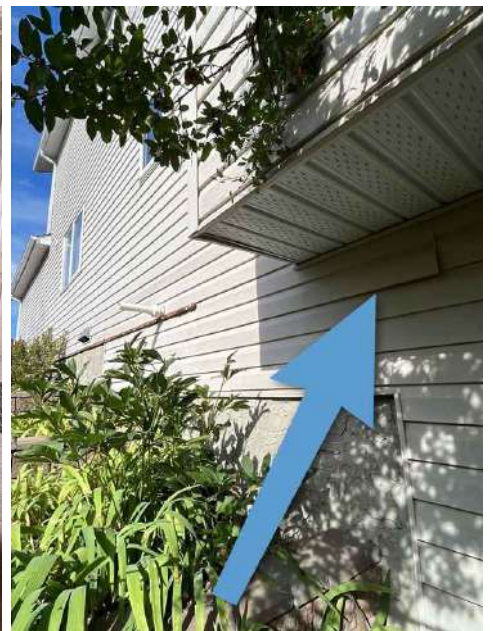
2.33.3 Siding

LOOSE SIDING

It is recommended that siding be properly attached to prevent weather damage.

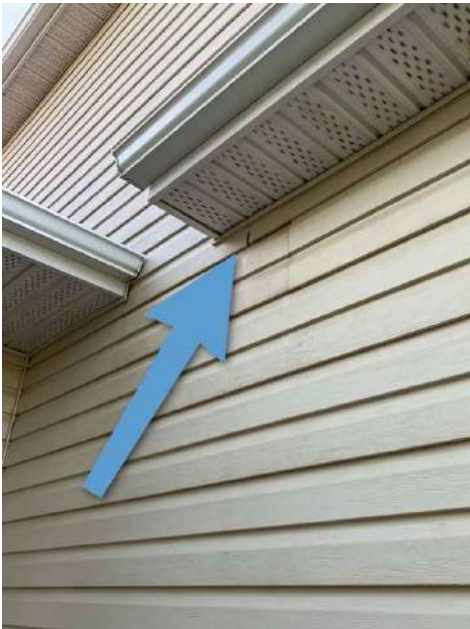
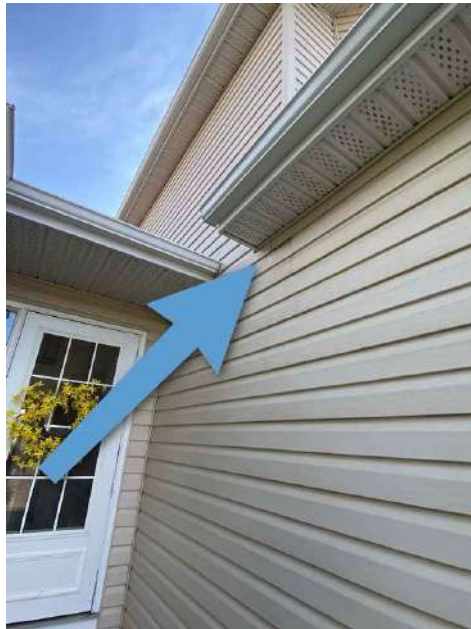
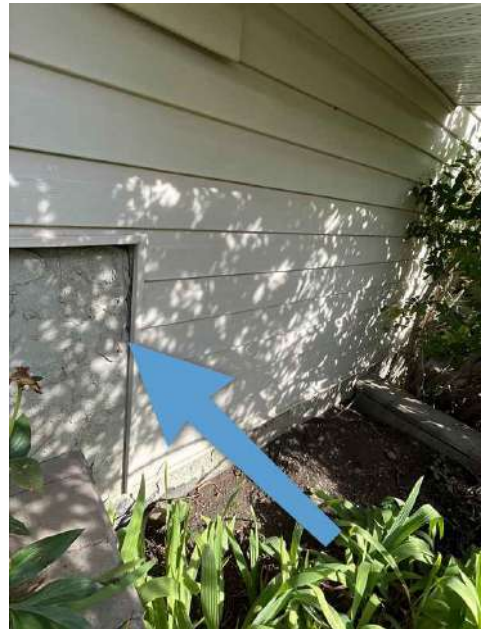
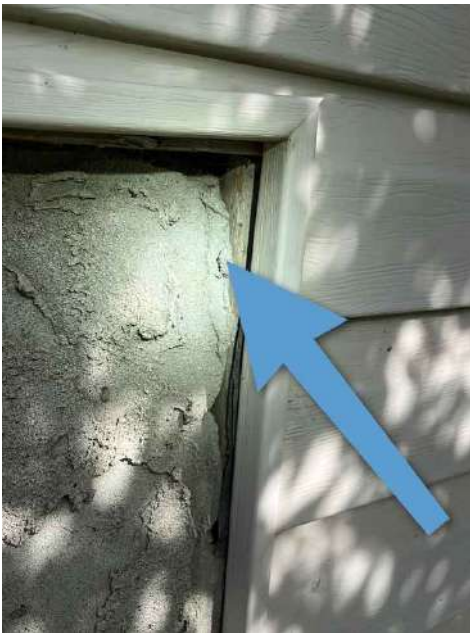
It is always recommended to seal / caulk any gaps and penetrations around the building envelope. Doing so helps prevent weather and critters from entering and damaging the structure.

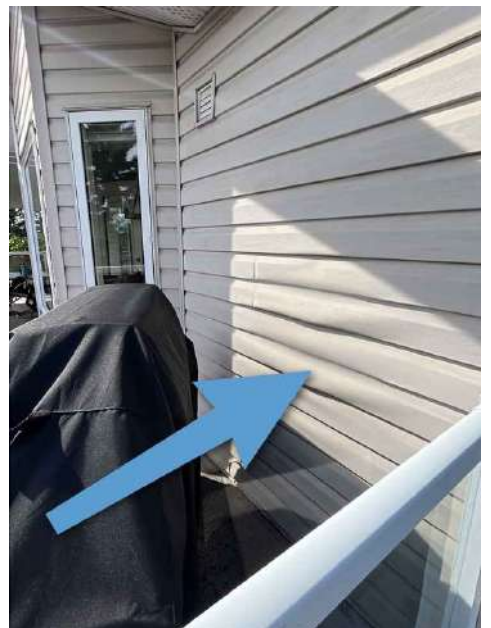
2.33.5 Siding

WARPING/BUCKLING

Contact a qualified siding specialist.

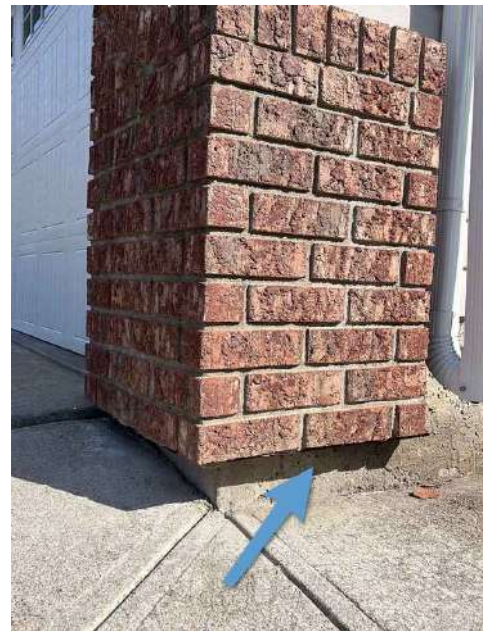
2.33.6 Siding

WEEP HOLES MISSING

Weep holes were noted to be missing. It is recommended these be added every 32" at a minimum to allow water drainage from between the brick and the structure.

Contact a qualified masonry professional.

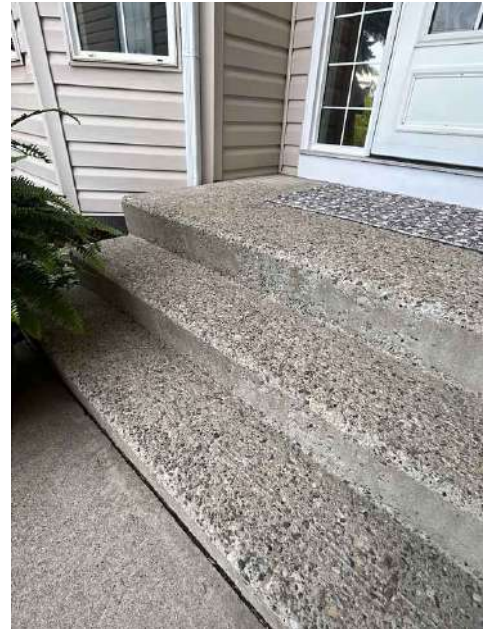
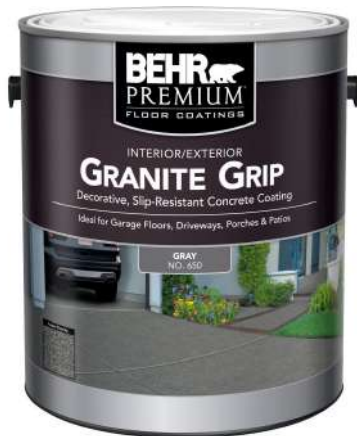
CRACKS / SPALLING IN STAIRS

The entrance steps were given a brief inspection. Typical cracks and spalling were noted. It is recommended these areas be repaired to prevent further deterioration.

Contact a qualified concrete contractor.

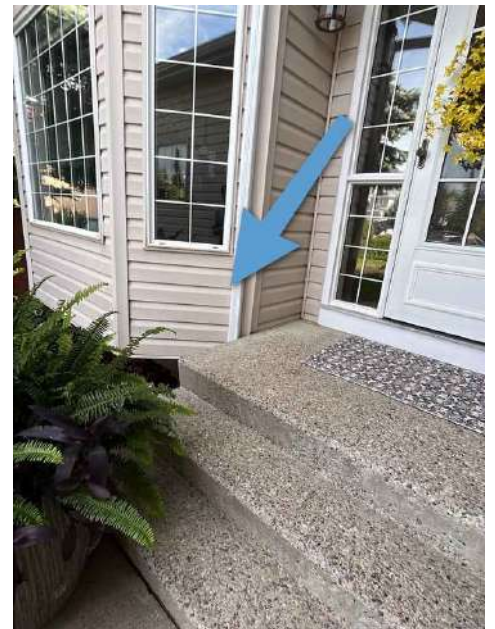
HANDRAILS RECOMMENDED

It is recommended to install handrails and balusters to help prevent falling incidents.

Contact a qualified carpenter.

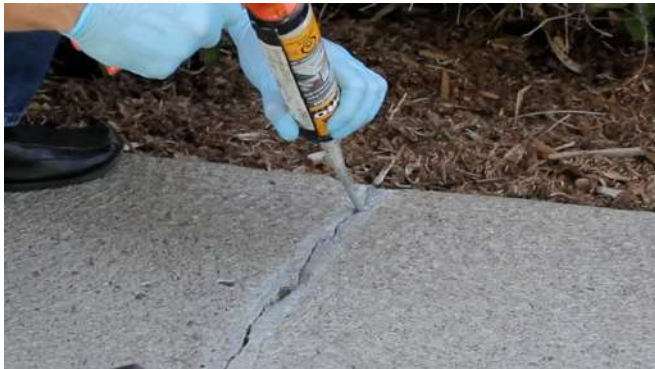
CRACKS / DAMAGE

Typical cracking and or spalling was found at the walkway. A masonry sealant, such as Sikaflex, can be used which may help prevent further expansion of the cracks by preventing water penetration and further cracking when it freezes in colder temperatures.

Recommendation
Contact a qualified landscaping contractor

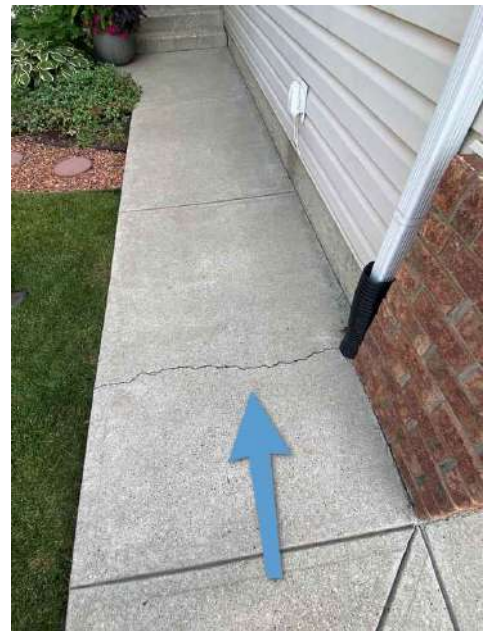
2.43.2 Walkway(s)

It is recommended to have level walkways to prevent tripping hazards.

Recommendation
Contact a qualified landscaping contractor

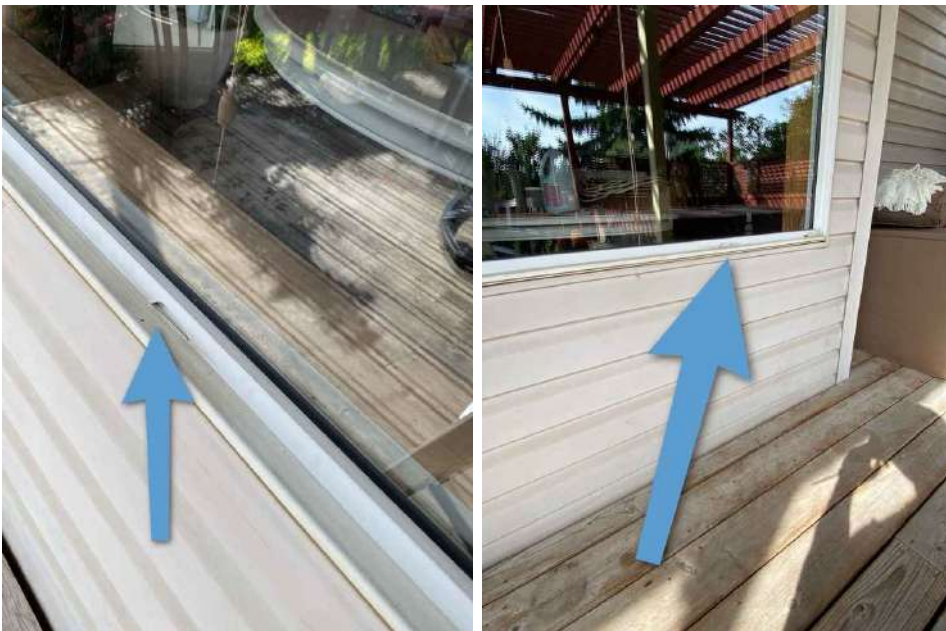
2.44.2 Windows

SEAL / GLAZING FAILURE

One or more windows appear to have a failed glazing / seal. Although often considered a cosmetic issue, mold and wood rot may be a side product in the future. It is recommended to budget to replace the unit.

Recommendation
Contact a qualified window
