PROPERTY REPORT

1234 Main Street
Calgary, AB T3K3V9

Buyer Name
09/17/2024 9:00AM

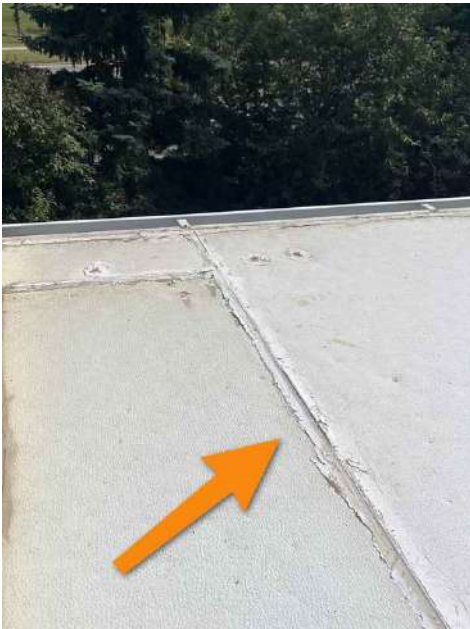
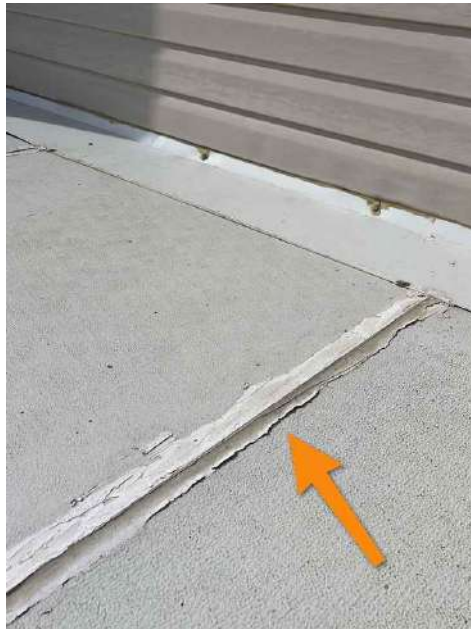
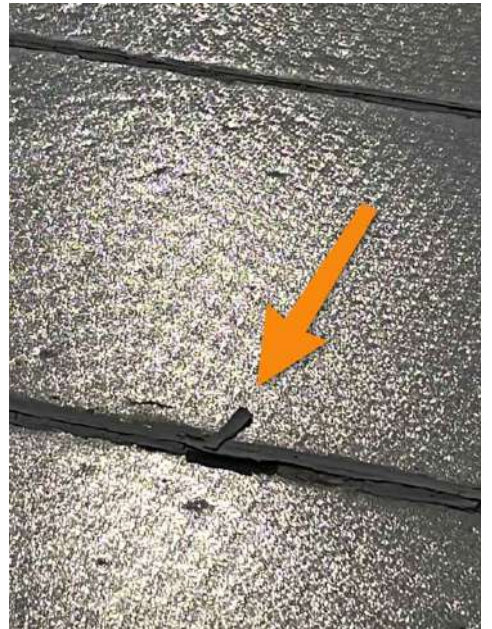
DETERIORATING SEALANTS

Various areas were noted to have sealants that are deteriorating. These should be budgeted to be repaired.

Contact a qualified roofing professional.

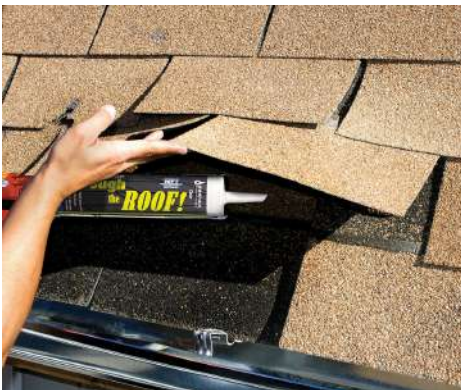
3.2.2 Coverings

LOOSE

Some of the roof covering materials were noted to be loose on the roof line. It is recommended to better secure the units.

Recommendation
Contact a qualified roofing professional.

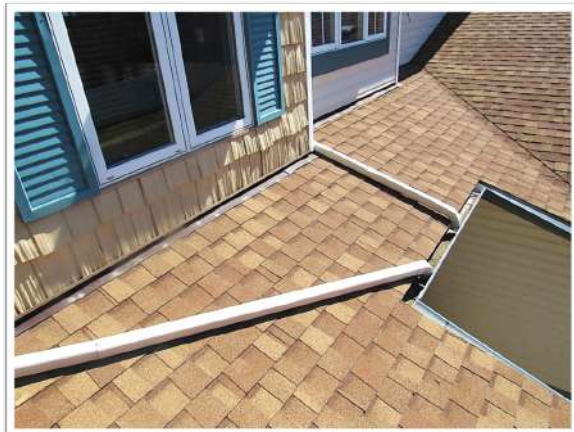
3.3.2 Downspouts / Gutters

DISCHARGE ONTO LOWER ROOF

It is recommended that all downspout and gutter discharge from upper to lower roofs be connected to the nearest gutter system via downspout extension. This prevents the premature erosion of the roof covering materials directly below the downspout from the upper roof.

Recommendation
Contact a qualified gutter contractor

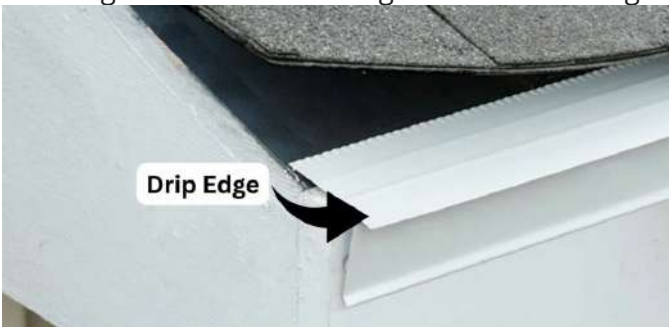
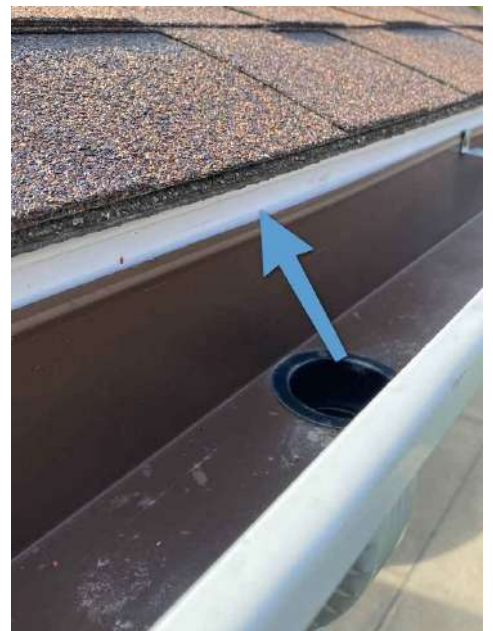
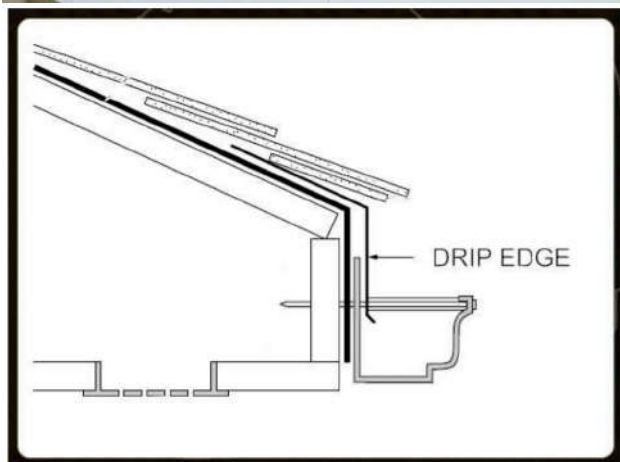
3.4.1 Flashings

DRIP EDGE NOT INSTALLED

No drip edge flashing was noted on the roof line. While this is not a requirement, it is recommended drip edge flashing be added as it helps to prevent water migrating up and underneath the roof covering material and rotting out the sheathing below.

Recommendation
Contact a qualified roofing professional.

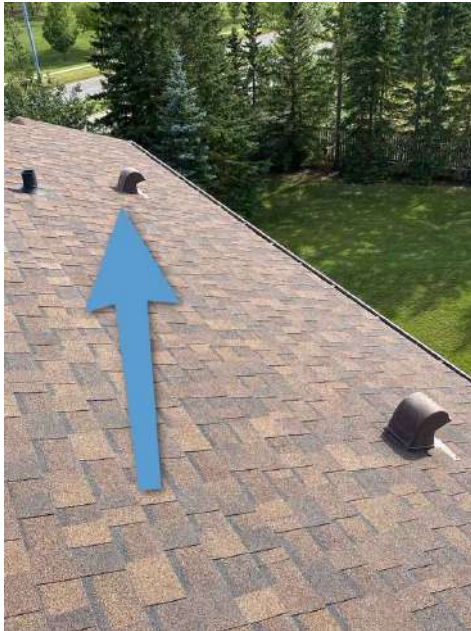
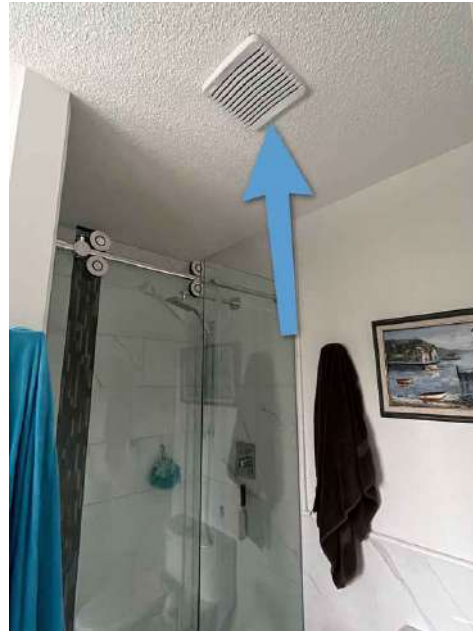
3.8.1 Roof Vents

INADEQUATE AIR MOVEMENT - VENTILATION FAN

Inadequate air flow was noted at the following fan(s). This should be further investigated.

Contact a qualified handyman.

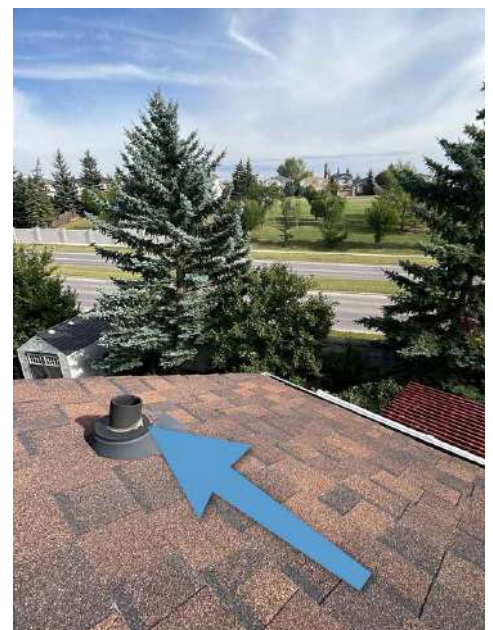
3.11.1 Vent Stacks

VENT PIPE SIZE - TOO SHORT

It is recommended to upsize the following vent termination to mitigate frost enclosure during the colder season.

Contact a qualified plumbing contractor.

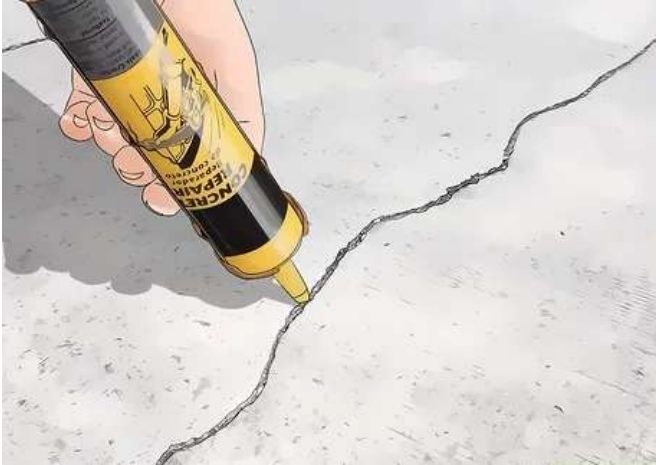
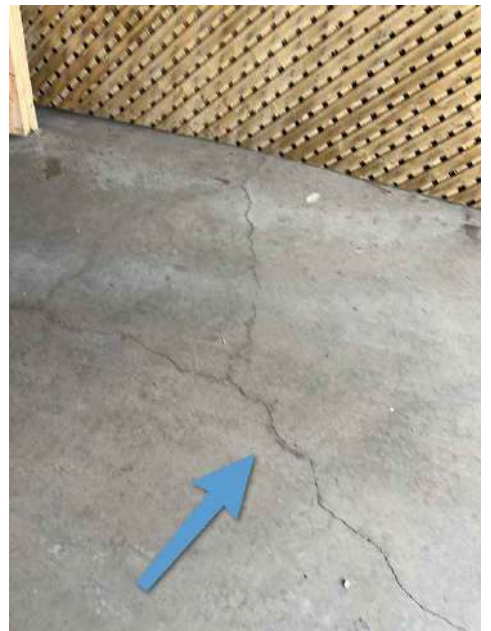
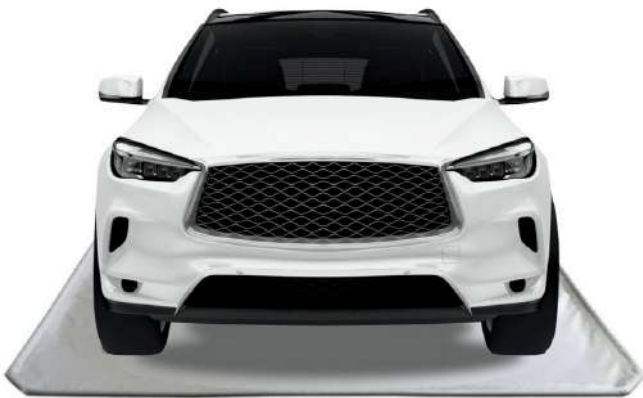
4.10.1 Floor

TYPICAL CRACKS

Typical cracks and spalling were noted on the garage concrete slab. It is recommended to seal these areas to prevent further deterioration. A concrete based sealer, such as Sikaflex, may be used.

Recommendation
Contact a qualified driveway contractor.

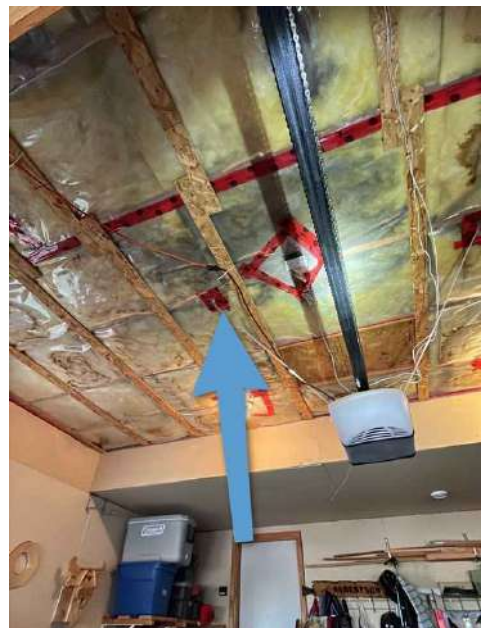
Extension cords should not be used as a permanent power source.

Recommendation
Contact a qualified electrical contractor.

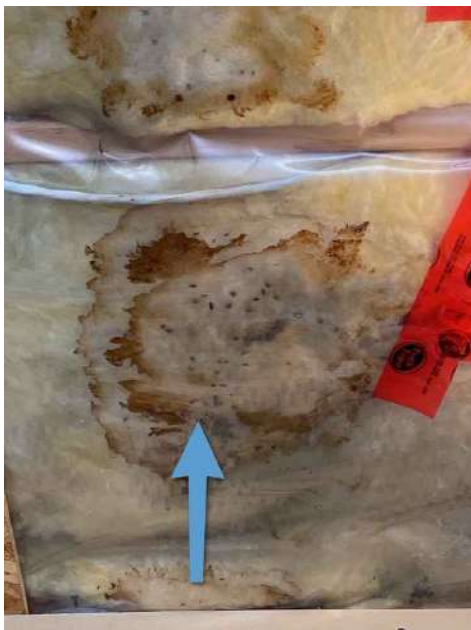
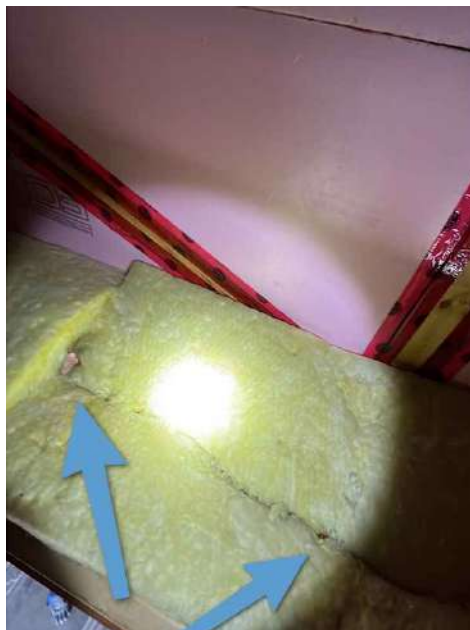
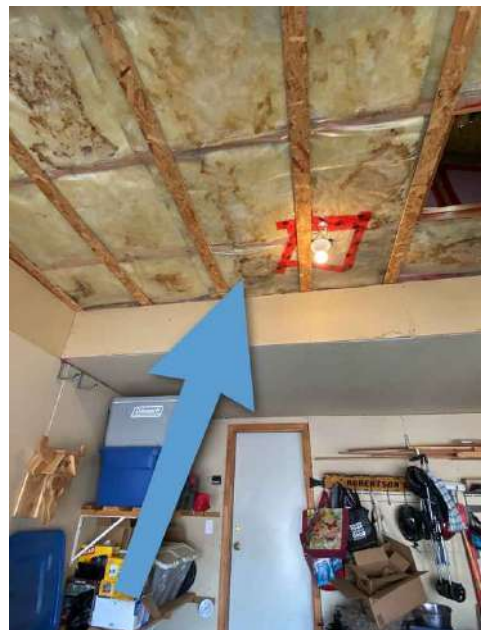
4.17.1 Hazardous Materials

EVIDENCE OF VERMIN

Evidence of vermin was noted at the structure. It is recommended these be removed and traps or possible pest control expert employed.

Recommendation

Contact a qualified pest control specialist.

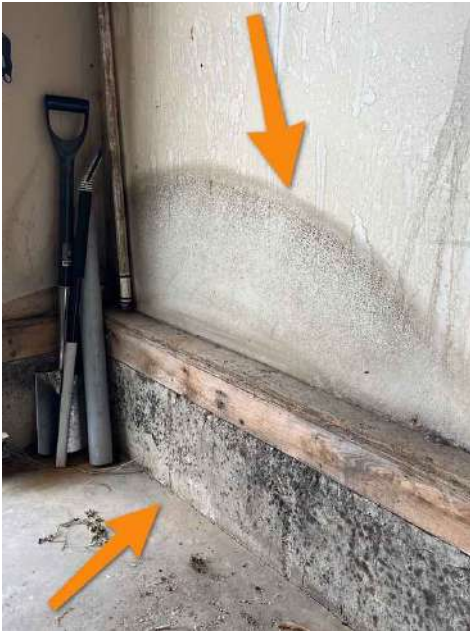
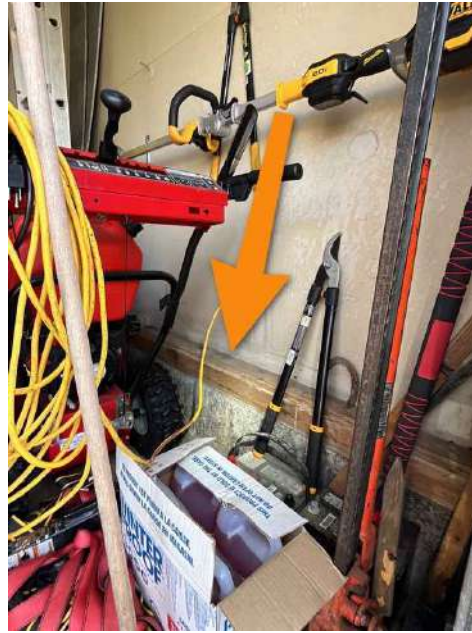
4.17.2 Hazardous Materials

POSSIBLE ORGANIC GROWTH

One or more areas were found to have, what appears to be organic growth. It is recommended to remove this by either using a mold killing agent or replacing the building material. With any renovations, additional signs of water damage may be found.

Recommendation

Contact a qualified mold remediation contractor

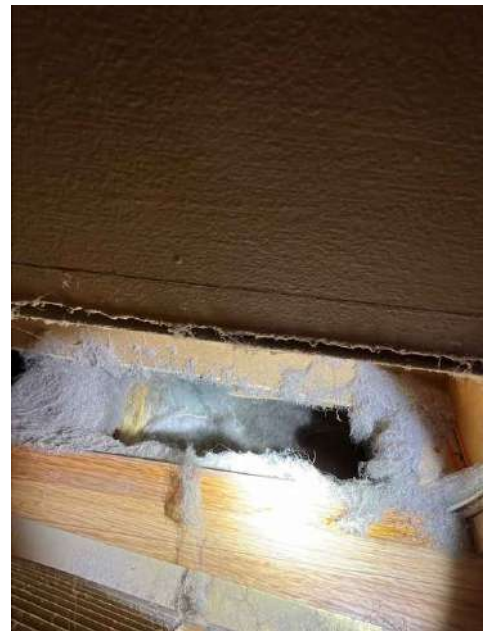
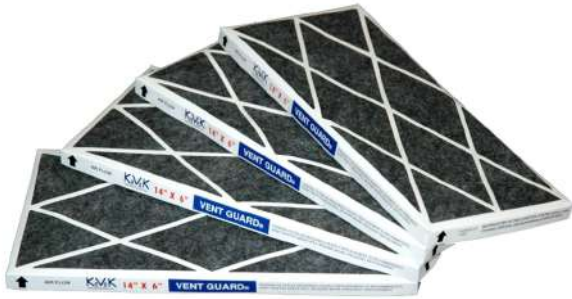
Debris was found in the duct work. These should be cleaned every 3-5 years depending on use. Dirty duct work can affect the quality of air in the structure resulting in allergy like symptoms. Occupants may install filtered return air duct grilles, but this installation should be consulted with an HVAC installer to ensure adequate air flow reaches the mechanical system. These can be readily purchased from local hardware stores.

Recommendation
Contact a qualified HVAC professional.

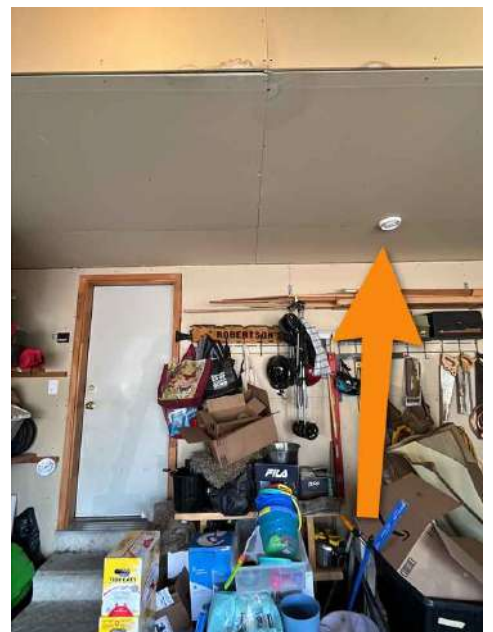
5.4.2 Distribution Systems

HVAC systems should not be shared between dwellings and garages. This should be terminated.

Recommendation
Contact a qualified HVAC professional.

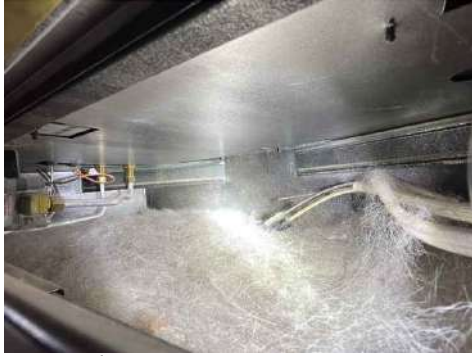
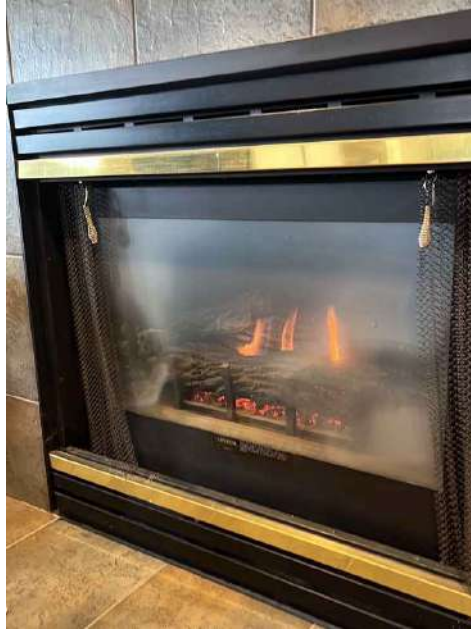
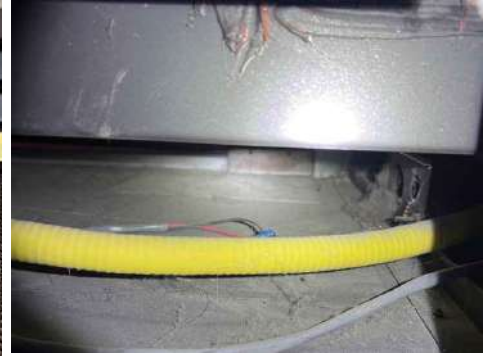
5.6.1 Gas Fireplace

CLEAN / SERVICE UNIT

It is recommended to clean the unit.

Recommendation

Contact a qualified fireplace contractor.

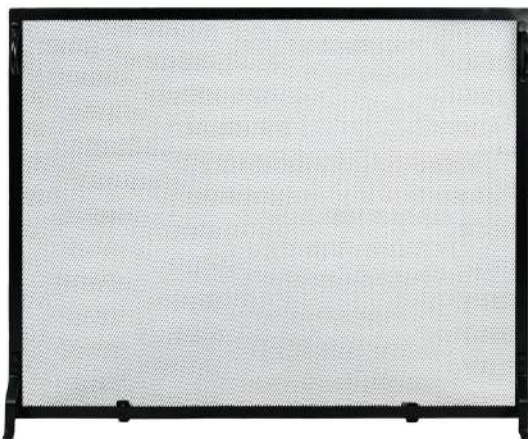
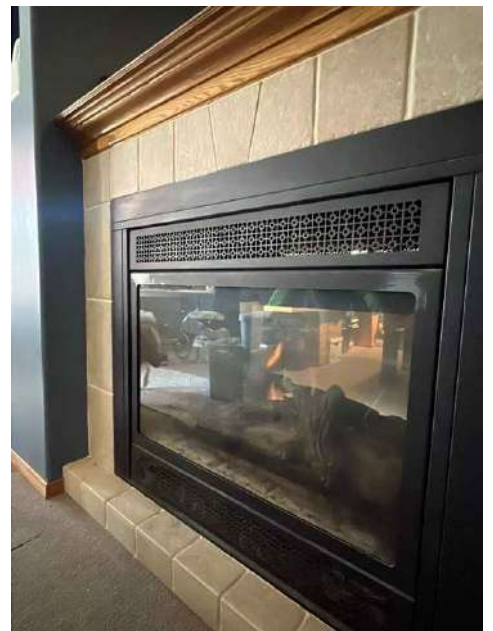
5.6.2 Gas Fireplace

NO SCREEN

It is recommended to install metal screens for fireplaces to prevent burns.

Recommendation
Contact a qualified
fireplace contractor.

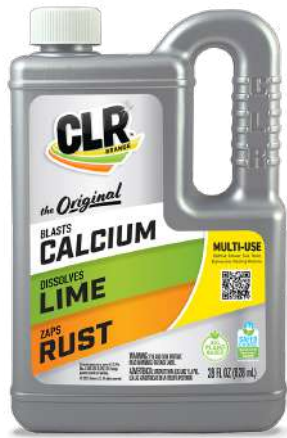
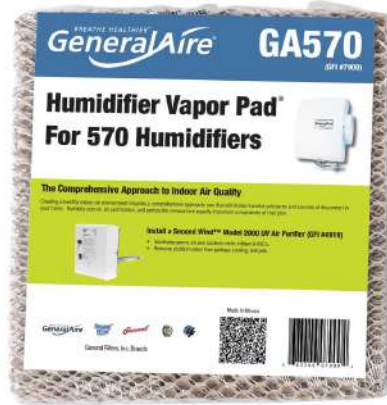
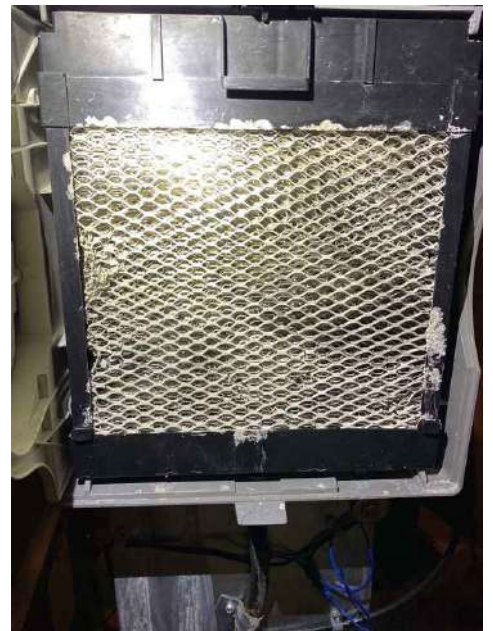
5.10.1 Humidifier

DIRTY PAD

It is recommended to clean or replace the pad as it was noted to have build up.

Recommendation

Contact a qualified professional.

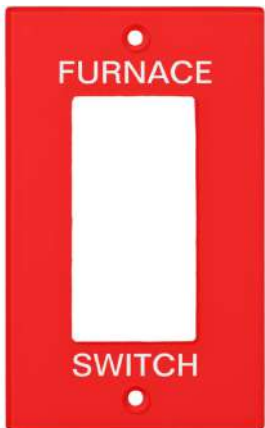
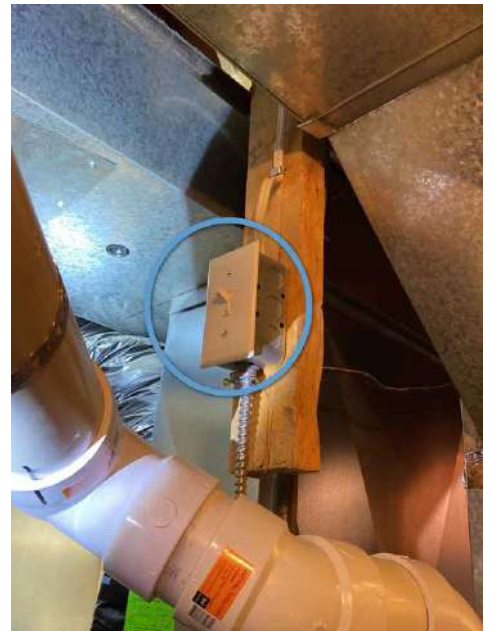
It is recommended to label disconnect switches.

Recommendation

Contact a qualified professional.

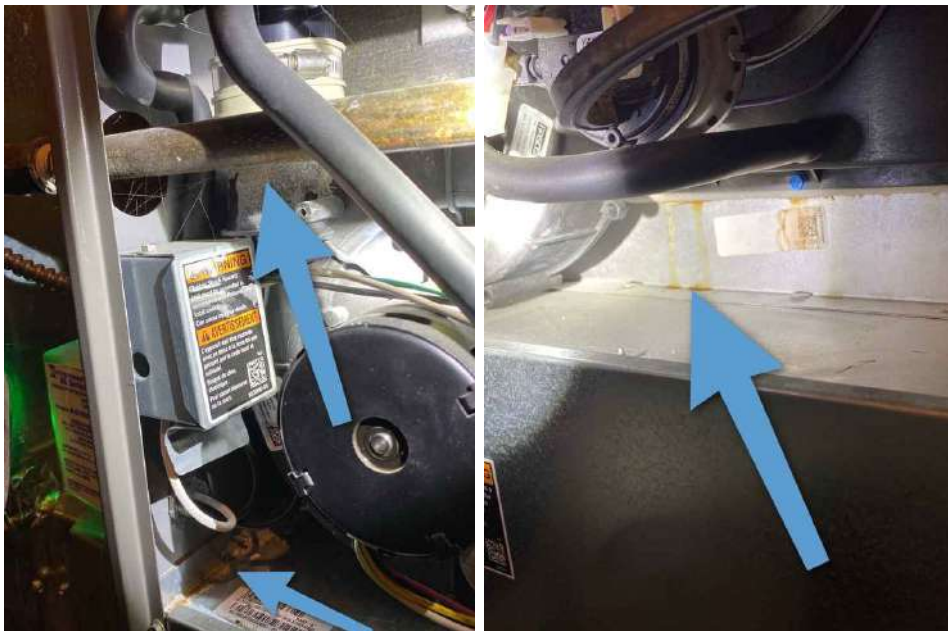
WATER MARKS NOTED - CAT. 4

While no active leaks were found in the following heat source, water marks were noted. It is recommended to service and monitor the unit.

Recommendation

Contact a qualified HVAC professional.

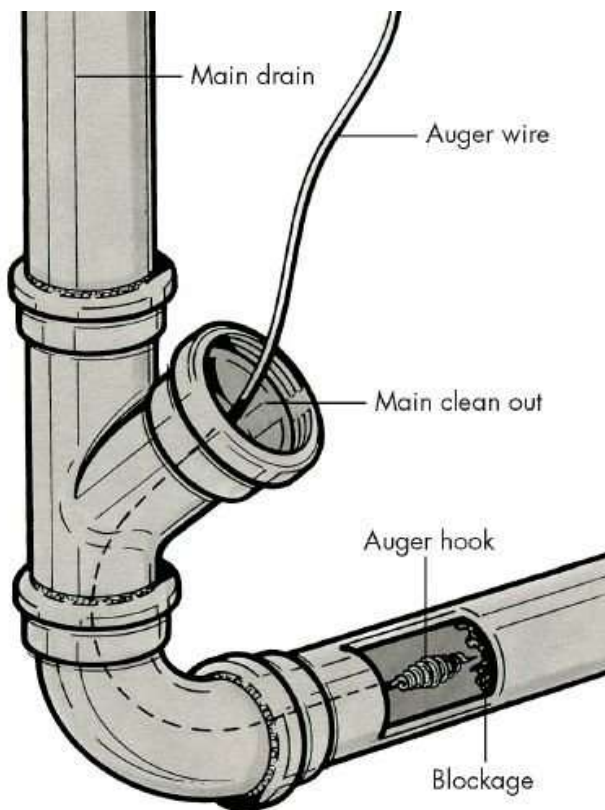
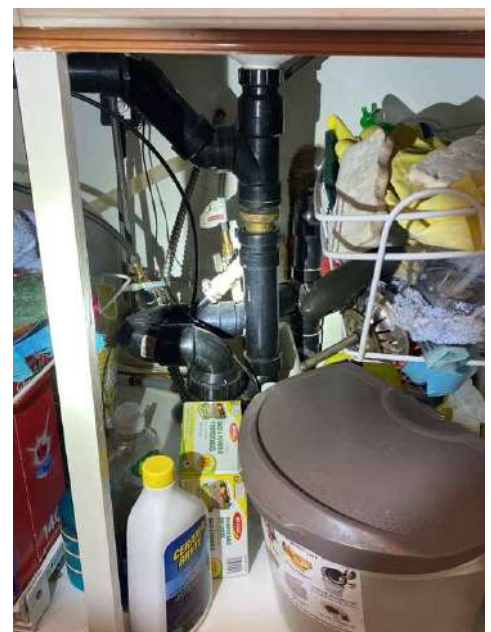
Kitchen

CLEAN OUT MISSING

It is recommended to have clean outs for cleaning.

Recommendation

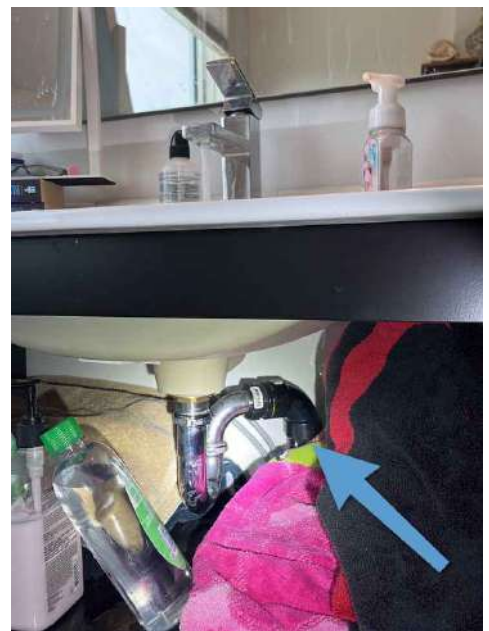
Primary Bathroom

IMPROPER TRAP

It is recommended that fixtures have vented p-traps to prevent siphoning. A qualified plumber should rectify this.

Recommendation
Contact a qualified plumbing contractor.

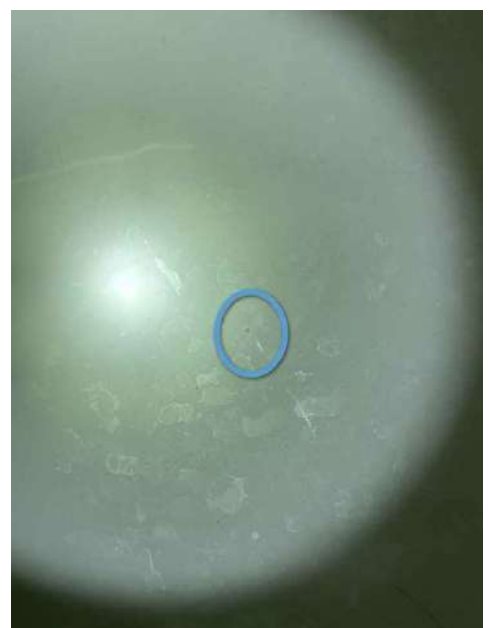
Upper Floor Bathroom

DAMAGE

Damage was noted at one or more fixtures. It is recommend to repair or replace the affected components.

Recommendation

Contact a qualified plumbing contractor.

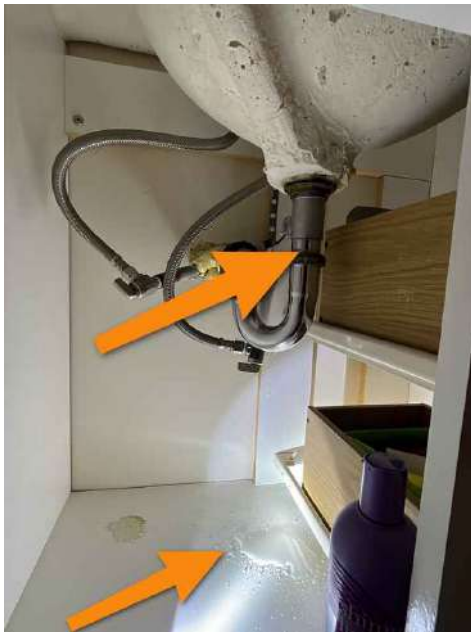
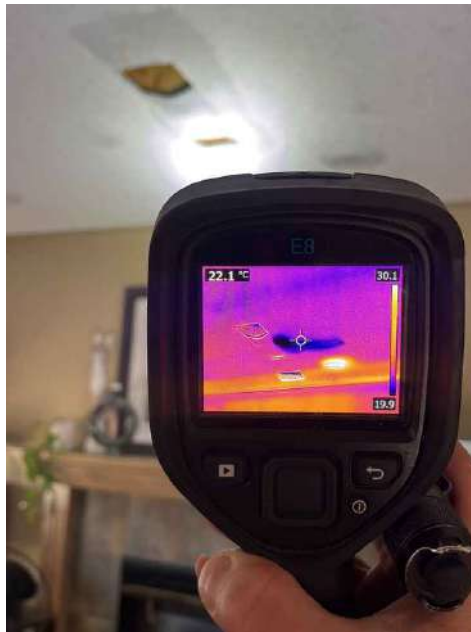
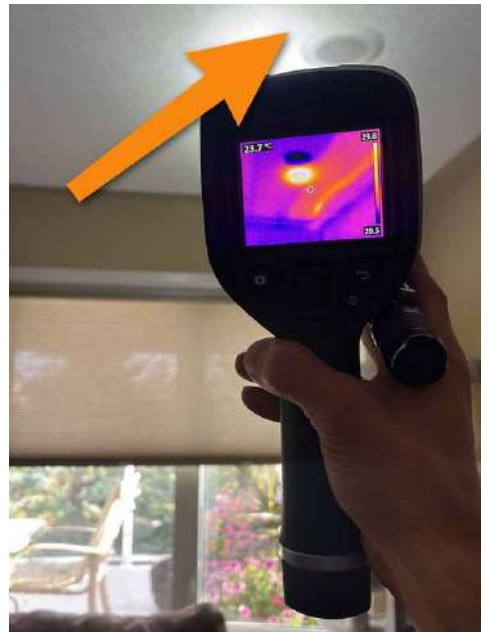
Basement Bathroom

LEAK

One or more leaks were noted during the inspection. It is recommended these be repaired.

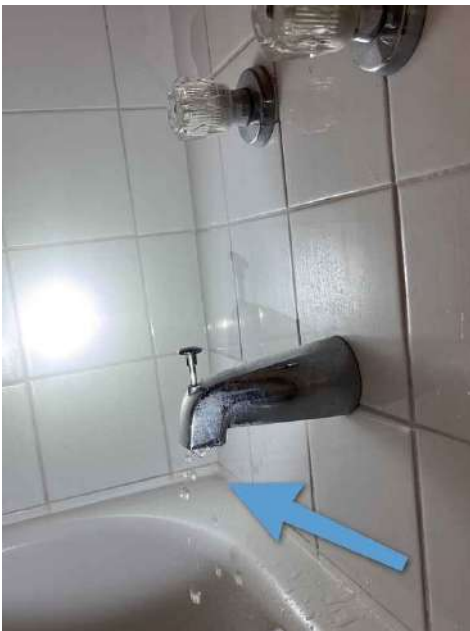
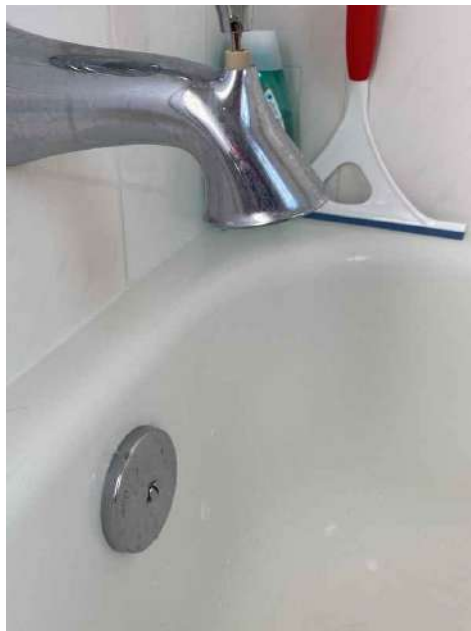
Upper Floor Bathroom

One or more shower diverters did not function as well as it is intended. Repair or replacement may be needed if increased enjoyment is desired.

Recommendation
Contact a qualified plumbing contractor.

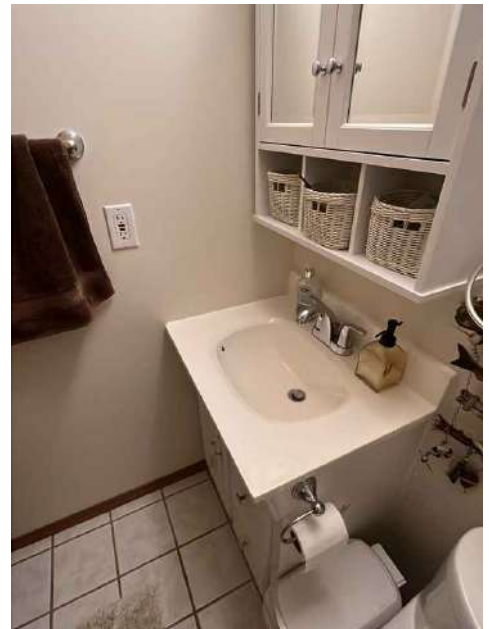
Basement Bathroom

One or more fixtures were noted to have a slow drain; this should be serviced to provide adequate drainage. Pouring baking soda followed by vinegar may help break up obstructions down hole if debris is the culprit.

Recommendation
Contact a qualified plumbing contractor.

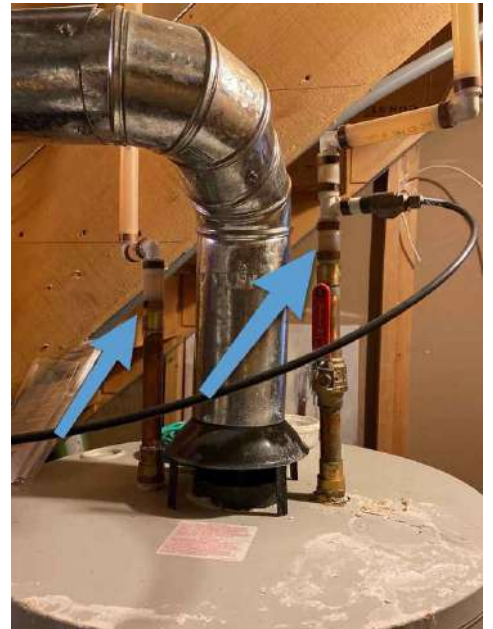
B vent clearance is a minimum of 1" from combustibles while C vents require 6". The clearance was not met in the following area(s). It is recommended that a qualified professional rectify this.

Recommendation
Contact a qualified plumbing contractor.

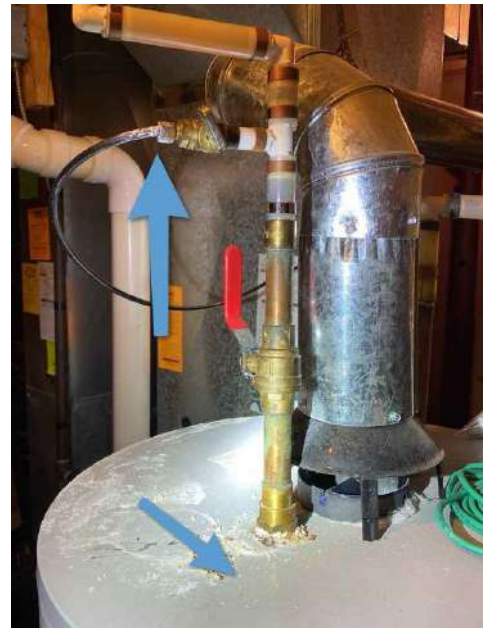
Water marks were noted at the water heater. It is recommended to inquire about the history of the event.

Recommendation

Contact a qualified plumbing contractor.

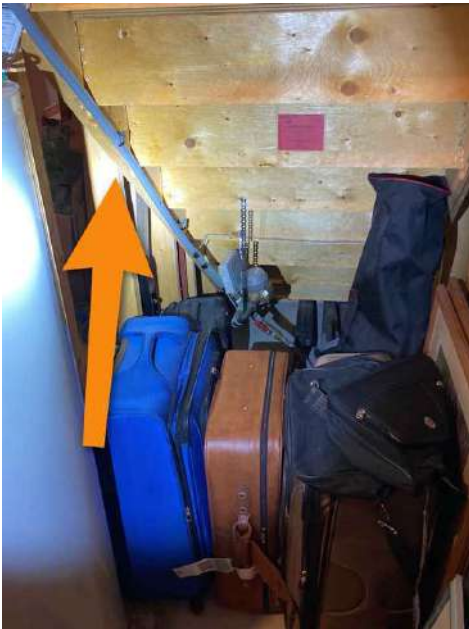
Polybutylene piping was found in the structure. This type of piping was prone to leak at the connection joints. It is recommended that this pipe be monitored for leaks. It is recommended that the potential buyer(s) inquire with the insurance provider to see if this material poses a concern for insuring the structure. This material was typically used between 1985 - 1995. Currently TD and Intact accept polybutylene lines for insurance purposes within a dwelling.

Recommendation

Contact a qualified plumbing contractor.

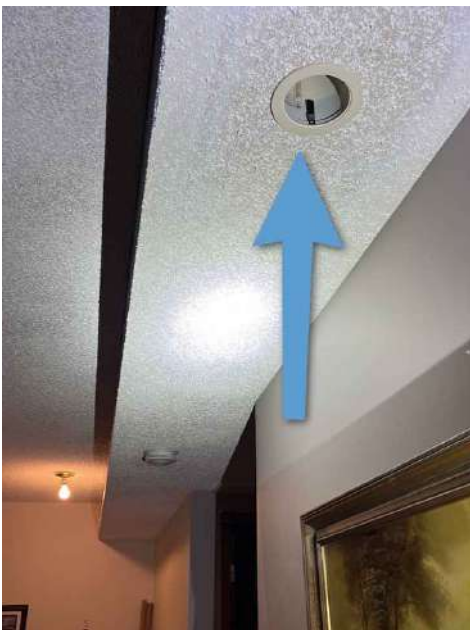
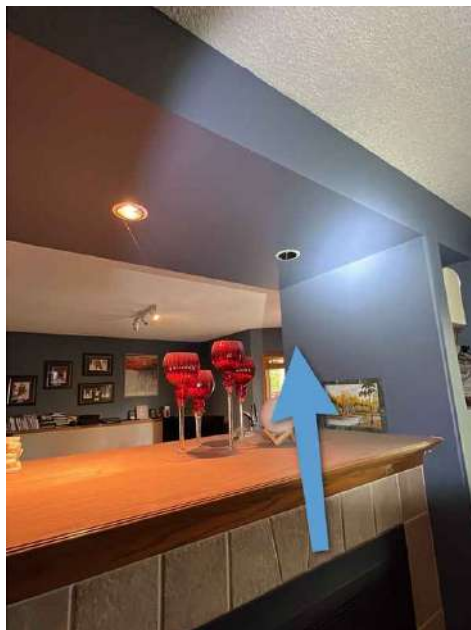
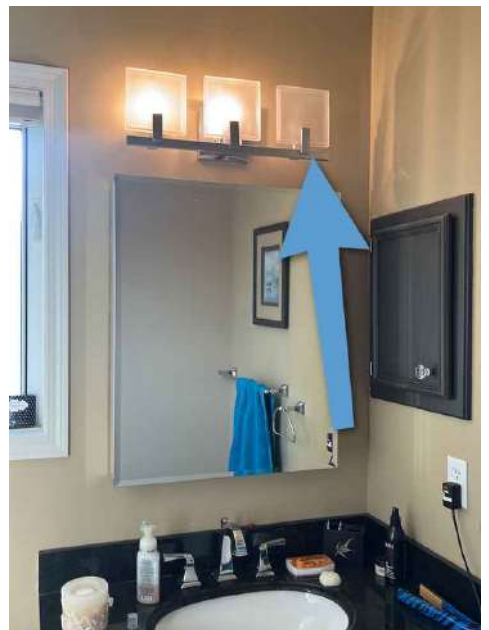
7.6.1 Lighting Fixtures

INOPERATIVE

One or more luminaries (lights) were found inoperative. This may be due to burnt bulbs, or could be a wiring / transformer issue, or operator error.

Contact a qualified electrical contractor.

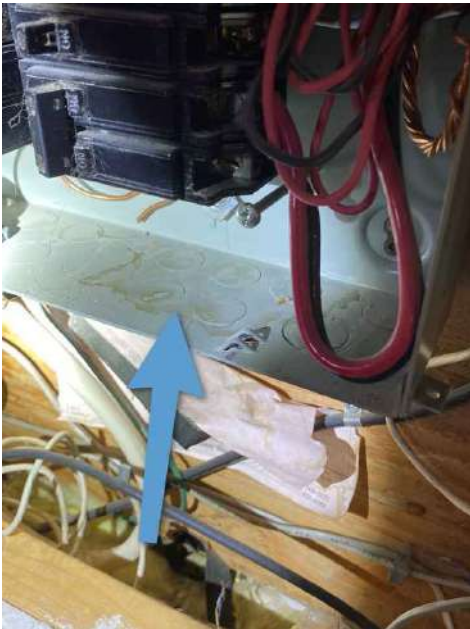
7.7.1 Main Panelboard

WATER MARKS

Water marks were noted in one or more areas of the panelboard. While no active moisture was noted during the inspection, the area should be monitored.

Contact a qualified electrical contractor.

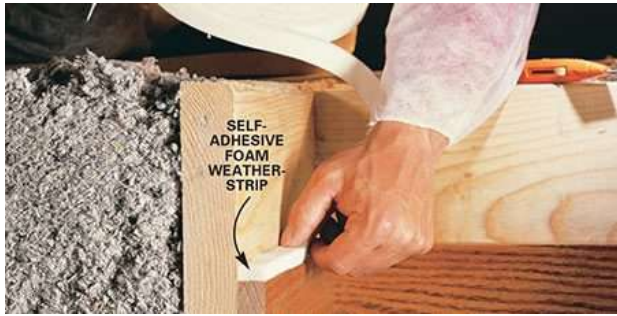
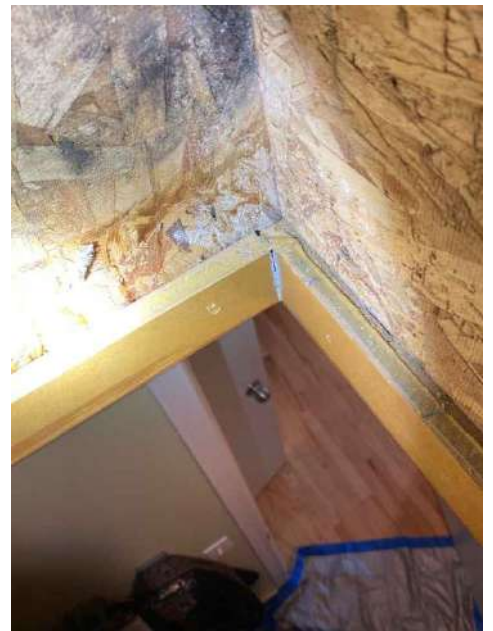
8.1.1 Attic & Foundation

ATTIC HATCH WEATHER STRIPPING DETERIORATED

The weather stripping in the attic hatch should be replaced as it is deteriorating. Weather stripping prevents warm and cold air contacting one another causing condensation (water) which is a precursor to mold development.

Recommendation
Contact a handyman or DIY project

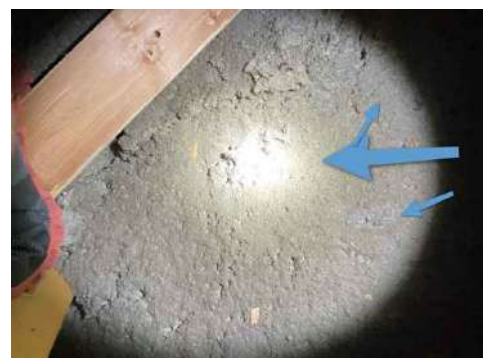
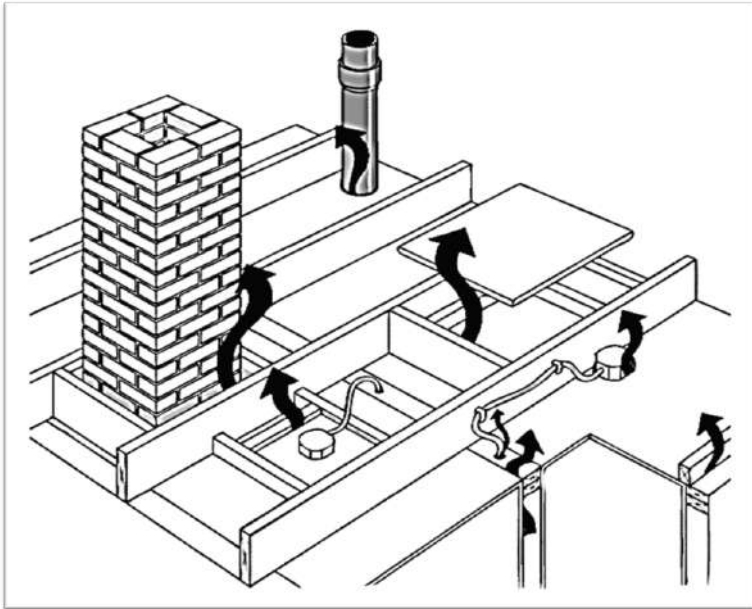
It appears that "attic rain" may have occurred in the past. This phenomenon occurs when warm, moist air is trapped in the attic space and freezes to the sheathing. When sudden warm periods occur outside, this causes the frost in the attic to thaw potentially damaging the building materials and dripping into the structure.

Recommendation
Contact a qualified roofing professional.

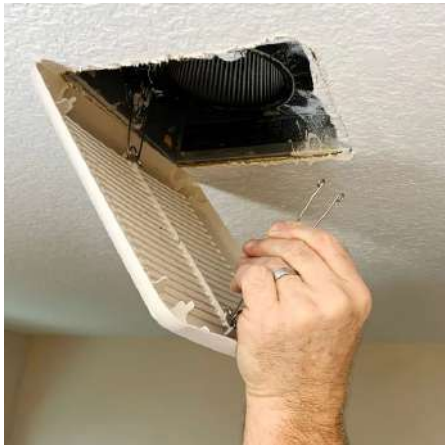
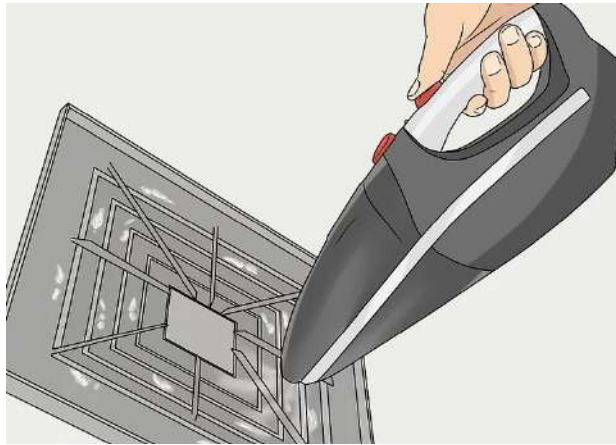
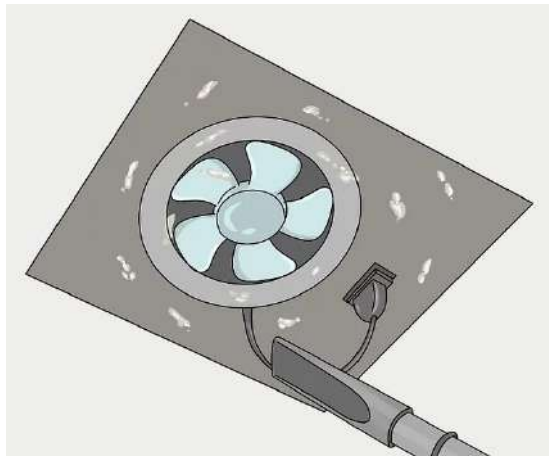
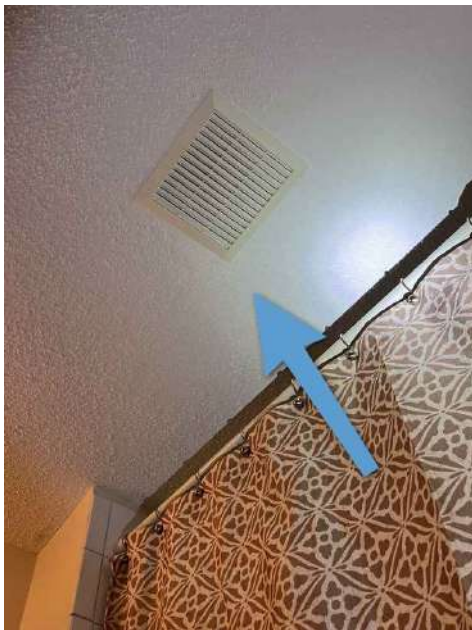
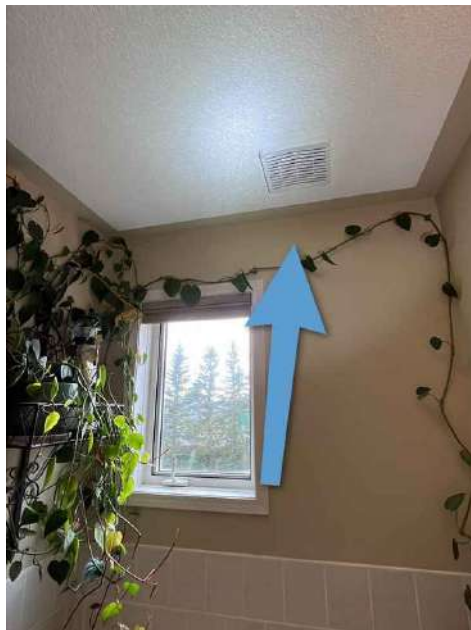
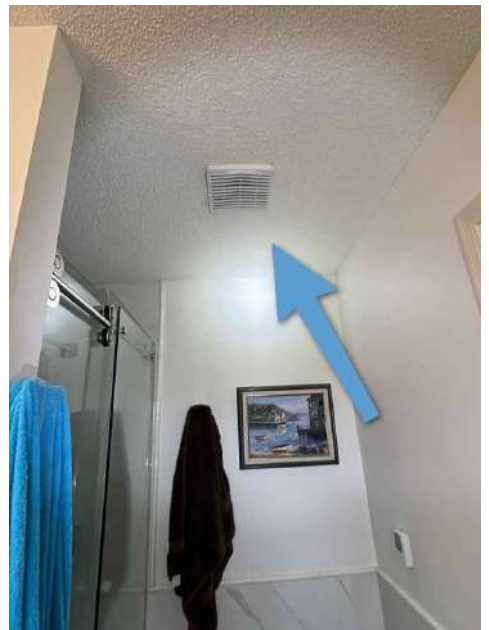
9.2.1 Exhaust Systems

DIRTY EXHAUST FAN COVER(S)

Some of the grills for the exhaust fans were found to be dirty; resulting in a loss of air flow. It is recommended to have these cleaned; using the dishwasher is a simple and quick method.

Contact a handyman or DIY project

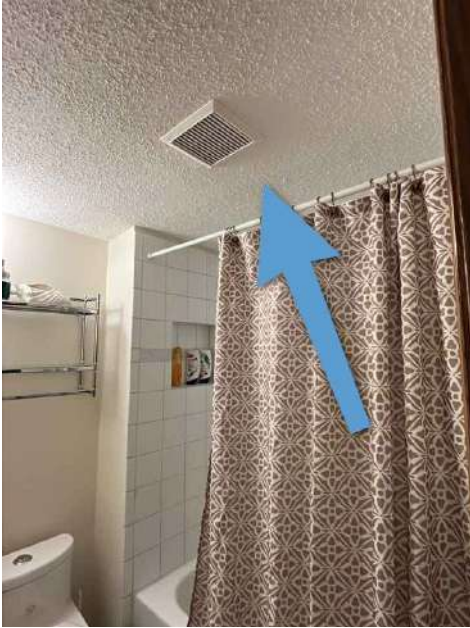
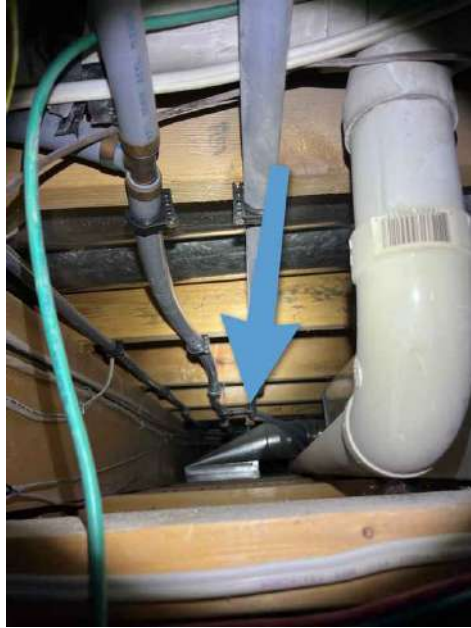
9.2.2 Exhaust Systems

TERMINATION POINT NOT FOUND

One or more fan termination points could not be found. This should be further investigated.

Contact a qualified handyman.

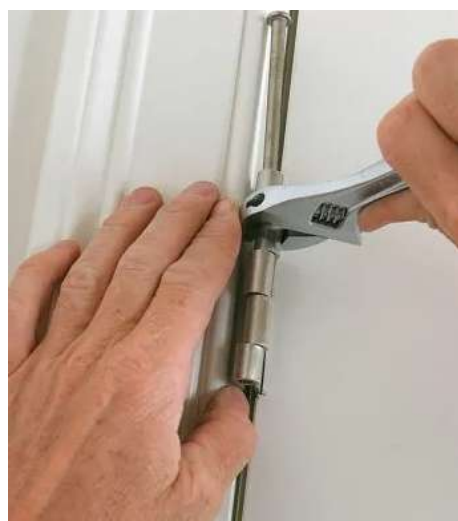
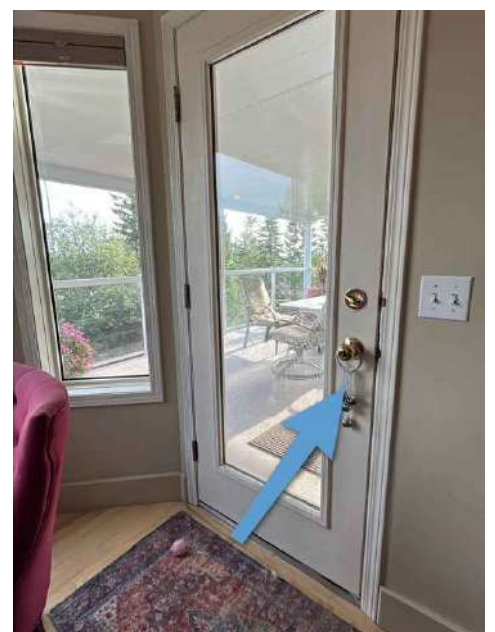
10.4.1 Doors

ADJUSTMENT NEEDED

One or more doors should be adjusted for smoother operation.

Recommendation
Contact a qualified professional.

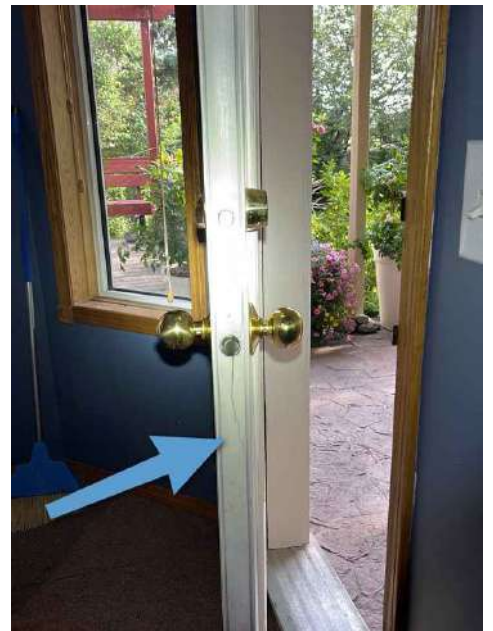
10.4.2 Doors

DAMAGE

One or more doors were noted to have damage.

Contact a qualified door repair/installation contractor.

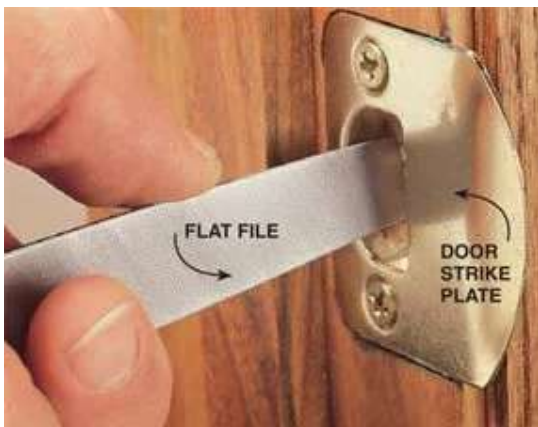
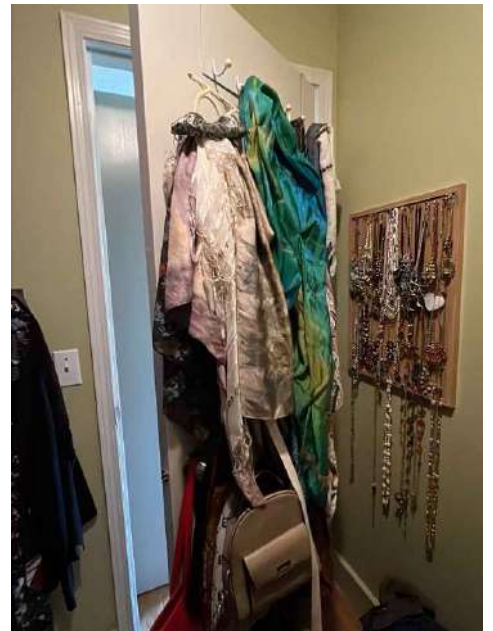
10.4.3 Doors

DOESN'T LATCH

One or more doors did not latch well. A servicing is recommended for smoother operation.

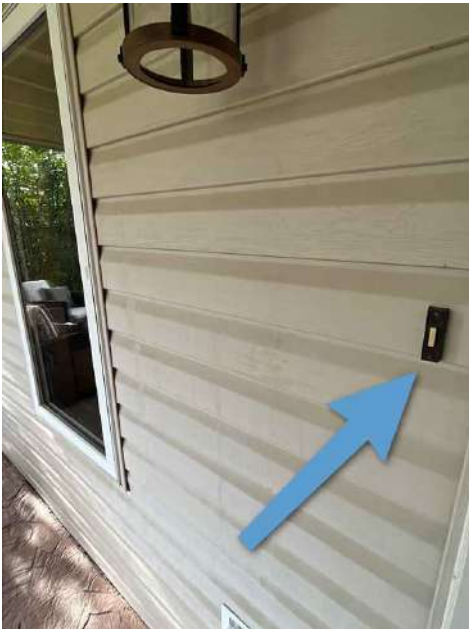
10.4.4 Doors

**DOORBELL
INOPERATIVE**

The inspector was unable to function the doorbell. Proper operation should be inquired or a possible servicing is needed.

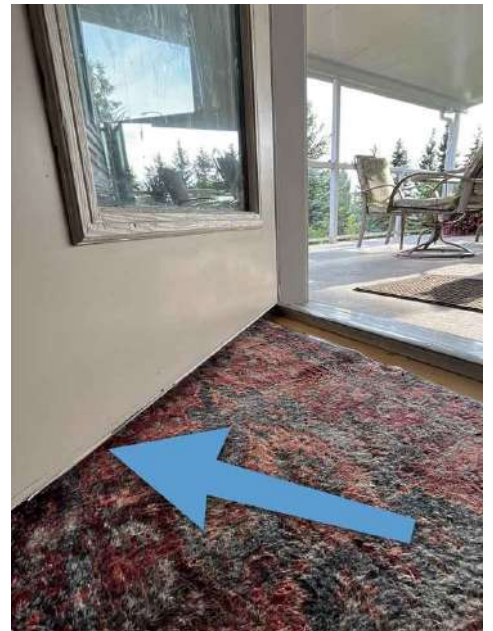
10.4.5 Doors

DOOR SWEEP(S)

One or more door sweeps should be replaced as they are beyond the service life. These help keep the outside weather from entering the building.

Contact a qualified door repair/installation contractor.

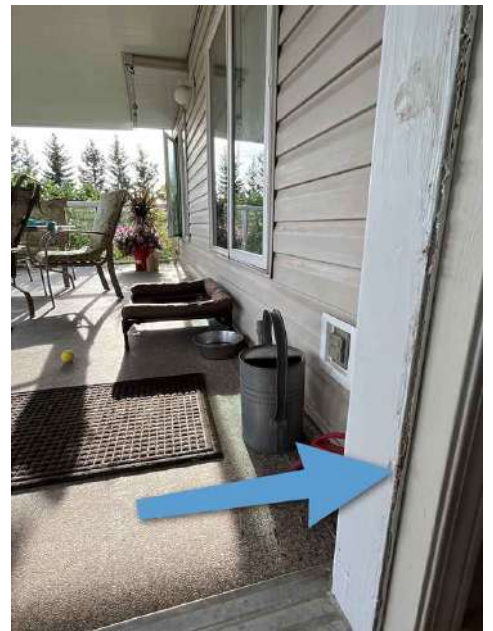
**WEATHERSTRIPPING
INADEQUATE**

It is recommended to install new weather stripping at the following exterior doors. Weather stripping helps to the seal against the weather.

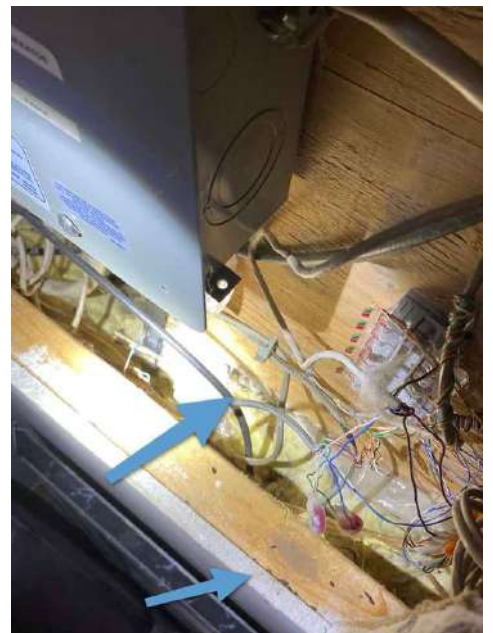
10.9.1 Rodents / Vermin

EVIDENCE OF RODENTS / VERMIN

Evidence of pests were noted in the structure. It is recommended to inquire on the history of any events.

Recommendation
Contact a qualified professional.
