PROPERTY REPORT

1234 Main Street
Calgary, AB T3K3V9

Buyer Name
09/17/2024 9:00AM

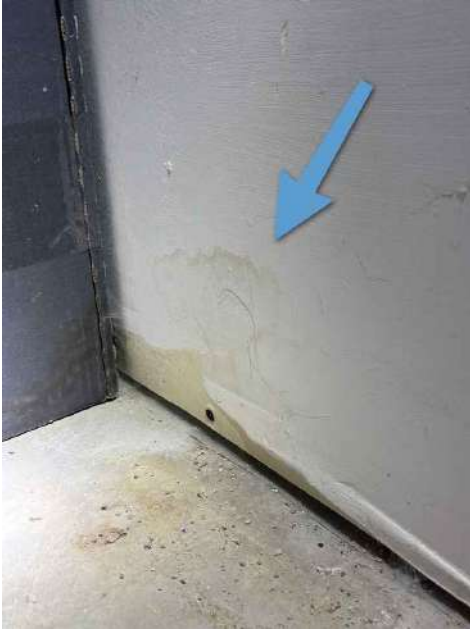
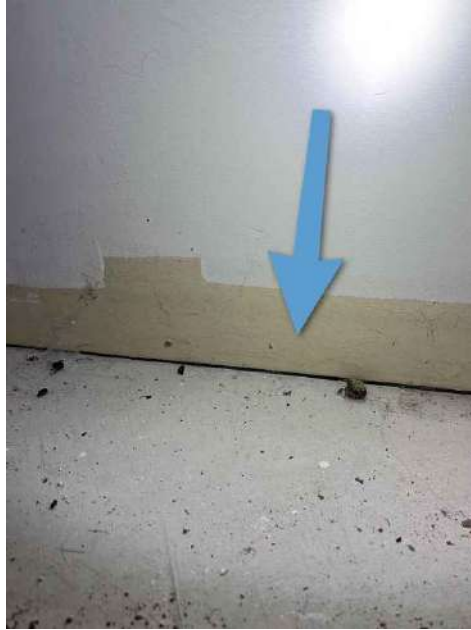
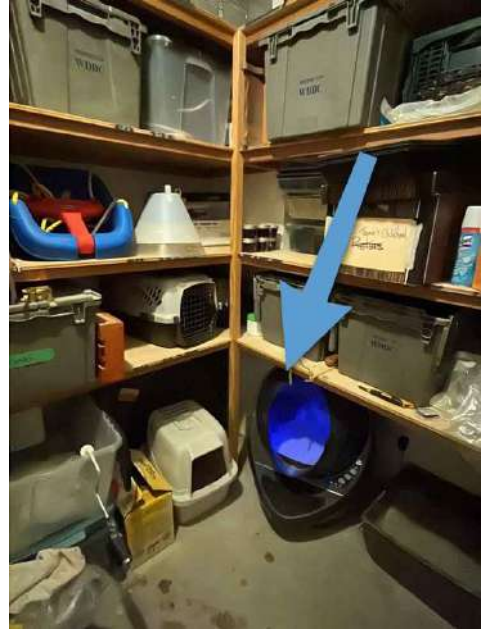
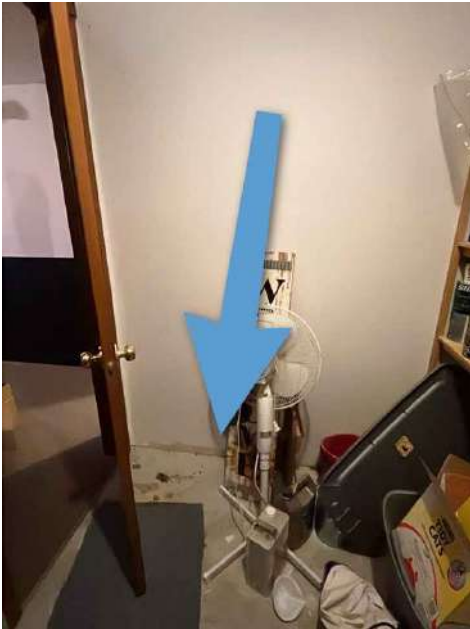
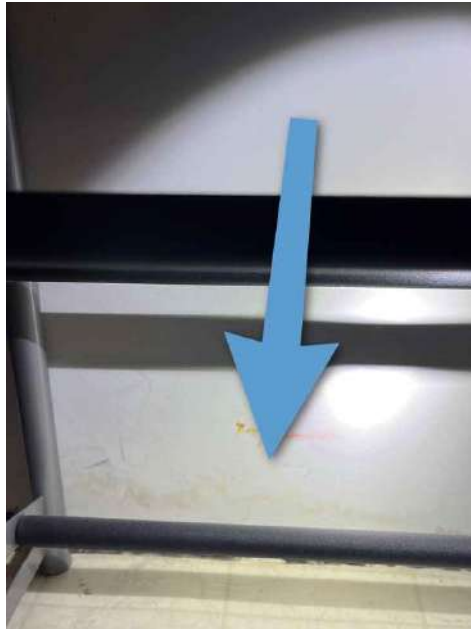
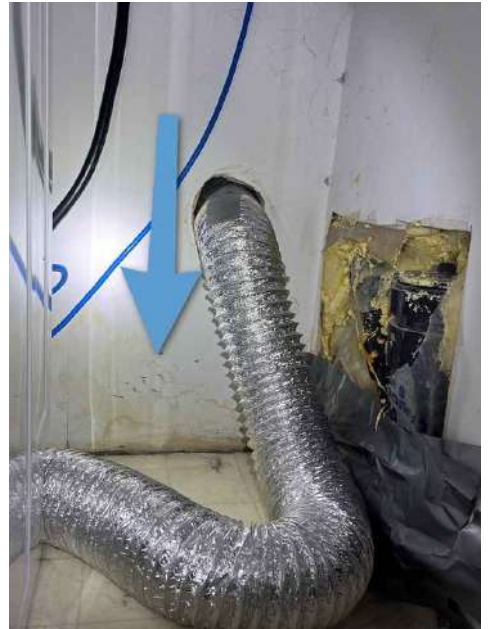
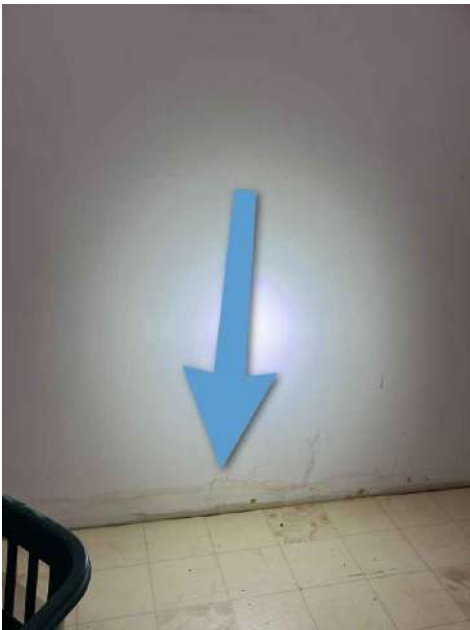
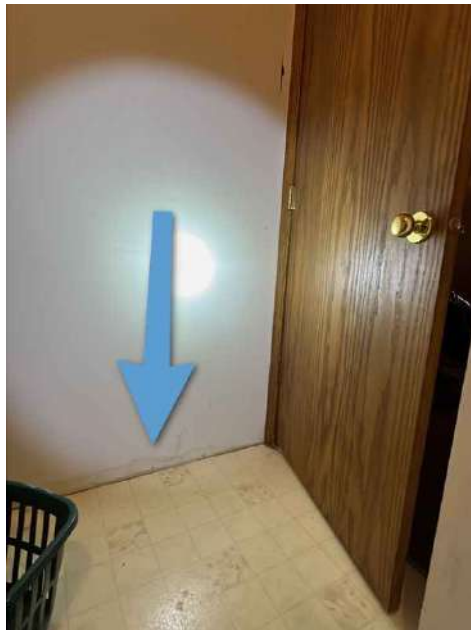
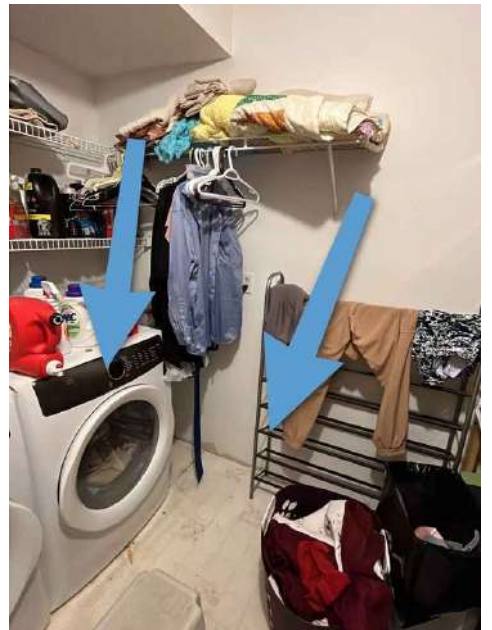
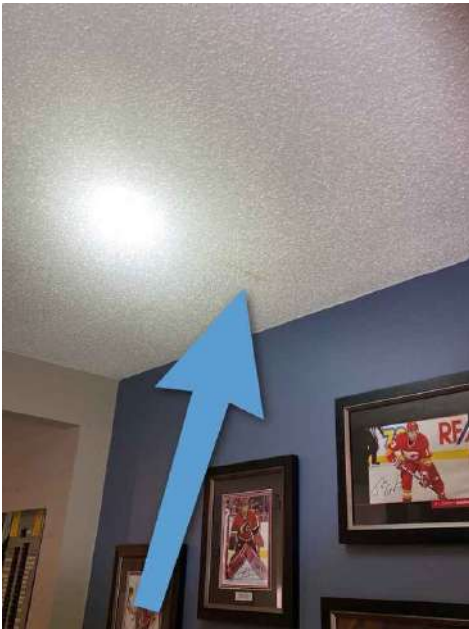
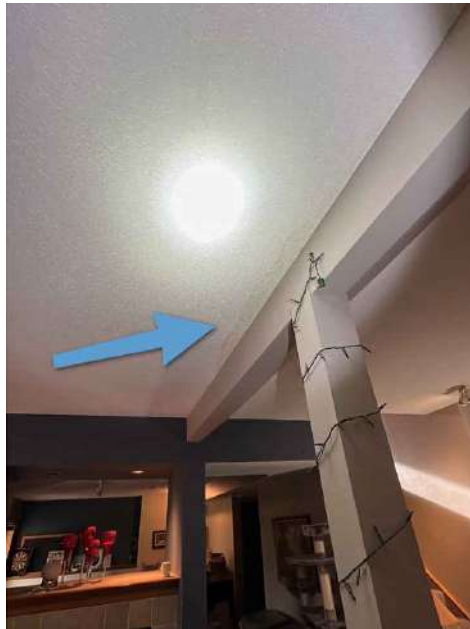
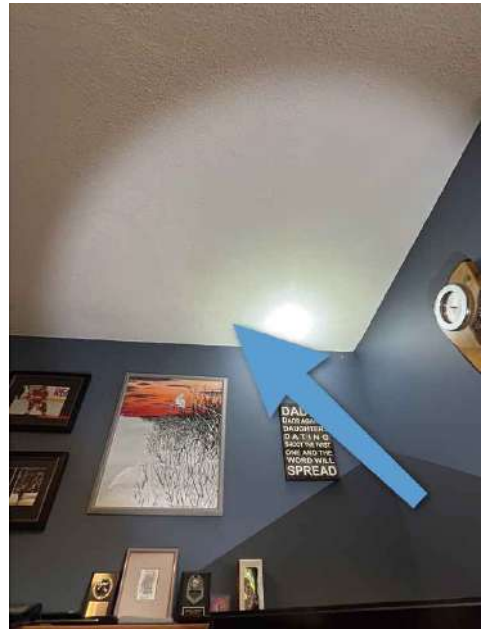
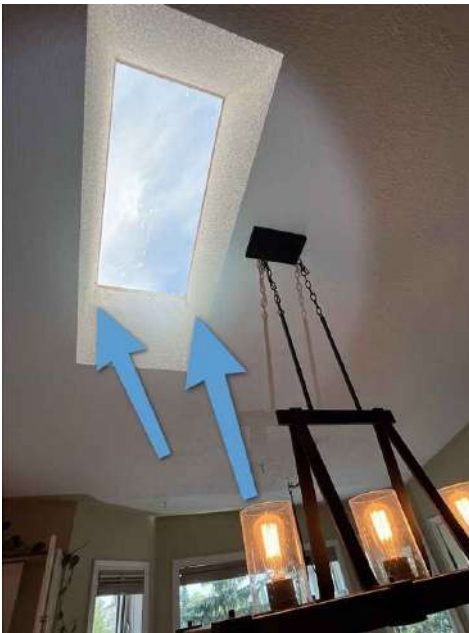
10.15.1 Water Marks / Damage

Water marks were noted in one or more areas. It is recommended to inquire on the history of the event(s).

Recommendation

Contact a qualified professional.

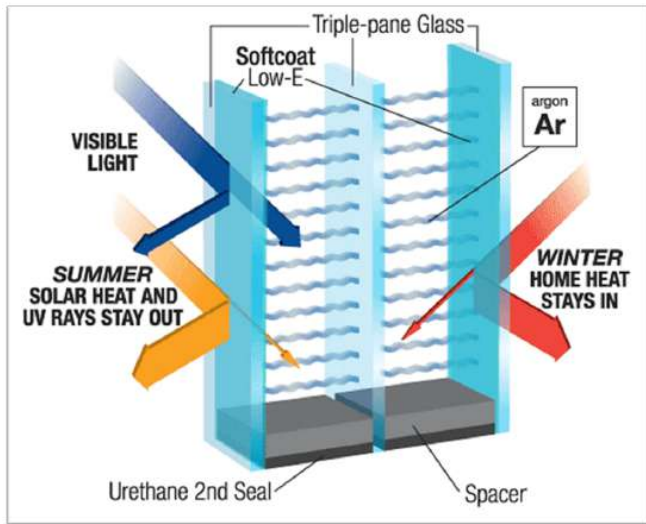
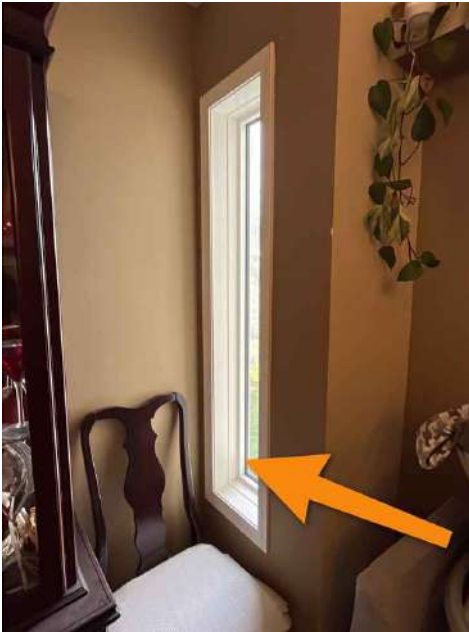
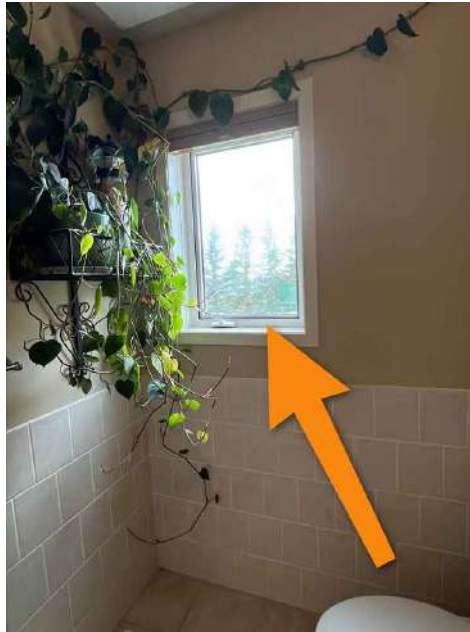
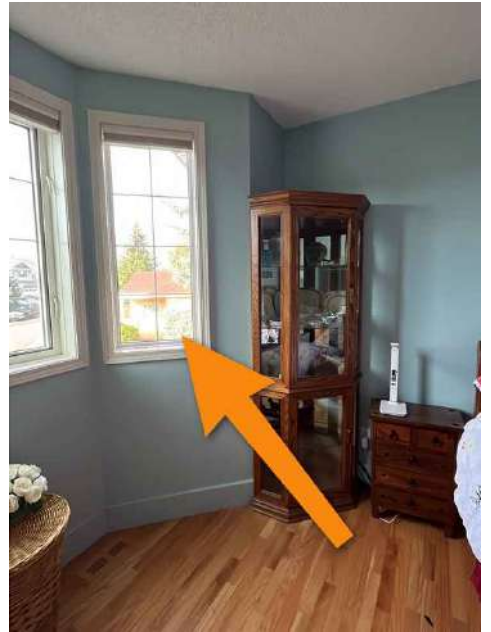
10.16.1 Windows

SEAL / GLAZING FAILURE

One or more windows in the structure exhibited a failed seal or glazing. Although often considered a cosmetic issue, mold and wood rot may be a side product in the future.

Recommendation

Contact a qualified window repair/installation contractor.

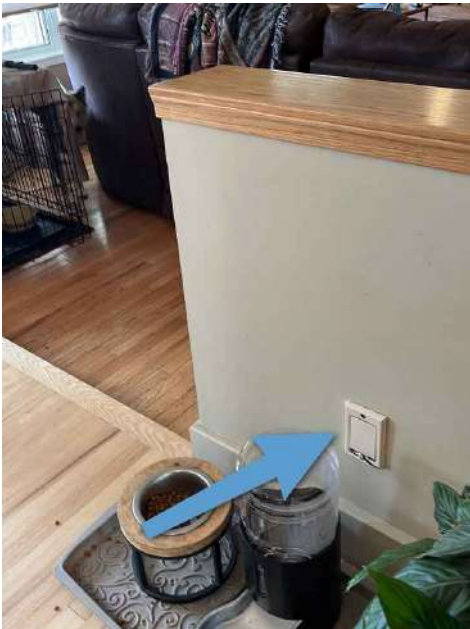
11.2.1 Central Vacuum

DAMAGED / LOOSE PORT

One or more ports were noted to be loose or damaged.

Recommendation

Contact a qualified appliance repair professional.

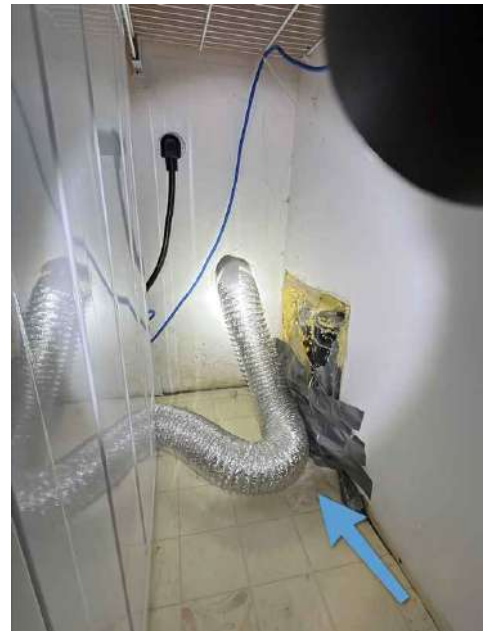
11.9.1 Washer / Dryer

DRYER VENT - CORRUGATED LINE

It is recommended to use smooth metal vent lines rather than corrugated ones as the lint may get stuck to the corrugations.

Recommendation

Contact a qualified professional.

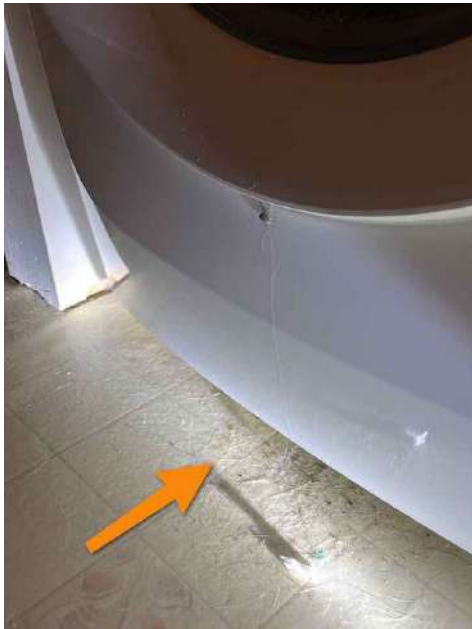
WASHER LEAK

A leak was noted at the washer. A service is recommended.

Recommendation

Contact a qualified appliance repair professional.
